July 21, 2020

Reference: The Courtyards of Carlisle
Moisture Testing and Water Infiltration Investigation
Becht Project Number 20-0338

Moisture Probe Summary Tables and Photographs

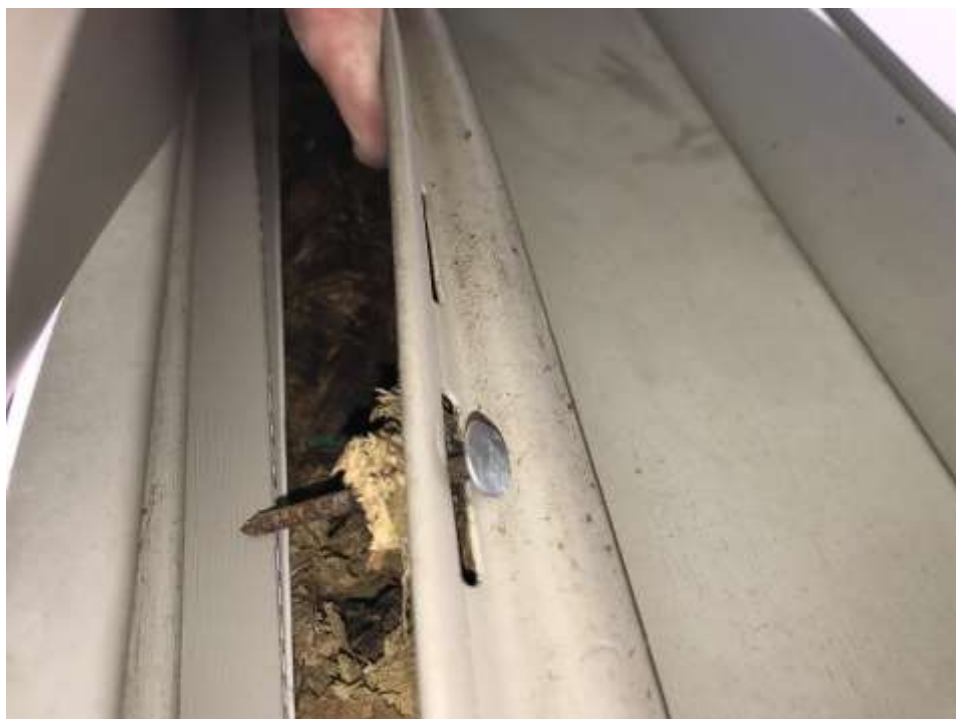
Building 1 - 1324 North West Street. Rot under window.

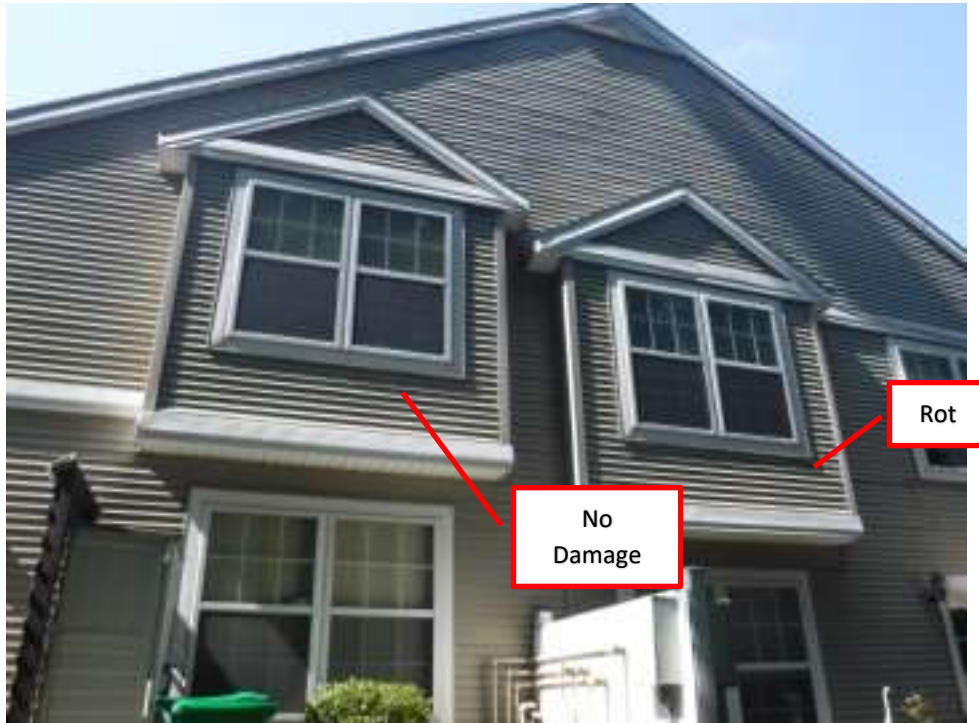
Building 1 - 6 Courtyard Drive and 1324 North West Street. No Damage at 6 Courtyard Drive

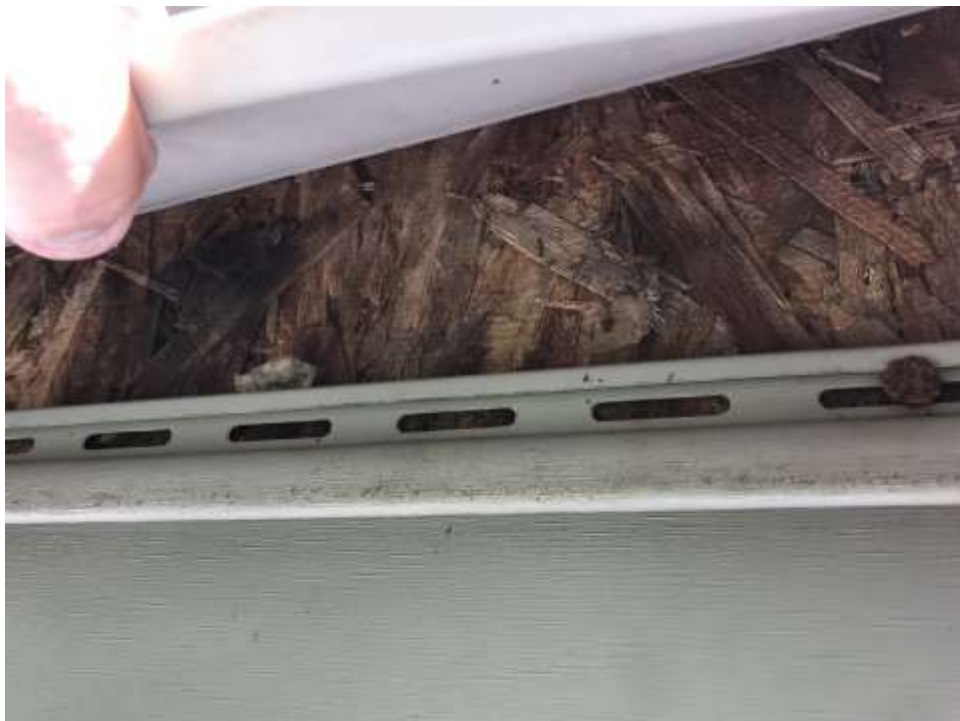
Building 1 - 1324 North West Street. Rot under window.

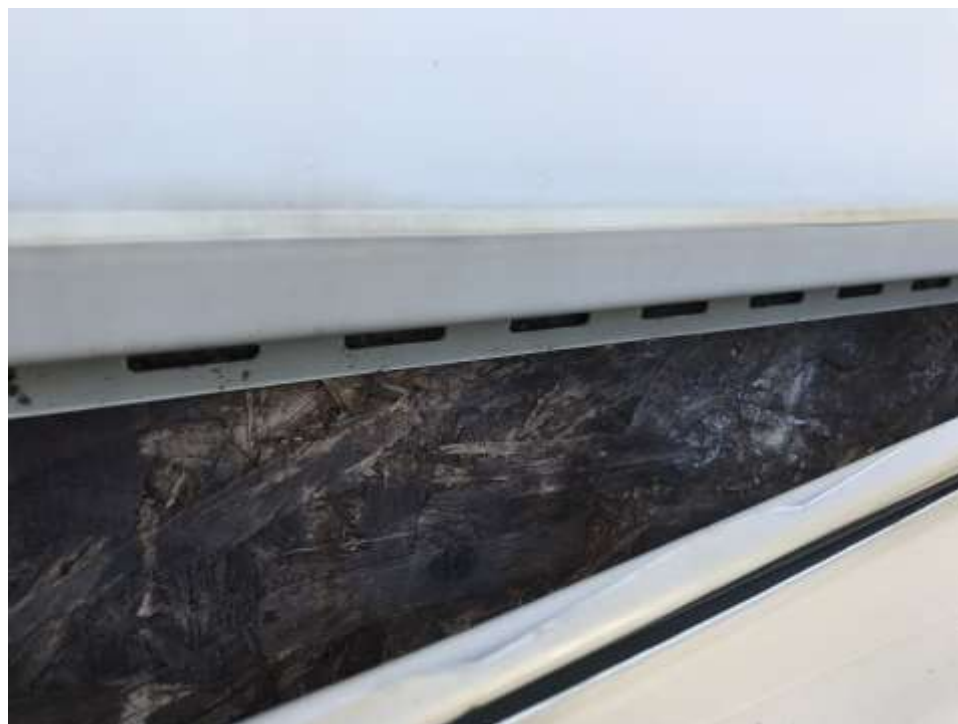
Building 1 - 2 Courtyard Drive. Rot under window.

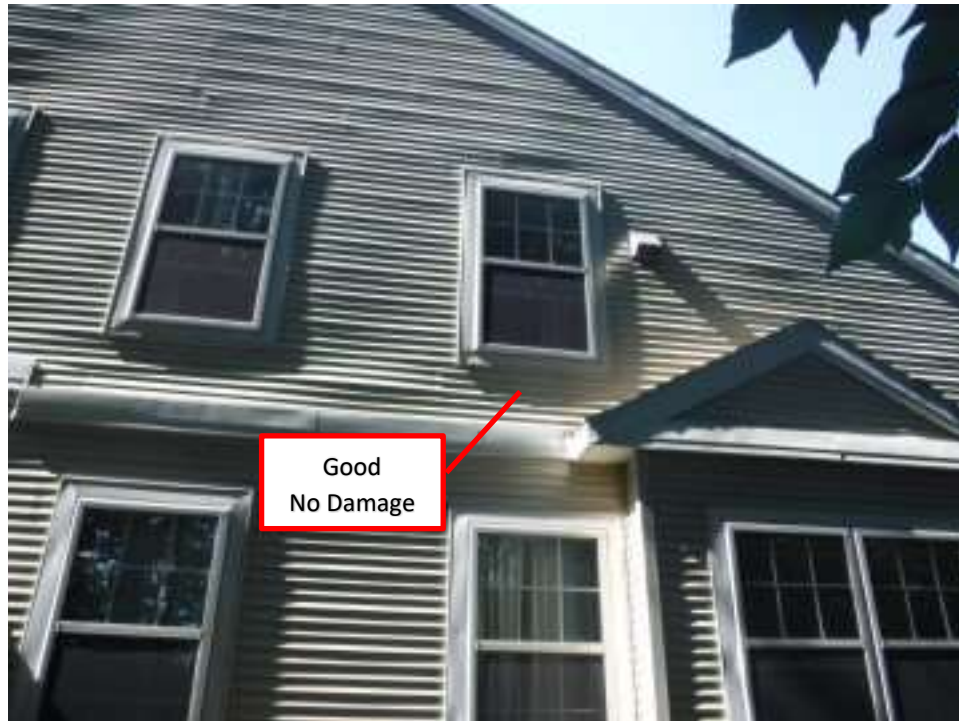
Building 2 - 12 Courtyard Drive

Good
No Damage

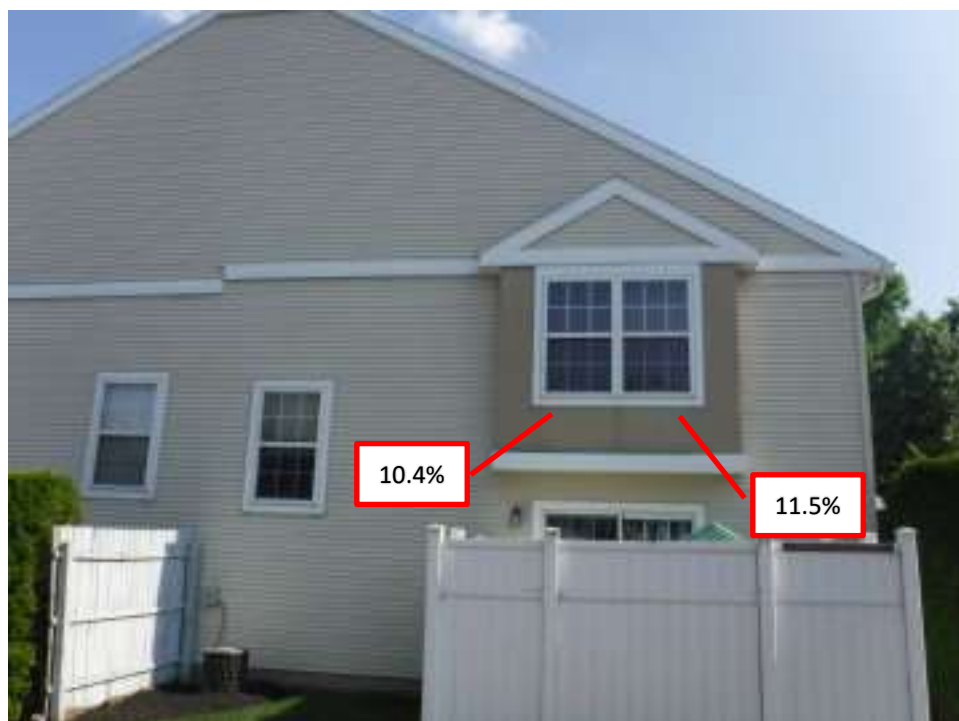
Building 2 - 14 Courtyard Drive

10.4%

11.5%

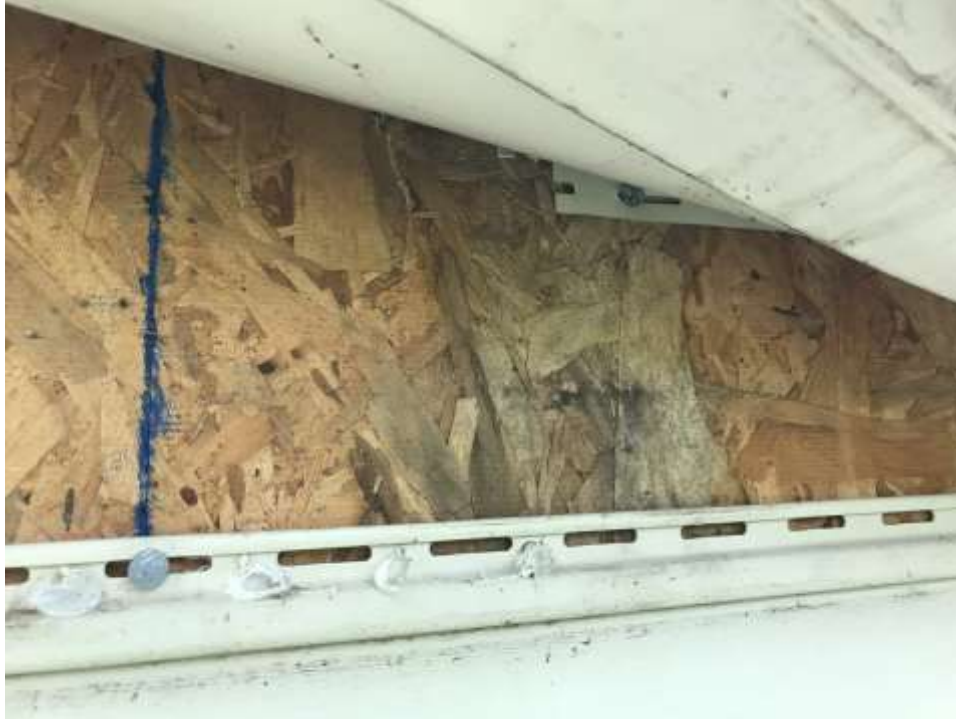
Building 2 - 18 Courtyard Drive. Stain under right window.

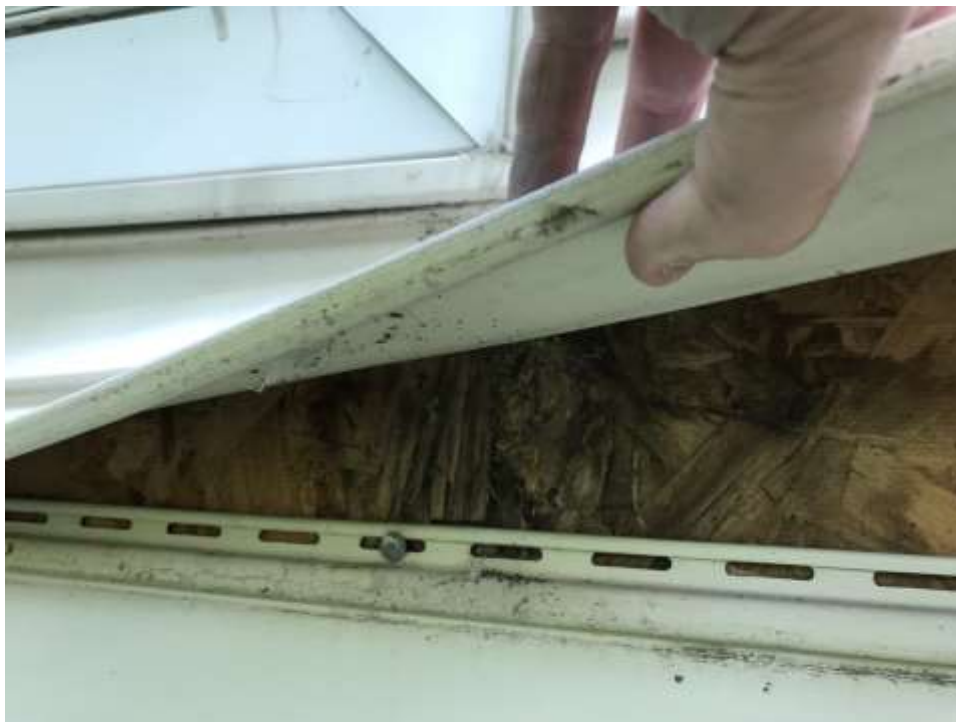
Building 2 - 18 Courtyard Drive. Stain under right window.

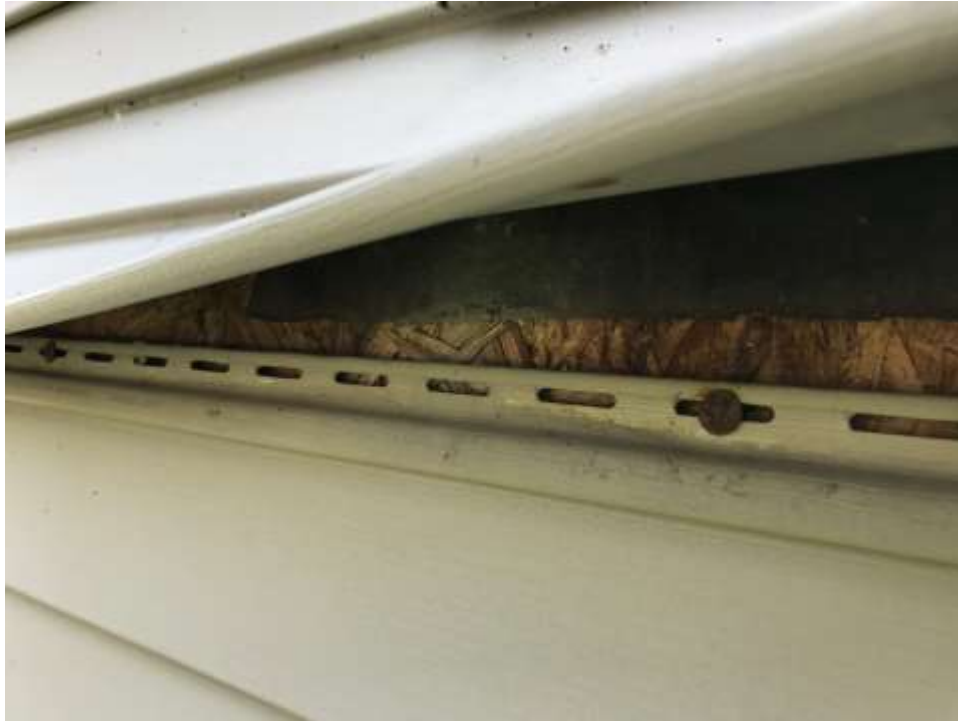
Building 3 - 26 Courtyard. Sheathing stained and flaking under 2nd floor window.

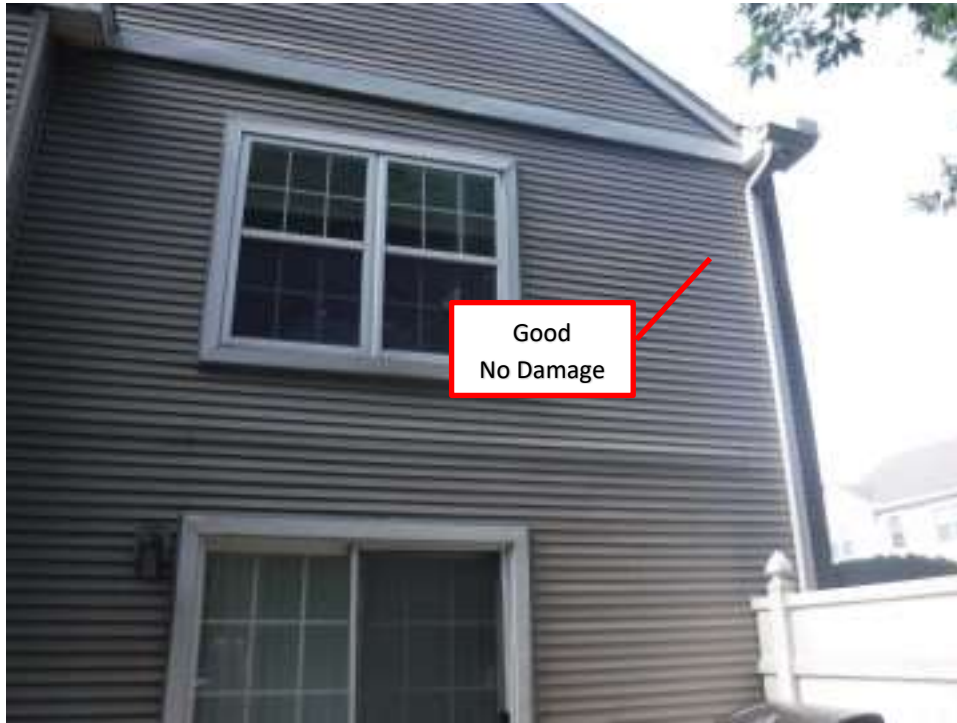
Building 5 - 48 Courtyard Drive

Good
No Damage

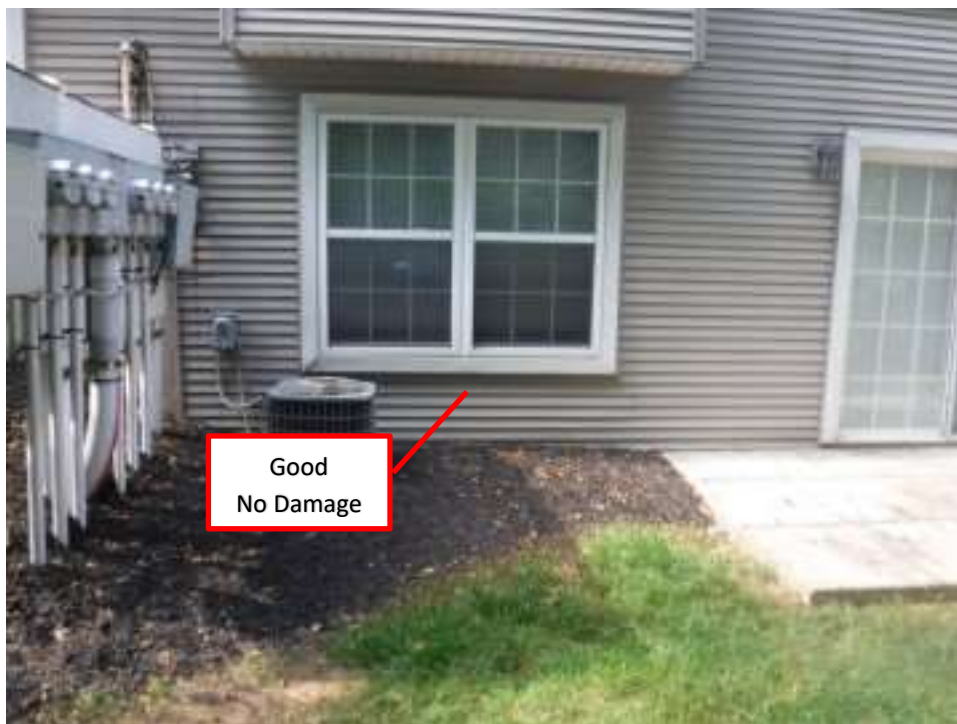
Building 5 - 48 Courtyard

Good
No Damage

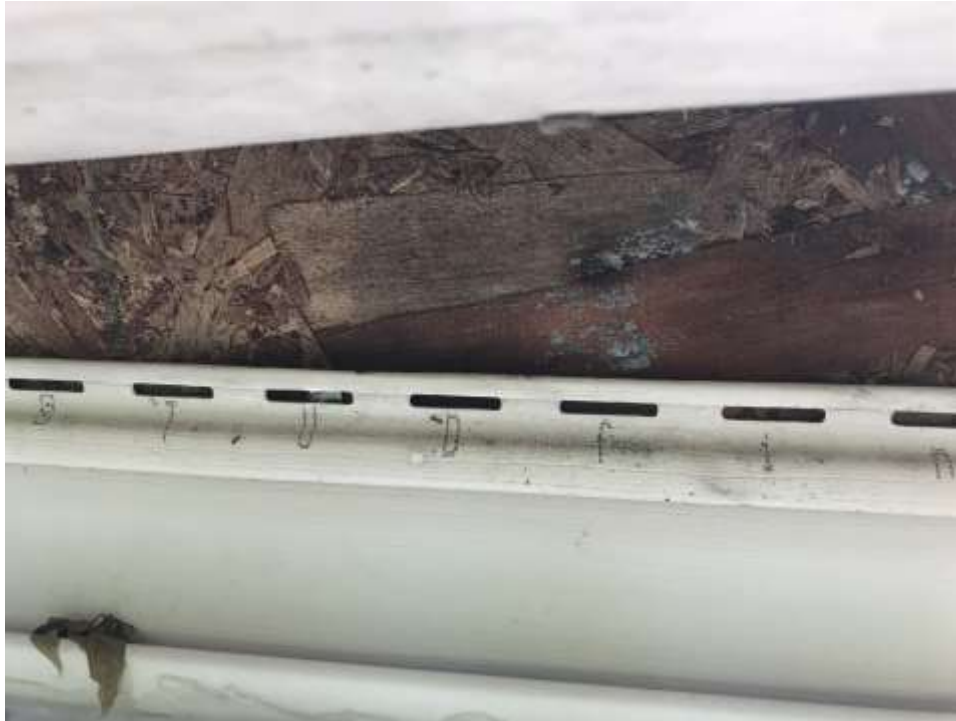
Building 6 - 66 Courtyard. Water stains, mold and ants observed.
