Project: Courtyards of Carlisle CA – Siding Project

Project #: 14372-04

Date: Nov 6, 8, 9, 2023

Field Report 1

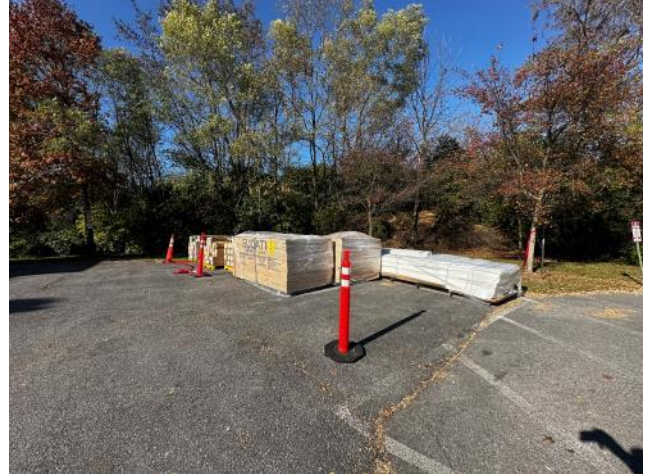
Photo #2: Overview of new materials at the parking area by Building 18 on Court Lane.

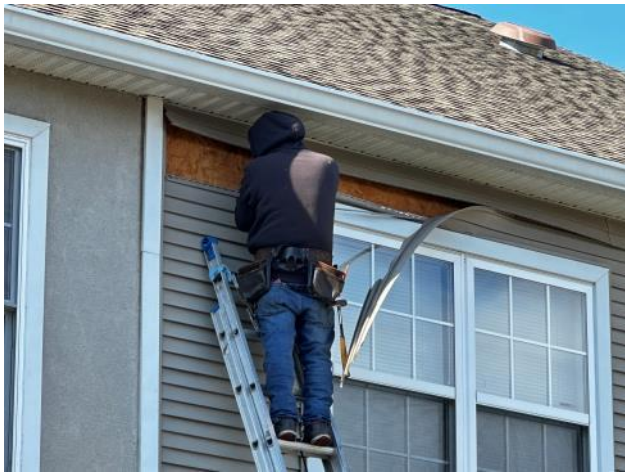
Photo #11: Overview of existing siding and soffit being removed.

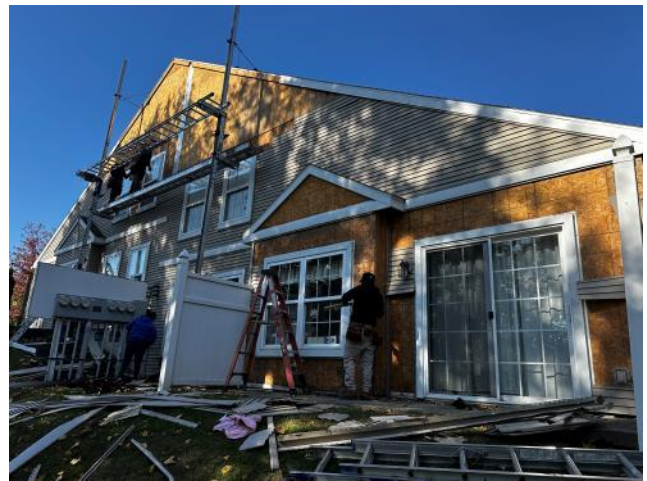
Photo #12: Overview of existing siding being removed at the side of Units 96 and 1239. No Water Resistant Barrier was observed.

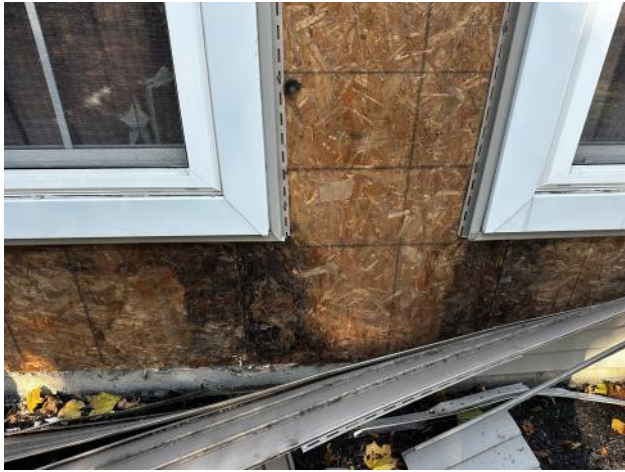
Photo #13: Overview of existing sheathing that was observed in poor condition below windows at Unit 96.

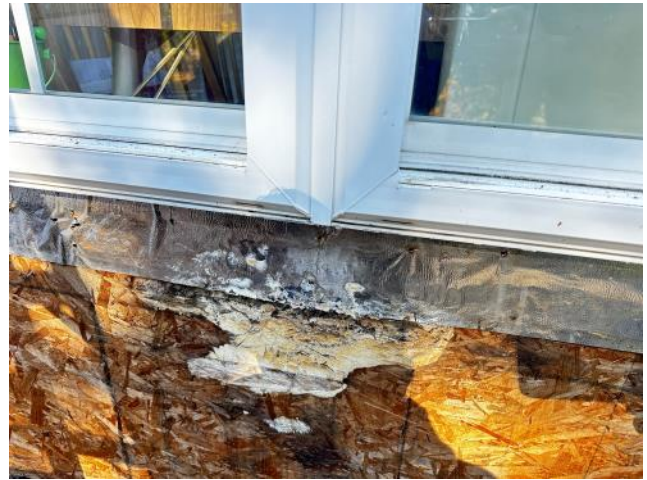
Photo #14: Overview of another section at another window where existing sheathing was observed in poor condition.

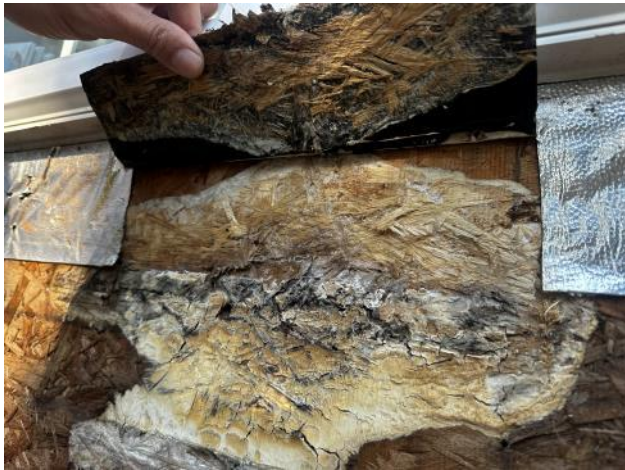
Photo #15: Water/moisture have been infiltrating through the existing window.

These existing conditions will need to be communicated to the homeowners in case they want to replace their windows and notify Lemus Construction. Even though new water resistant barrier is being installed and those deteriorated windows are being flashed, it does not guaranteed that those existing windows will not leak in the future. In the event that homeowners decline to replace their existing deteriorated windows, homeowners will need to be liable.

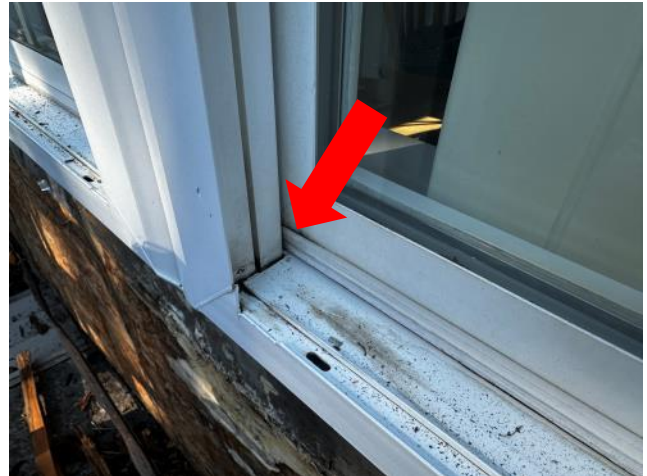
Photo #16: Many windows were observed to be failing.

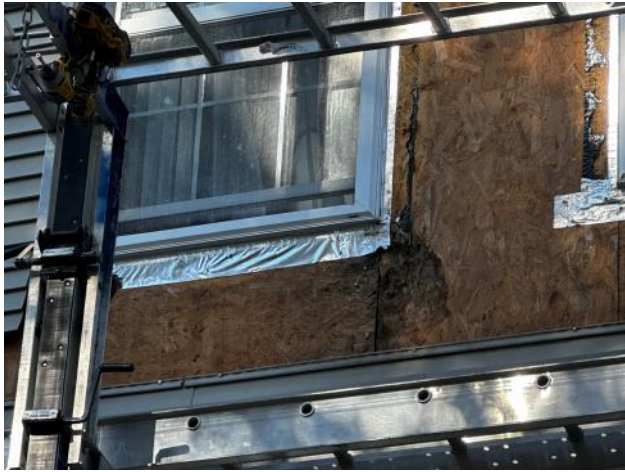
Photo #17: Overview of another section where the sheathing is damage below a window at Unit 1239.

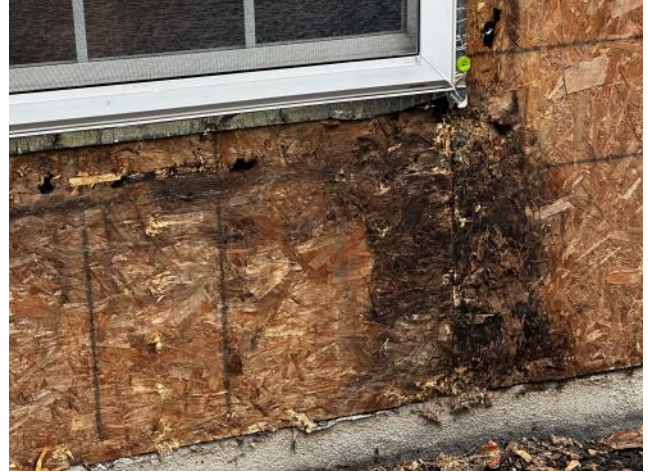
Photo #18: Overview of another section where the sheathing is damage below a window at Unit 96.

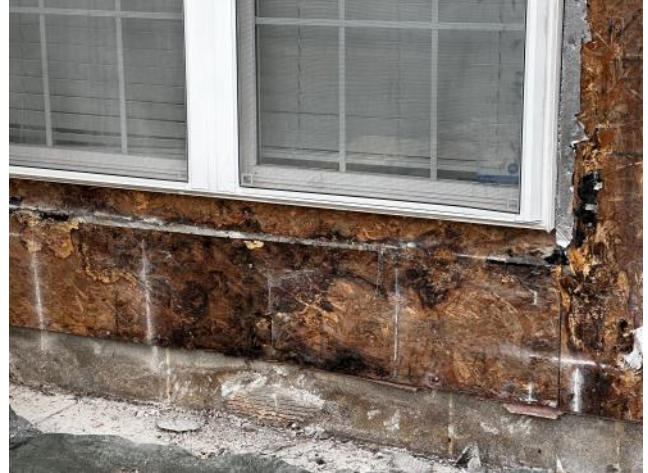
Photo #20: After the stucco was removed, the sheathing was observed to be damaged below a window at Unit 1241.

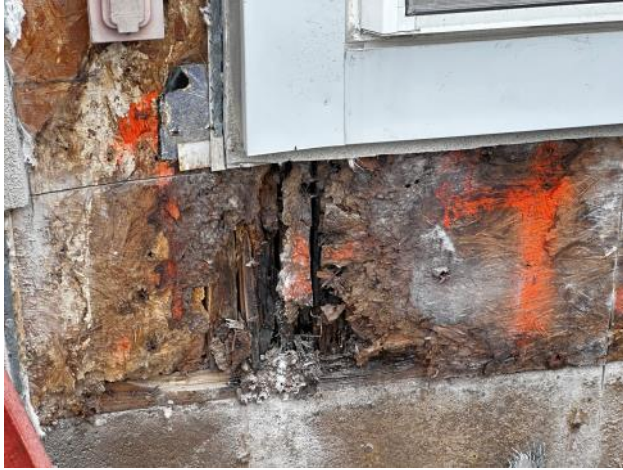
Photo #21: Overview of another section where the sheathing is damaged below a window at Unit 1241.

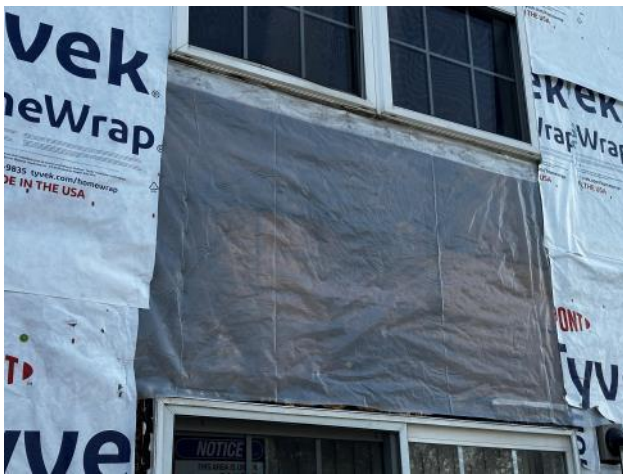
Photo #23: Plastic tarps are being temporally installed at the damaged sheathing sections until the crew properly replaces it with new sheathing. Overview of damaged sheathing between a sliding door and the upper window at Unit 1243.

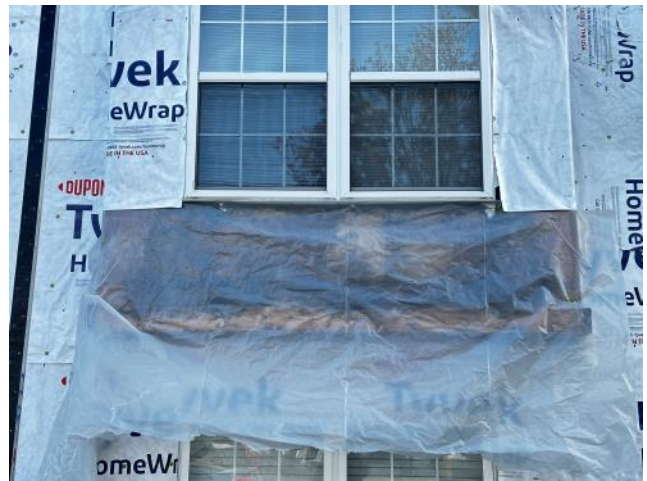
Photo #24: Overview of another damaged section at an upper box window where stucco was removed at Unit 92.

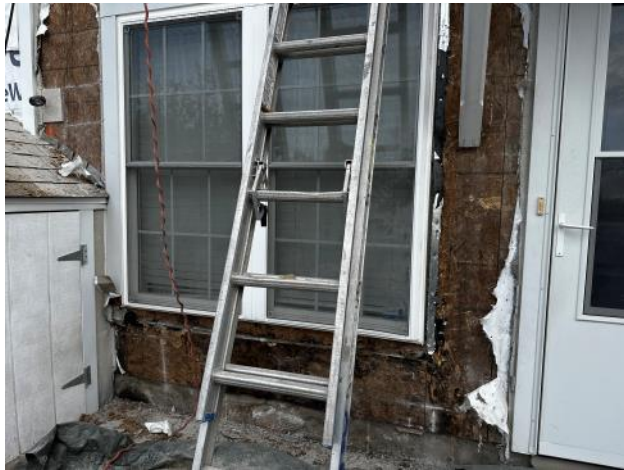
Photo #35: It should be noted that some "replacement windows" were observed where the existing stucco was located.

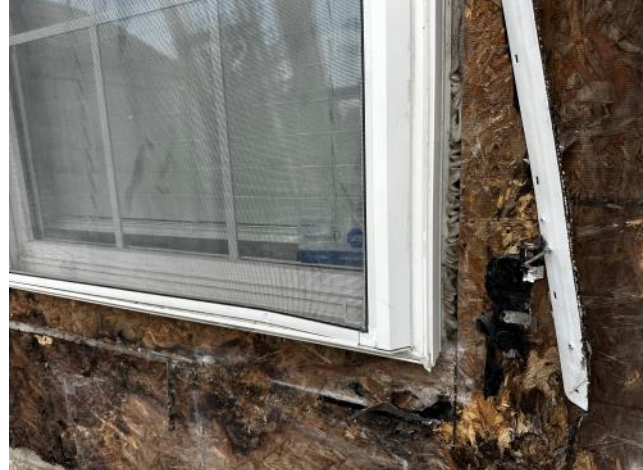
Photo #36: This "replacement windows" does not have any nailing flanges. Lemus will remediate this by installing new metal flanges. That way these windows can be properly flashed.

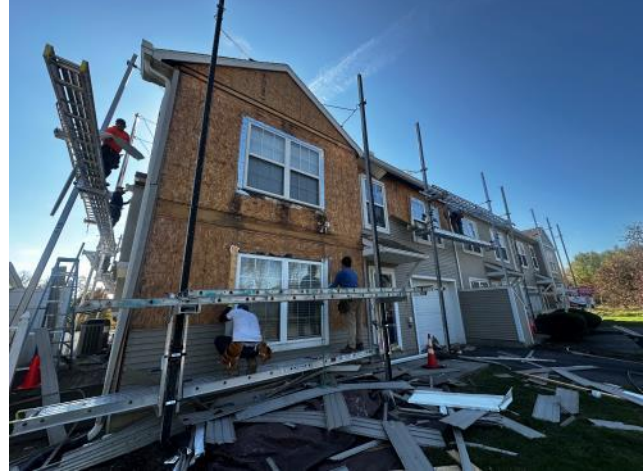
Photo #38: Overview of existing siding being removed at the front of the Building. No Water Resistant Barrier was observed.

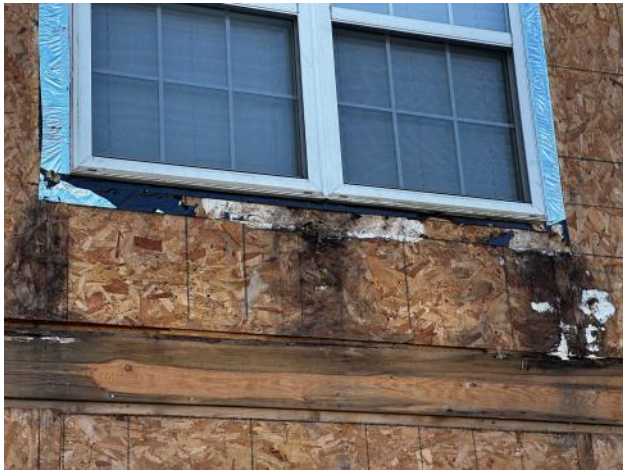
Photo #39: Overview of existing sheathing that was observed in poor condition below an upper window at Unit 115.

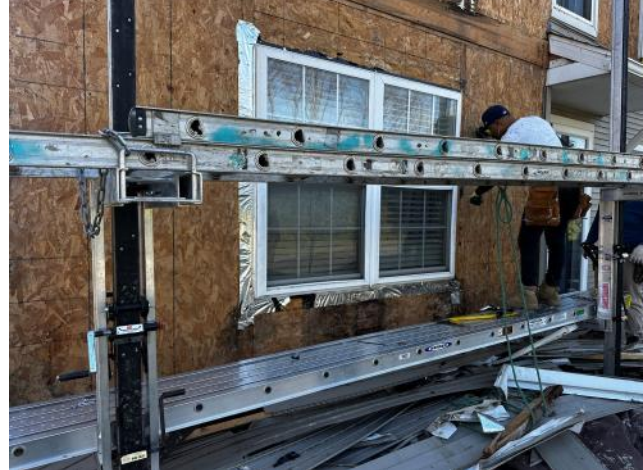
Photo #40: Overview of existing sheathing that was observed in poor condition below a lower window at Unit 115.

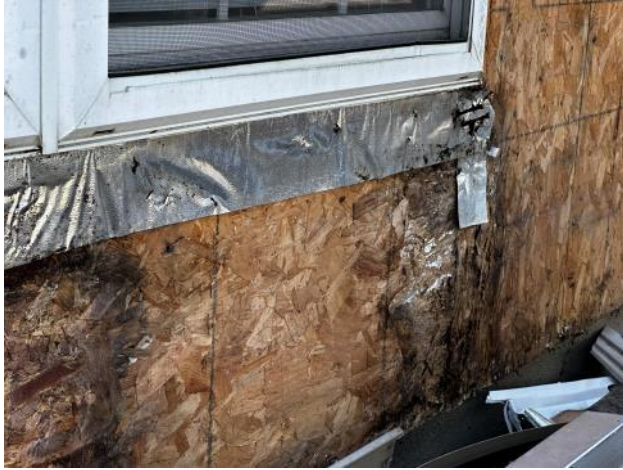
Photo #41: Water/moisture have been infiltrating through the existing window.

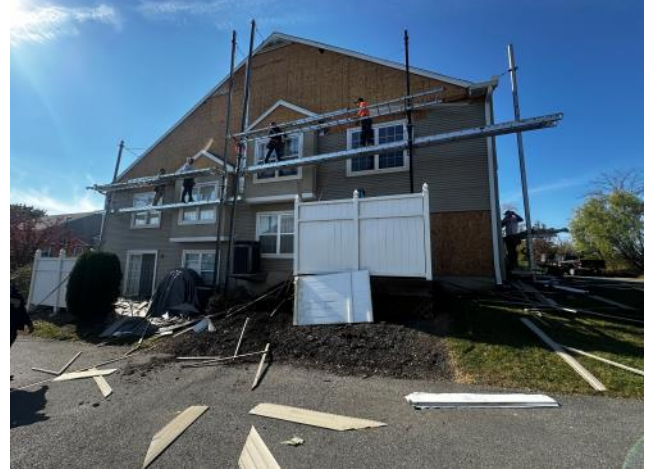
Photo #42: Overview of existing siding/stucco being removed at the side of the Building. No Water Resistant Barrier was observed.

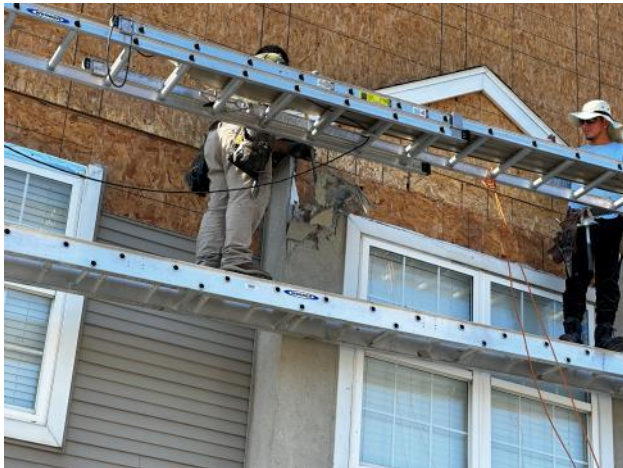
Photo #43: Overview of existing stucco being removed at a box window. No Water Resistant Barrier was observed.

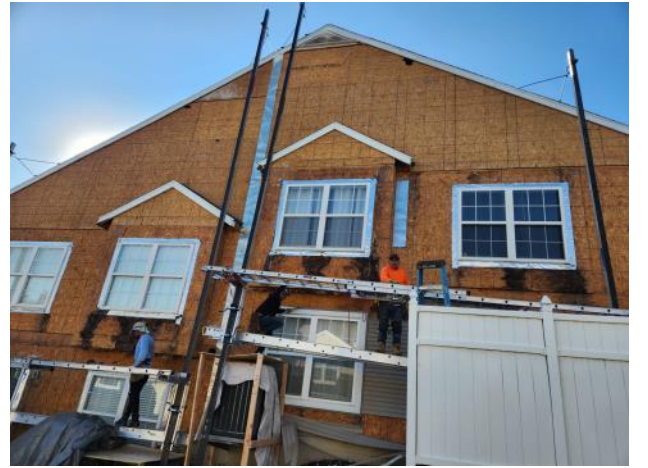
Photo #44: Overview of other sections where the sheathing is damage below windows at Units 105 and 115.

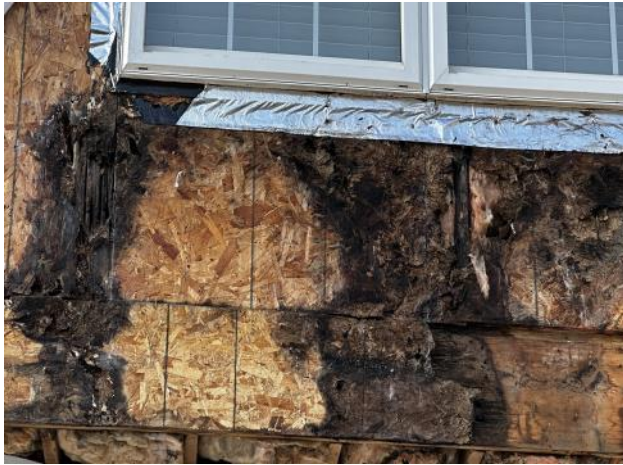
Photo #45: Overview of a section where the sheathing was severely damaged below the box window at Unit 115.

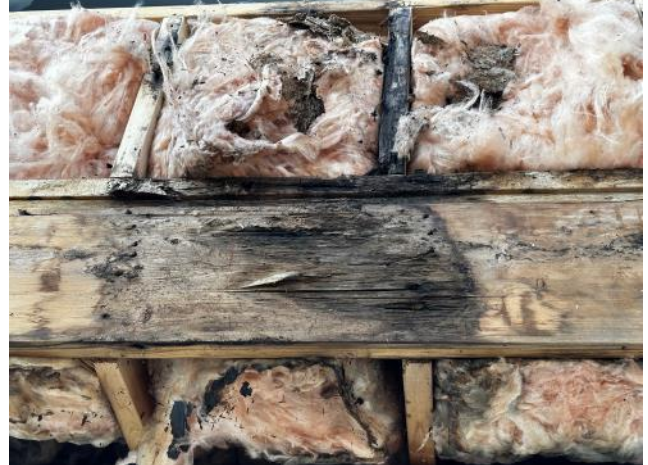
Photo #46: After sheathing in poor condition was removed, 2x10 floor joist was observed to be damaged.

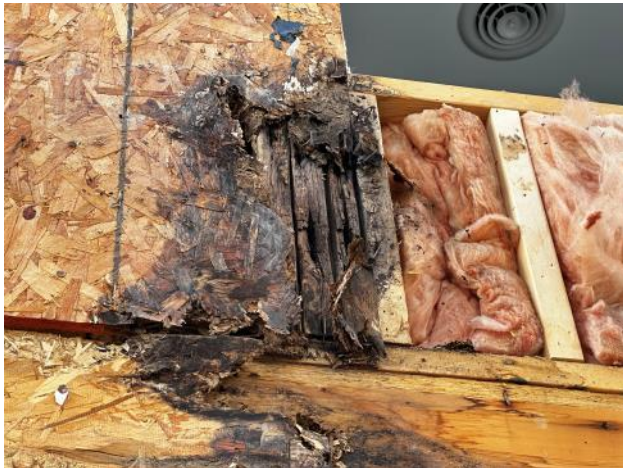
Photo #47: Framing studs were also observed to be in poor condition.

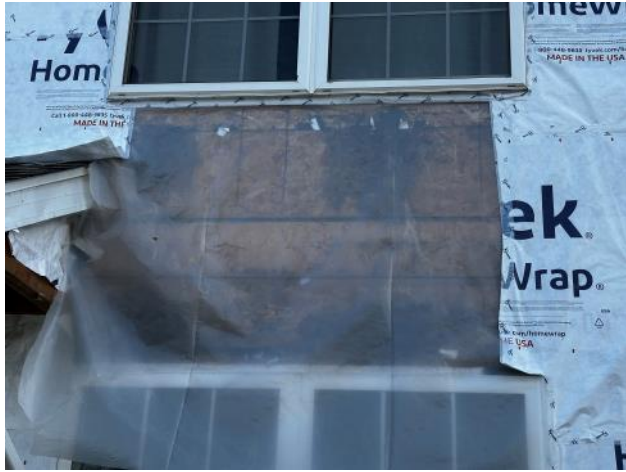
Photo #49: Plastic tarps are being temporally installed at the damaged sheathing sections until the crew properly replaces it with new sheathing. Overview of damaged sheathing between the upper and lower windows at Unit 111.

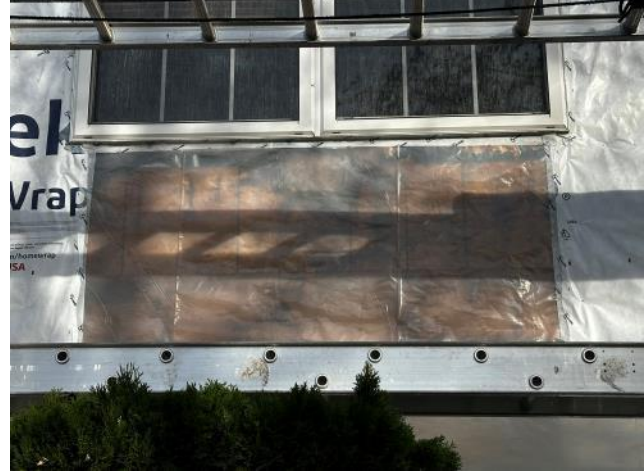
Photo #50: Overview of another section where the sheathing is damage below a window at Unit 109.

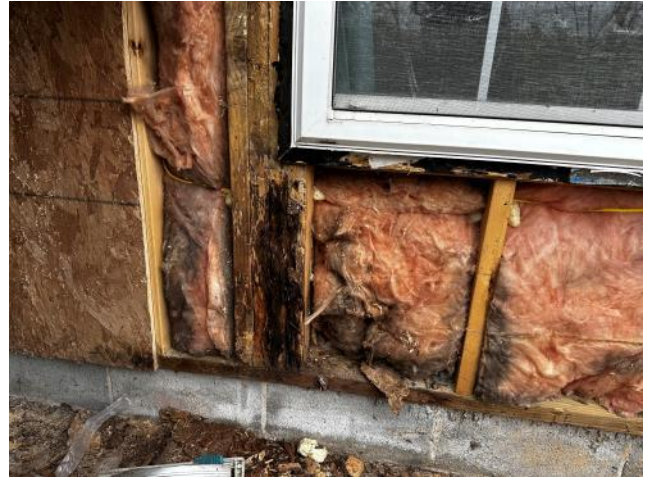
Photo #54: Overview of damaged framing studs.

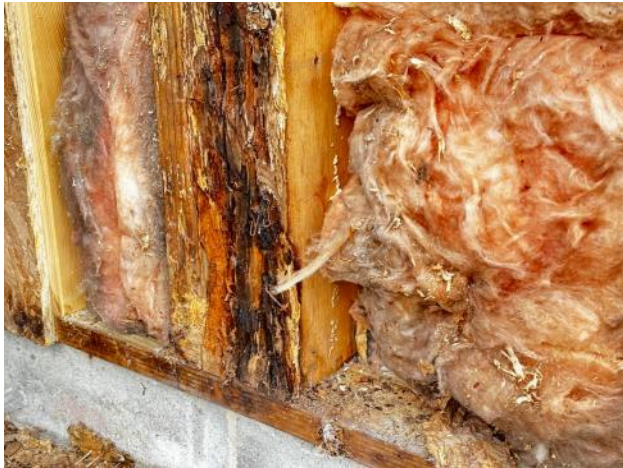
Photo #55: In this case was surface rot. It was instructed to reinforce these studs with new 2x4s and 2x6s as needed.

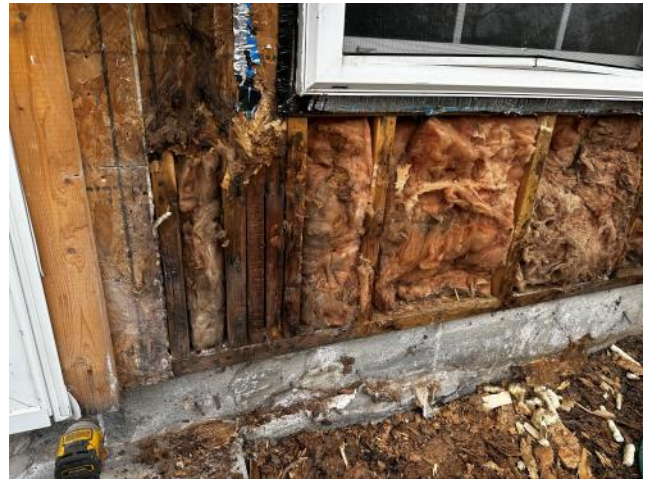
Photo #58: Overview of surface rot.

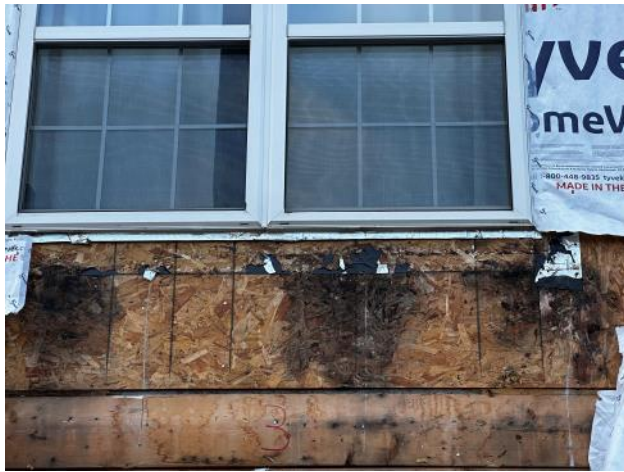
Photo #63: Overview of another section where the sheathing is damage below an upper window.

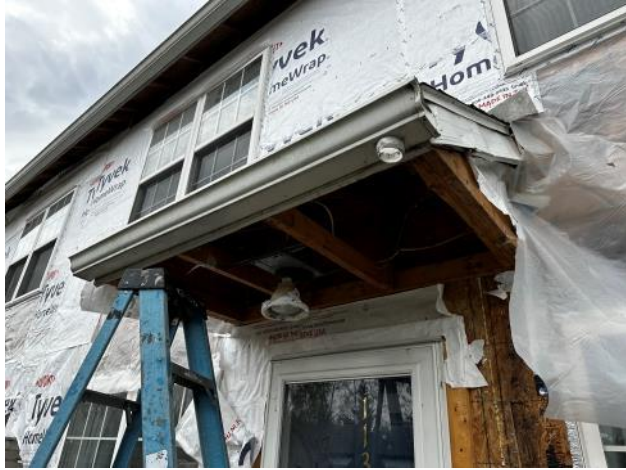
Photo #69: It should be noted the Lemus brought to the attention to the Board to eliminate the bracket at the small entrance roofs. While they were working, it was inspected one of those entrances.

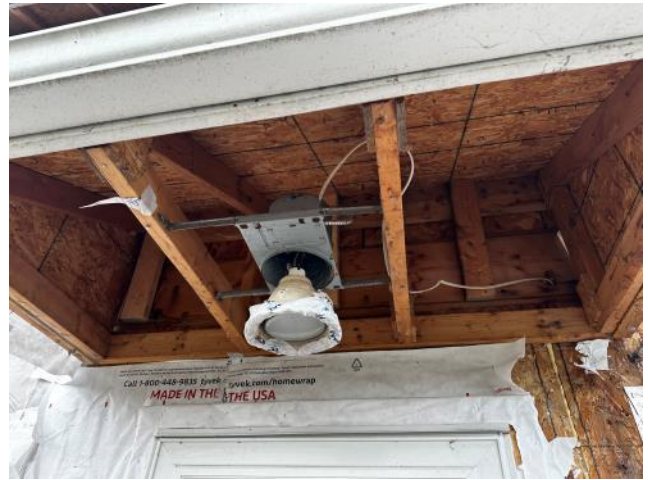
Photo #70: The brackets were temporally removed and it was verified that those brackets are not doing any structural support. It was instructed to reinforce the structure that is attached to the main wall with structural screws. This will need to be inspected case by case.

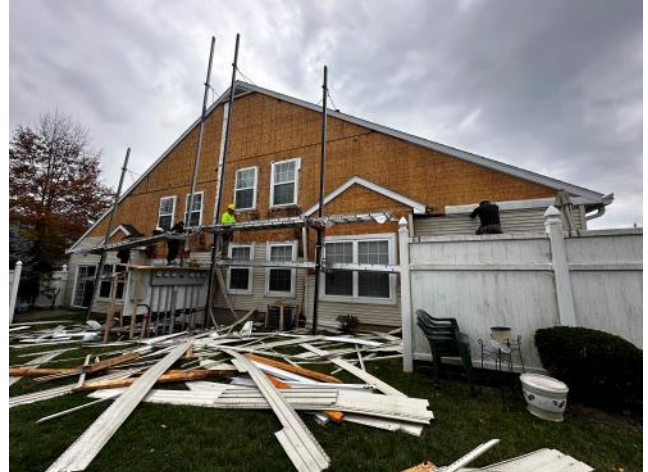
Photo #72: Overview of existing siding being removed at the side of the Building. No Water Resistant Barrier was observed.

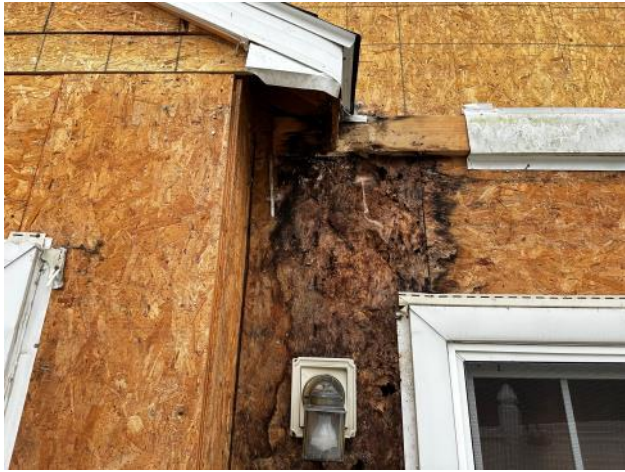
Photo #73: Overview of damaged sheathing that was observed at a section where a kick-out flashing is missing on the roof at Unit 103.

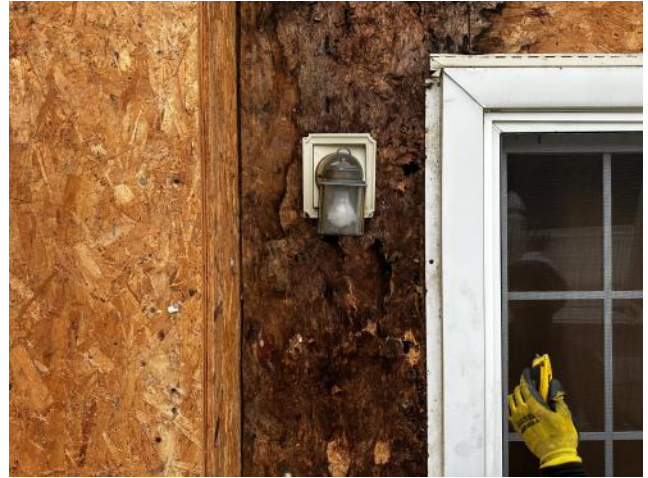
Photo #74: This section is severely damaged all the way down to the sliding door.

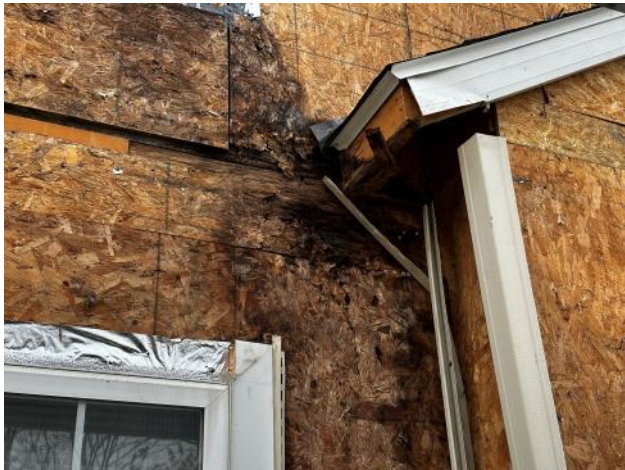
Photo #75: Overview of the other side of the gable roof having the same damaged conditions at Unit 103.

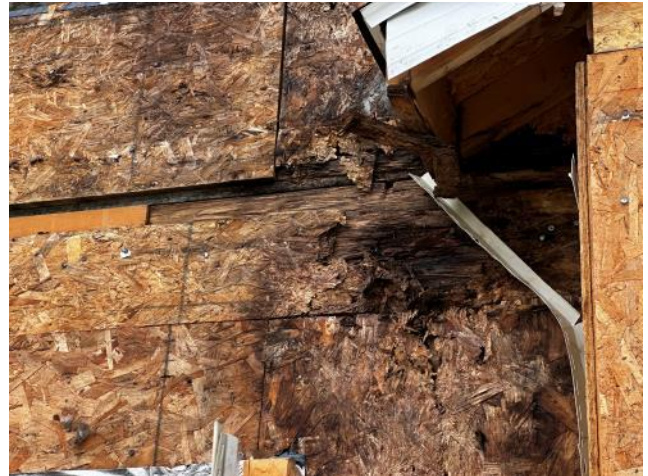
Photo #76: This section is also severely damaged.

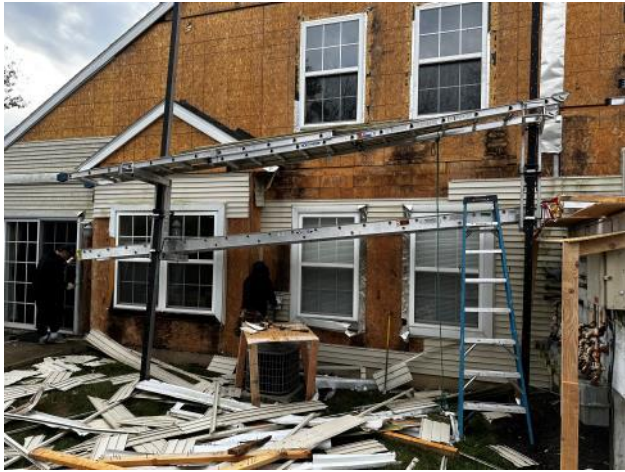
Photo #77: Overview of existing siding being removed. No Water Resistant Barrier was observed.

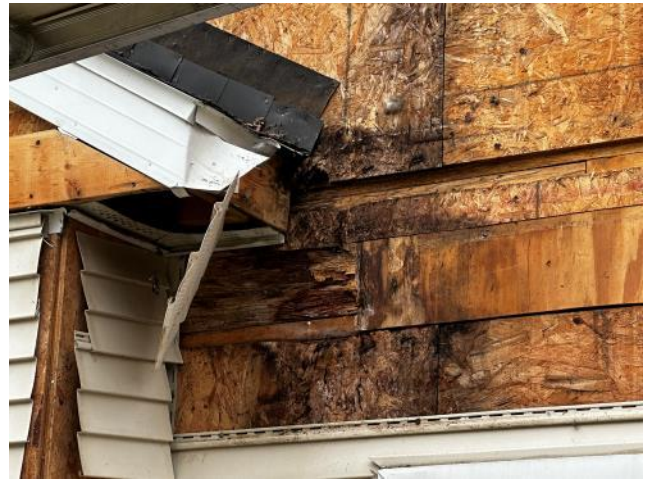
Photo #78: Overview of damaged sheathing that was observed at a section where a kick-out flashing is missing on the roof at Unit 97.

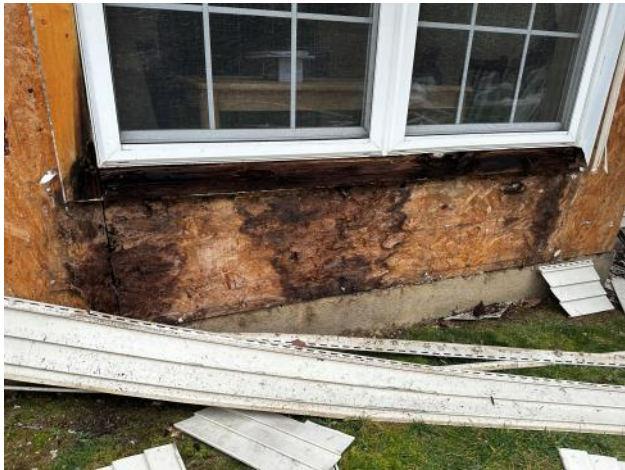
Photo #79: Overview of another section where the sheathing is damage below a window at Unit 97.

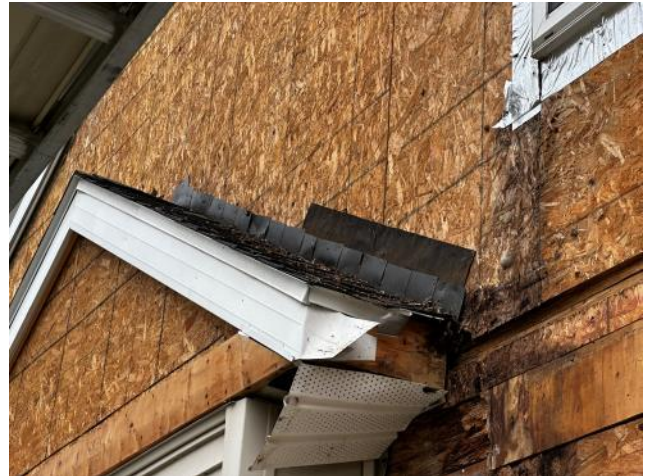
Photo #80: It should be noted that no Leak Barrier was observed up the walls.

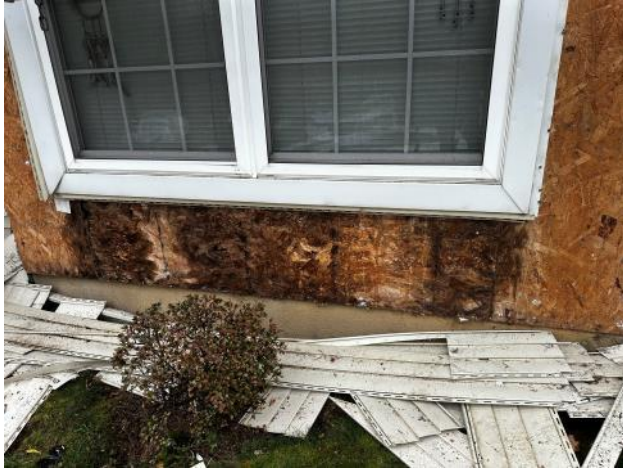
Photo #81: Overview of another section where the sheathing is damage below a window at Unit 103.

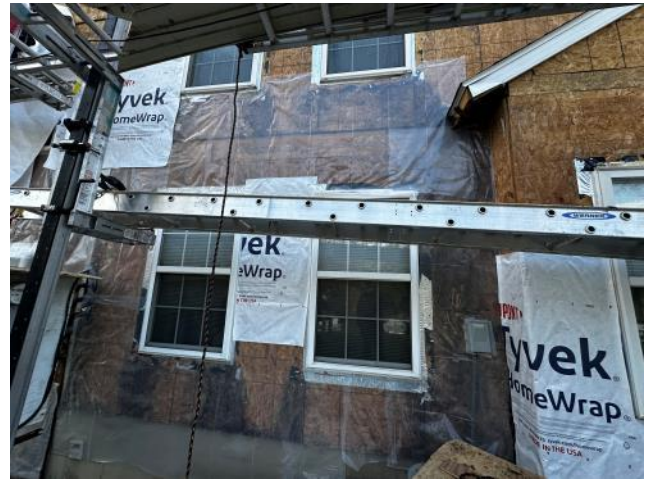
Photo #82: Plastic tarps are being temporally installed at the damaged sheathing sections until the crew properly replaces it with new sheathing.

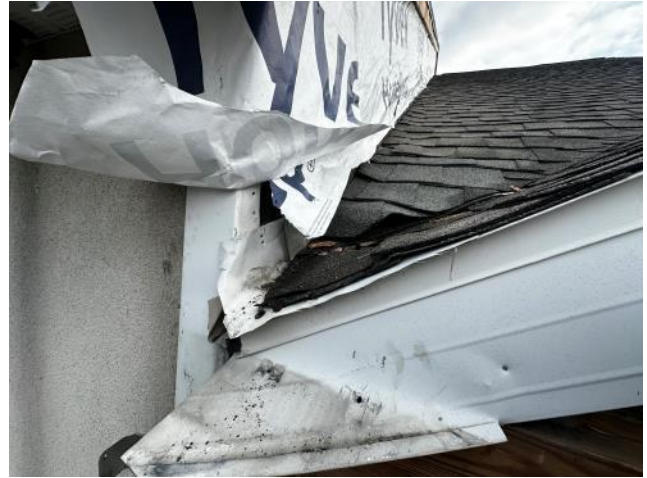
Photo #86: Damaged sheathing was observed at this location. Lemus will remediate this by installing metal flashing at the transition of the valley with the main wall.
