**Project:** Courtyards of Carlisle CA – Siding Project

**Project #:** 14372-04

## Field Report 2

Purpose of Visit: To oversee the progress of siding replacement

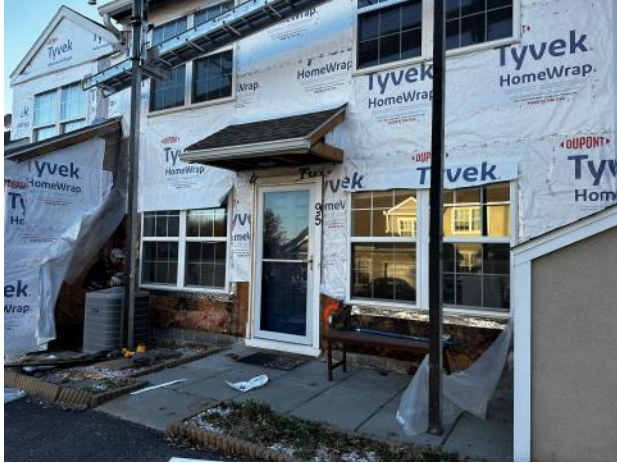
Photo #45: Overview of a section where the sheathing was severely damaged where stucco was installed at Unit 95.

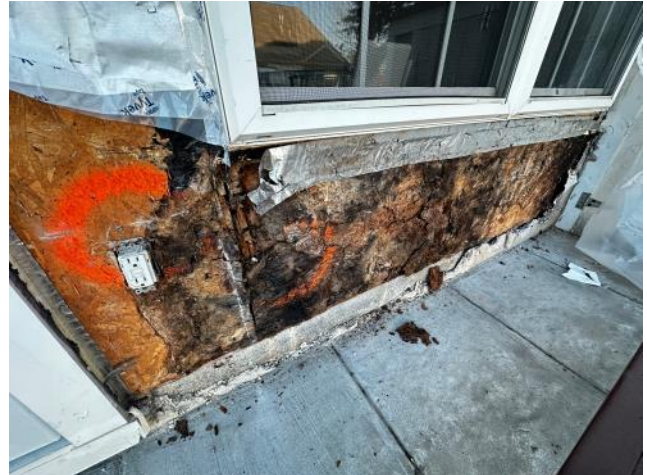
Photo #46: Overview of existing sheathing that was observed in poor condition below windows at Unit 95.

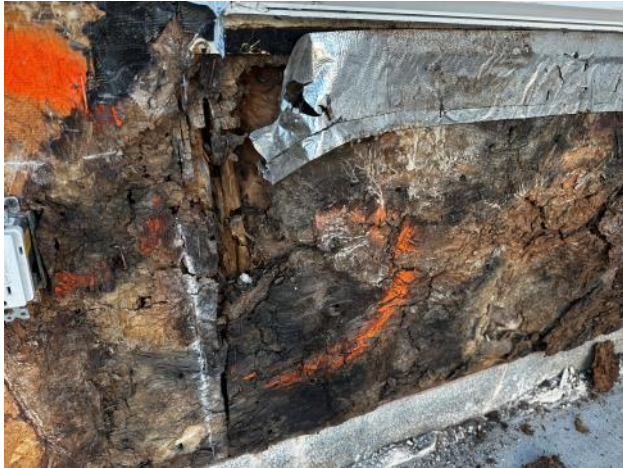
Photo #47: Framing studs were also observed to be in poor condition.

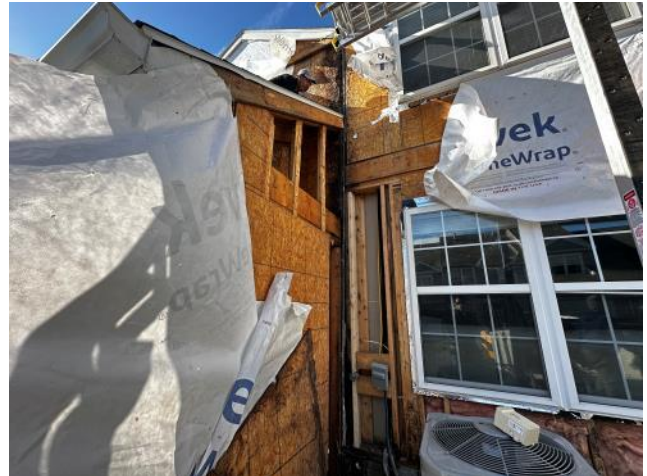
Photo #48: Overview of a section where the sheathing was severely damaged between Units 93 & 95.

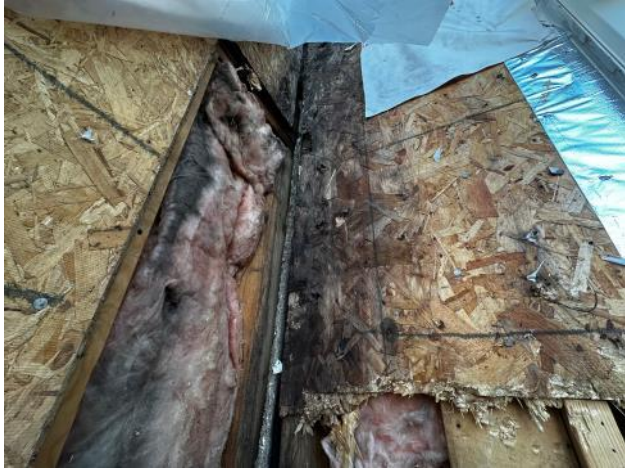
Photo #49: The wood damaged was extended all the way to the top of the separation wall.

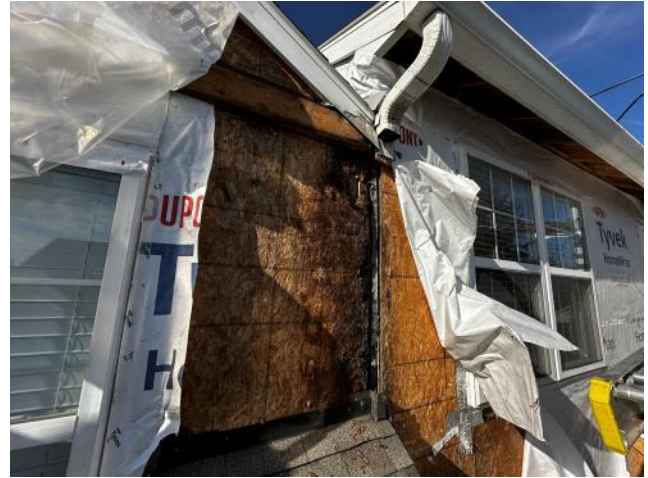
Photo #50: The lack of the proper flashing at the tight section of the roof valley is the reason for water being infiltrated.

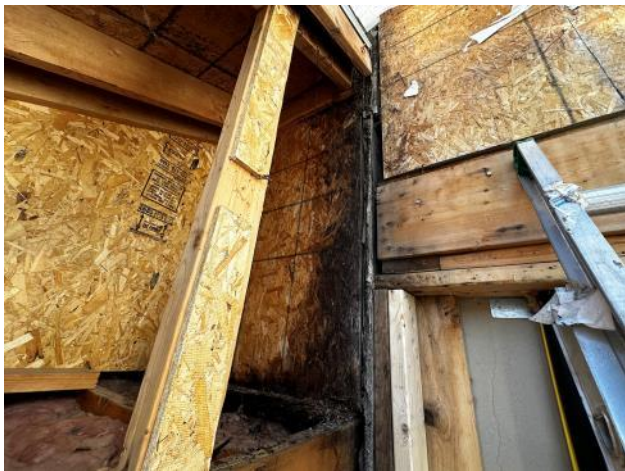
Photo #51: Overview of damaged wood.

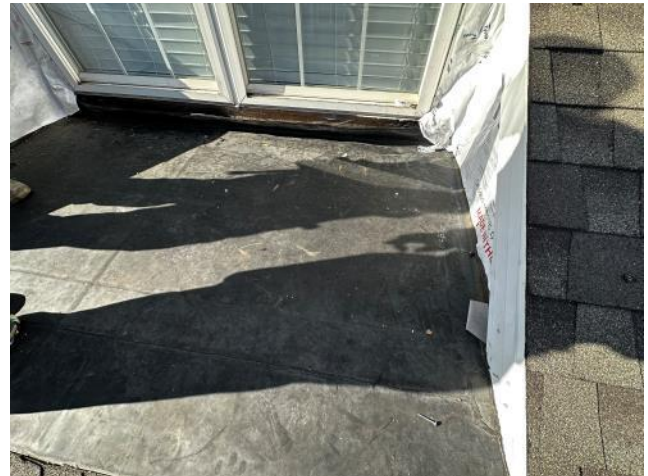
Photo #52: Window at the flat roof of Unit 93 was observed to be failing.

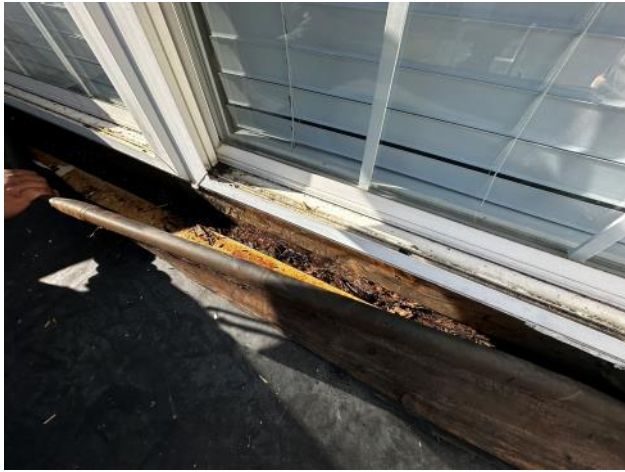
Photo #53: The wood damaged was extended underneath the flat roof. Roof deck was observed to be damaged as well. Lemus got approval from management to remediate this section accordingly.

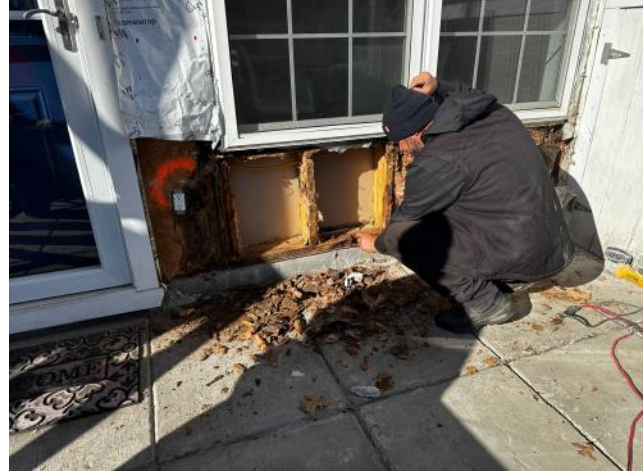
Photo #54: After sheathing in poor condition was removed at the lower windows of Unit 95, framing studs were observed to be damaged as well.

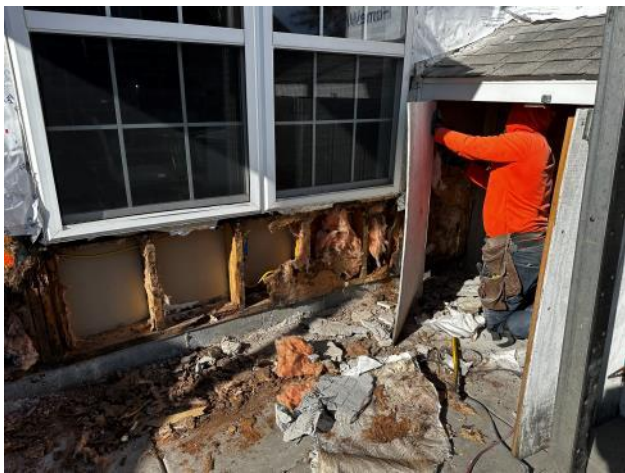
Photo #55: The wood damaged was extended inside the small storage.

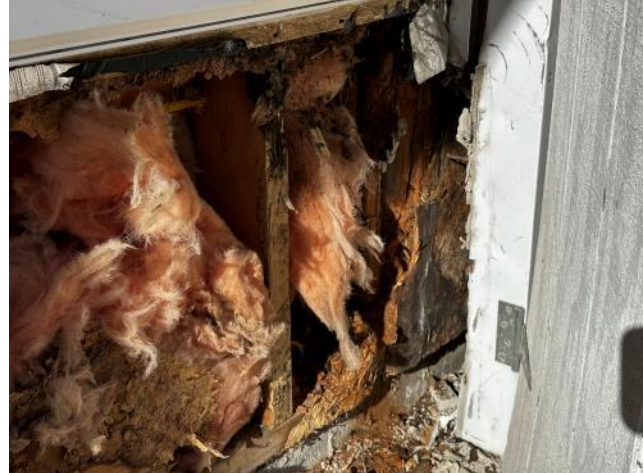
Photo #56: Overview of damaged section inside the storage enclosure.

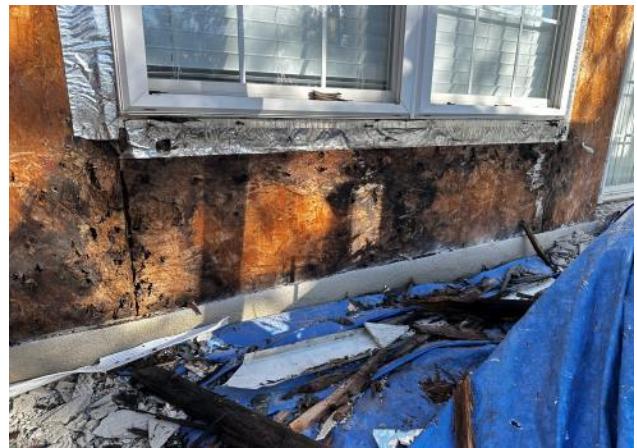
Photo #62: Overview of existing sheathing that was observed in poor condition after the stucco was removed.

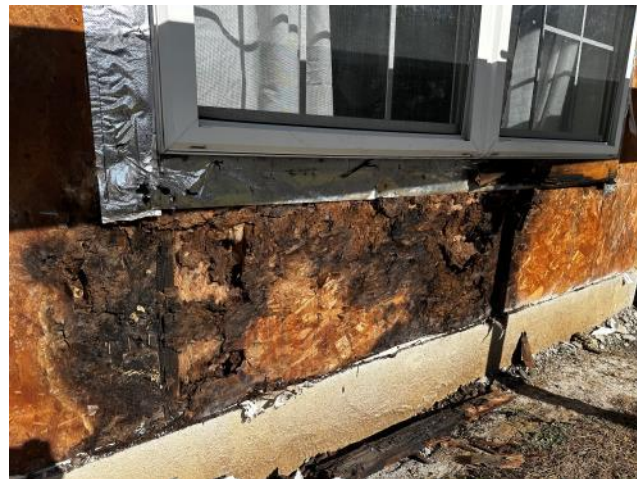
Photo #64: Overview of existing sheathing that was observed in poor condition after the stucco was removed.

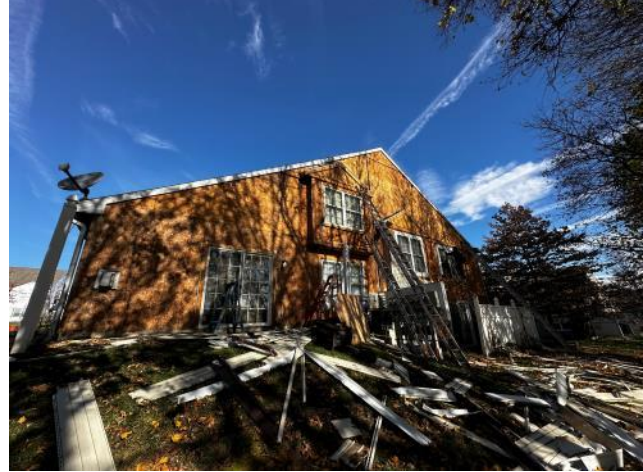
Photo #78: Overview of existing siding being removed at a main side of the Building. No Water Resistant Barrier was observed.

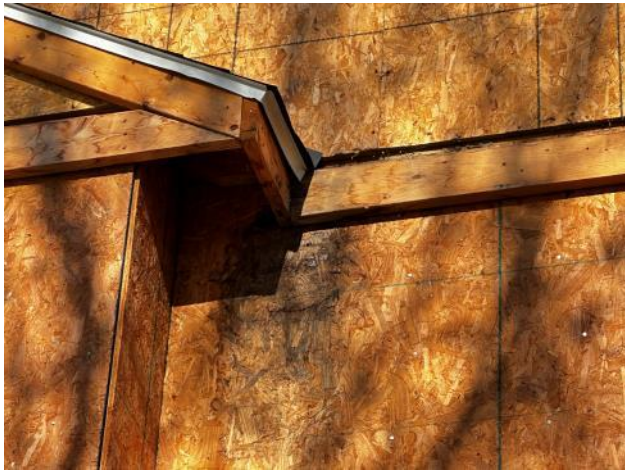
Photo #79: Overview of damaged sheathing that was observed at a section where a kick-out flashing is missing on the roof at Unit 90.

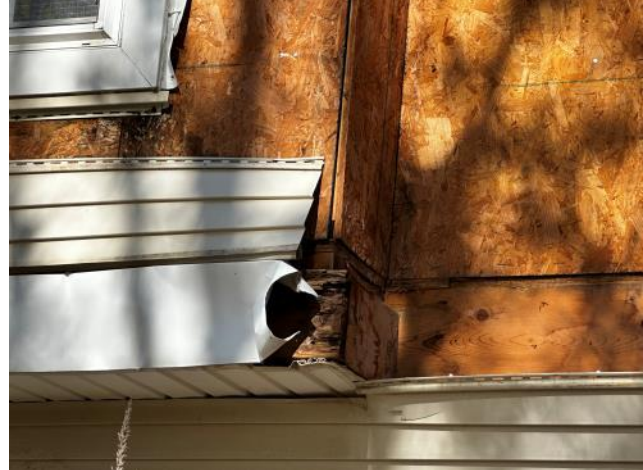
Photo #80: Overview of damaged sheathing that was observed at a box window.

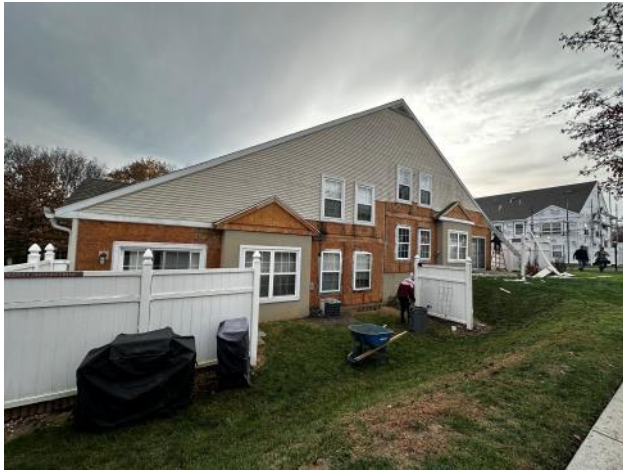
Photo #81: Overview of existing siding being removed at the other main side of the Building. No Water Resistant Barrier was observed.

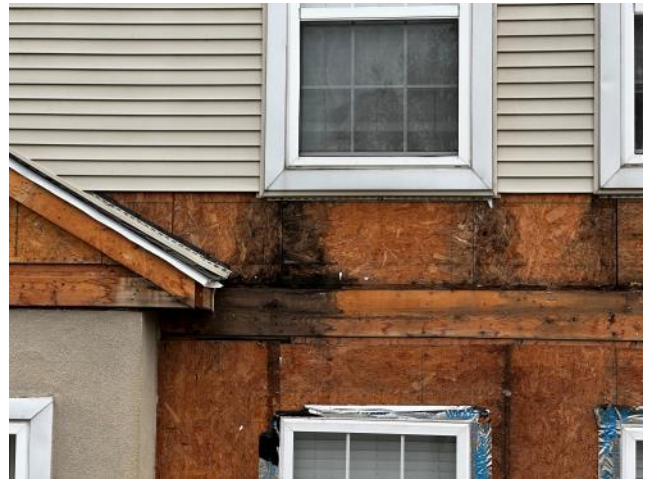
Photo #82: Overview of damaged sheathing that was observed at a section where a kick-out flashing is missing on the roof and below windows at Unit 80.

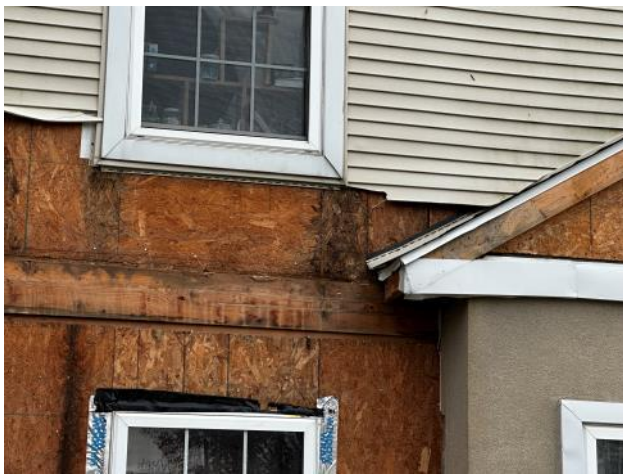
Photo #83: Overview of damaged sheathing that was observed at a section where a kick-out flashing is missing on the roof and below windows at Unit 86.

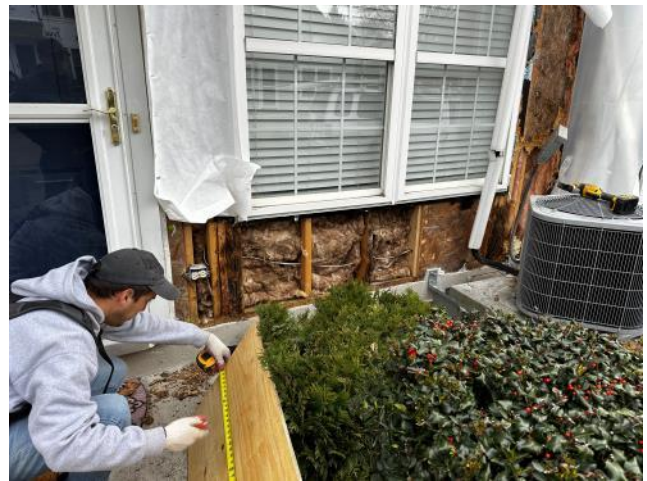
Photo #84: Overview of damaged sheathing being replaced where the stucco was located.

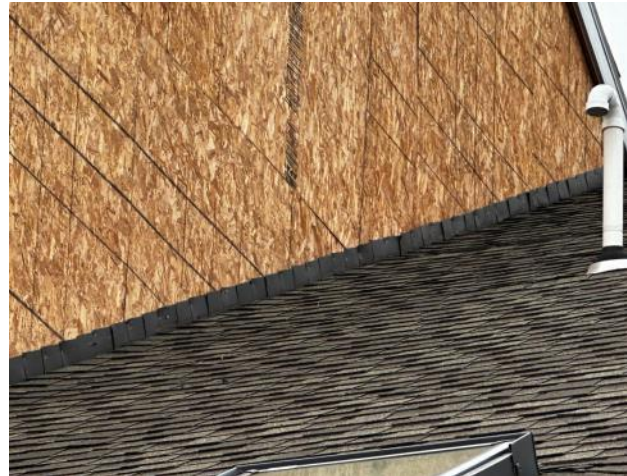
Photo #92: It should be noted that no Leak Barrier was observed up the roofing sidewalls.

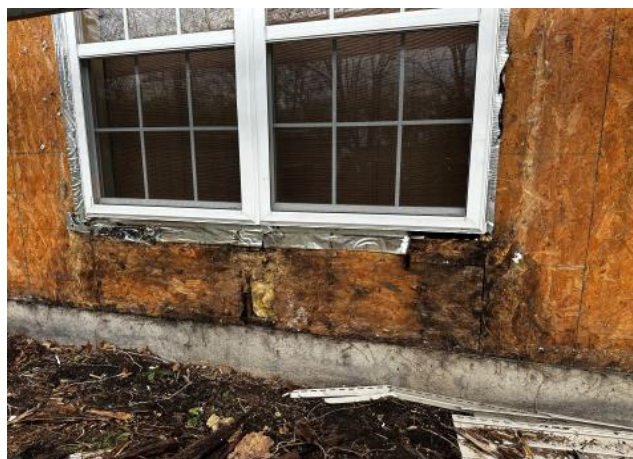
Photo #93: Overview of damaged sheathing that was observed below a lower window of Unit 79.

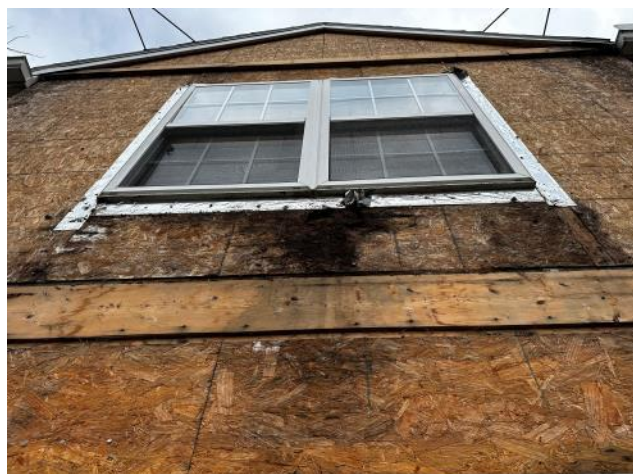
Photo #94: Overview of damaged sheathing that was observed below an upper window of Unit 77.

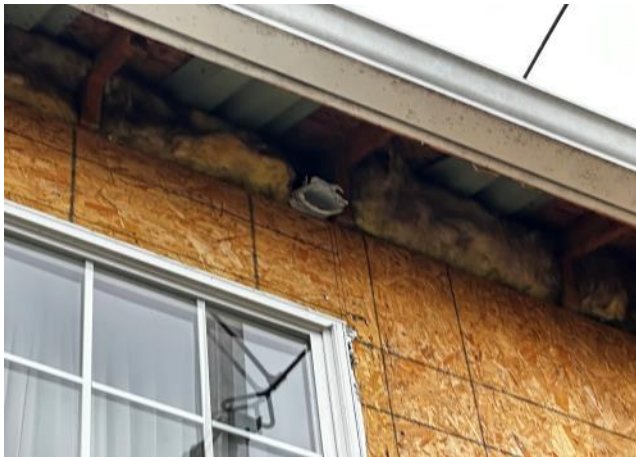
Photo #99: At Units 77 and 79, it should be noted that a few bathroom vent connections were observed not to be properly connected on the soffit. It was instructed to Lemus to connect those bathroom vents and properly terminate them with a proper soffit vent cap.
