Project: Courtyards of Carlisle CA – Siding Project

Project #: 14372-04

Field Report 3

Purpose of Visit: To oversee the progress of siding replacement

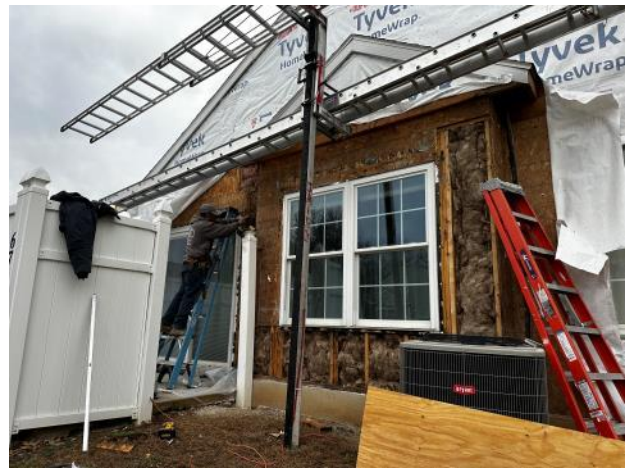
Photo #60: Overview of damaged sheathing being replaced at Unit 67. New insulation had to be replaced.

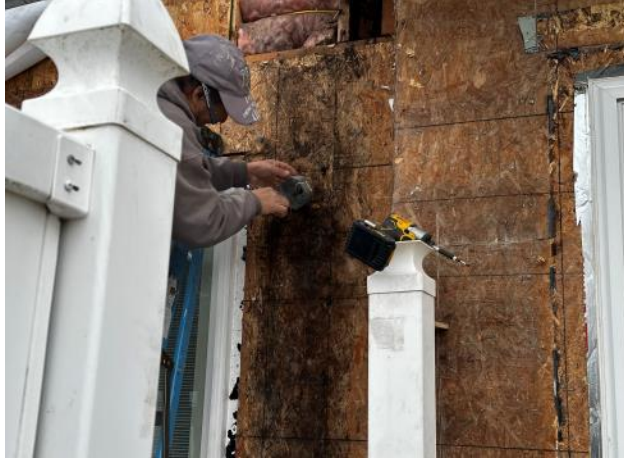
Photo #61: Overview of damaged sheathing being replaced at Unit 67.

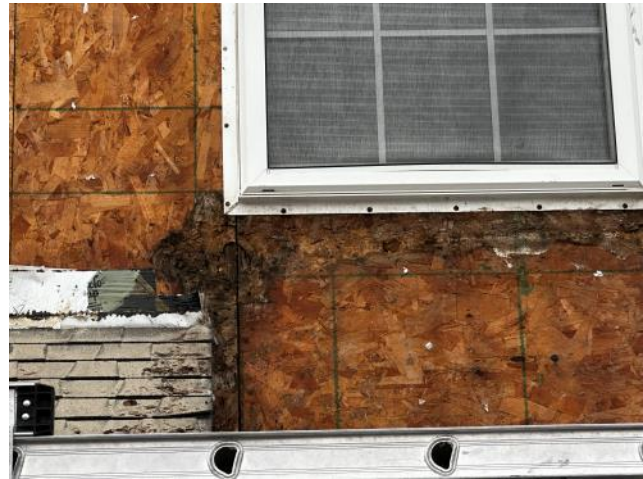
Photo #64: Overview of existing sheathing that was observed in poor condition below a window of Unit 63.

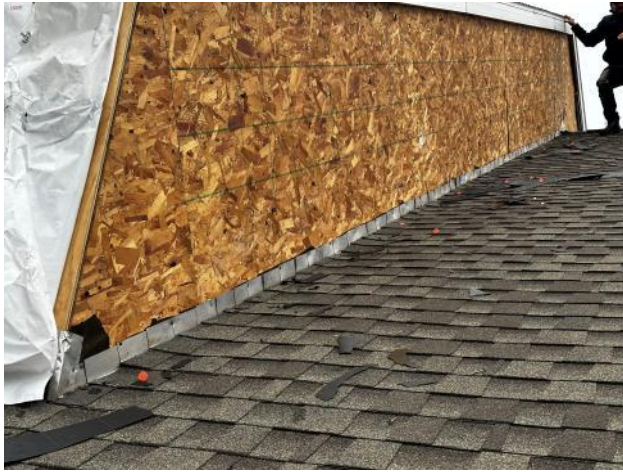
Photo #65: It should be noted that no Leak Barrier was observed up the roofing sidewalls.

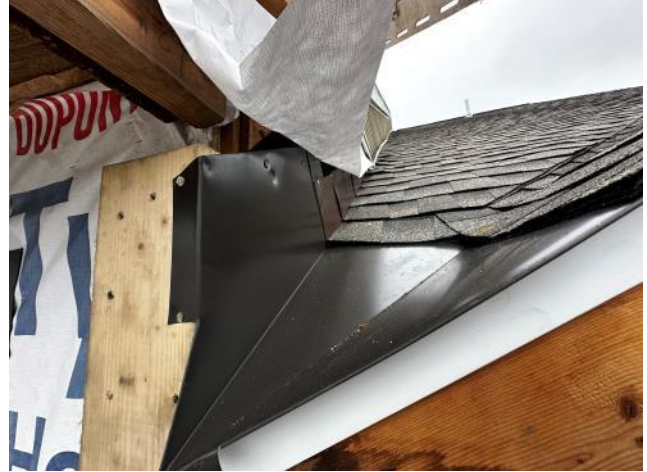
Photo #66: Overview of new metal gusset, and larger step flashing installed where a front roof gable meets a separation wall.

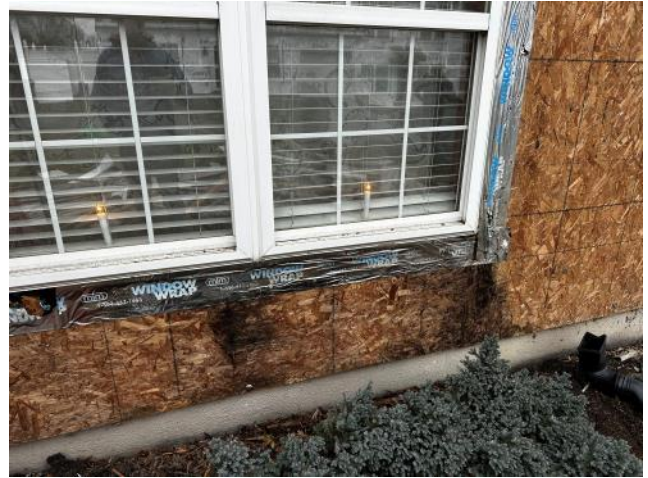
Photo #94: Overview of existing sheathing that was observed in poor condition below a window at Unit 74.

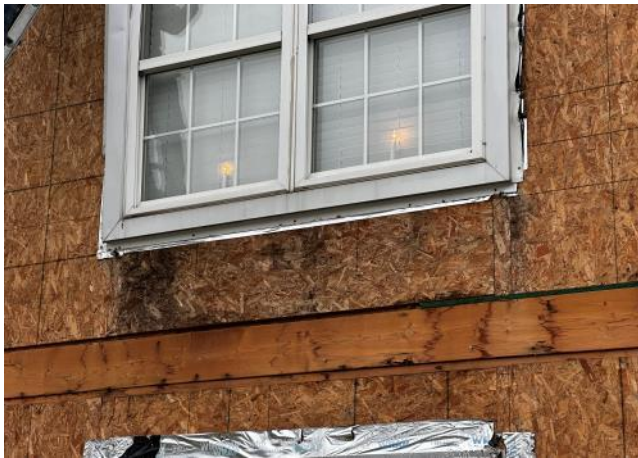
Photo #95: Overview of existing sheathing that was observed in poor condition below another window at Unit 74.

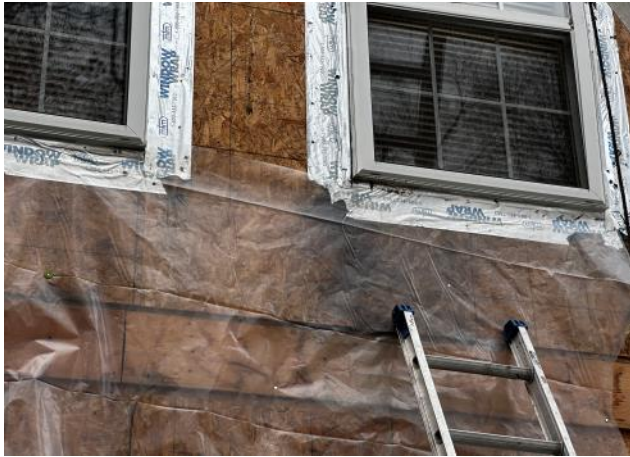
Photo #97: Overview of existing sheathing that was observed in poor condition below windows at Unit 72. Plastic tarps are being temporarily installed at the damaged sheathing sections until the crew properly replaces it with new sheathing.

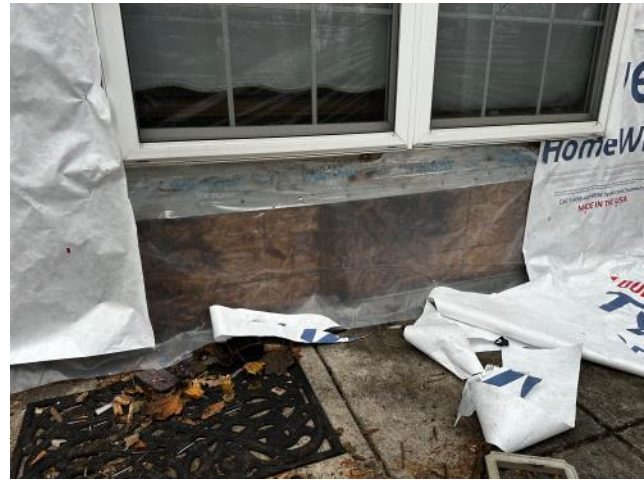
Photo #98: Overview of existing sheathing that was observed in poor condition below another window at Unit 72.

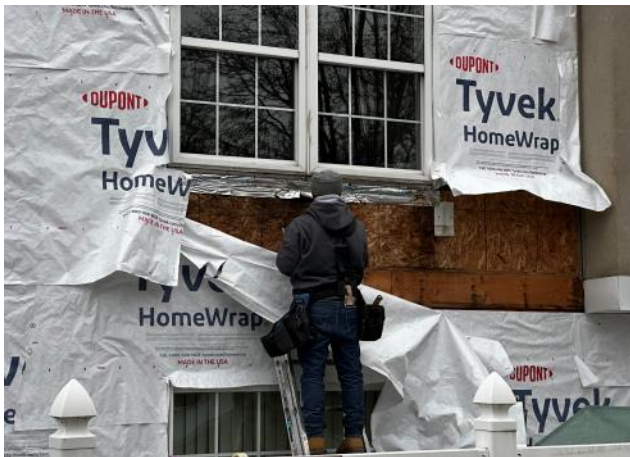
Photo #99: Overview of damaged sheathing being replaced.

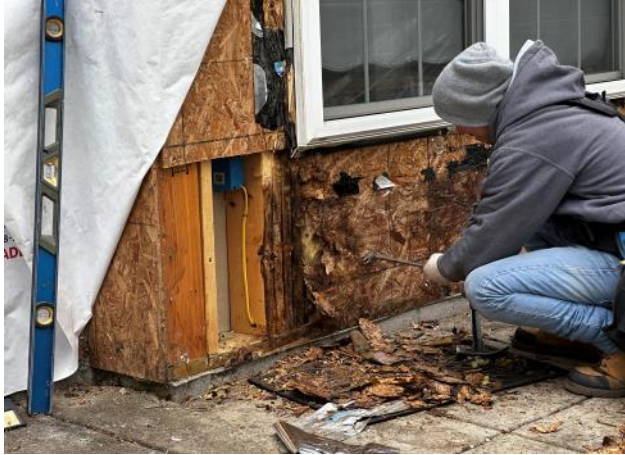
Photo #101: Overview of damaged sheathing being replaced.

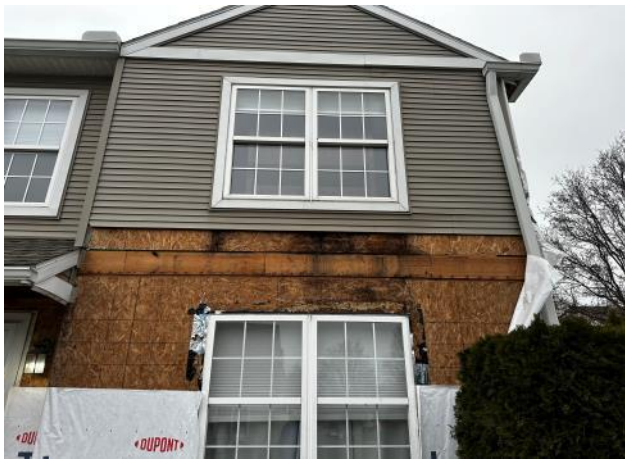
Photo #103: Overview of existing sheathing that was observed in poor condition below a window at Unit 68.

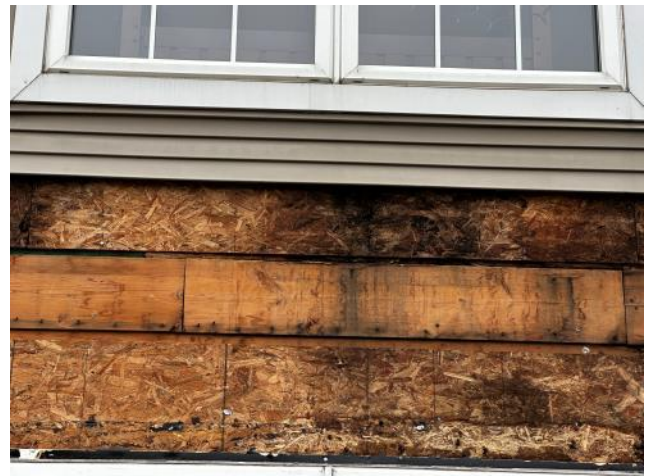
Photo #104: Overview of damaged wood.

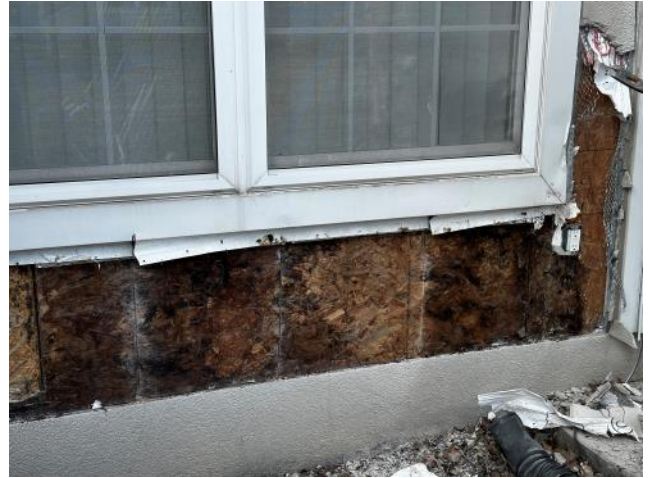
Photo #106: Overview of existing sheathing that was observed in poor condition below a window at Unit 70.

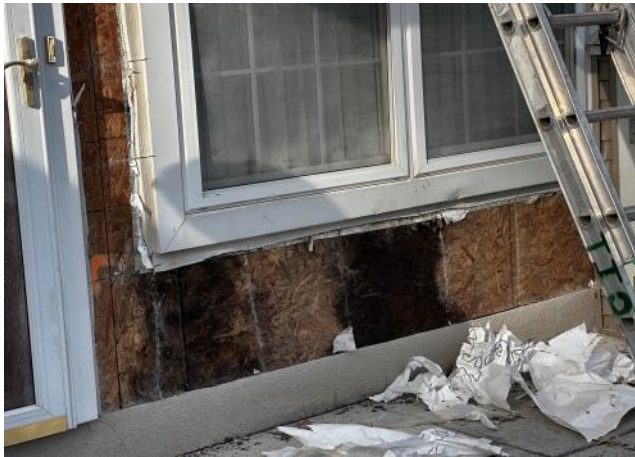
Photo #107: Overview of existing sheathing that was observed in poor condition below another window at Unit 70.

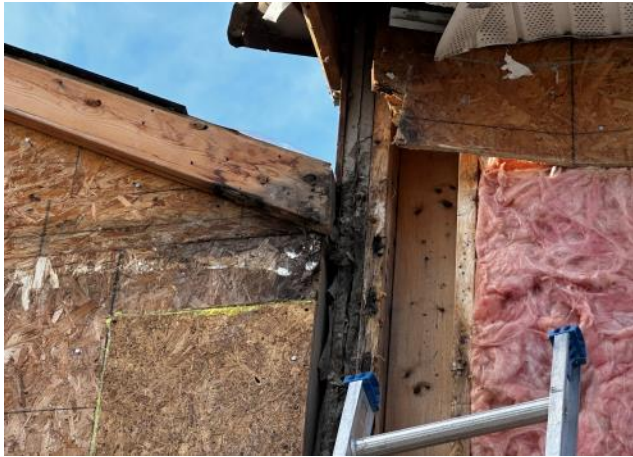
Photo #109: Overview of a section where roof gable meets a separation wall in poor condition due to the lack of flashing at the roofing valley.

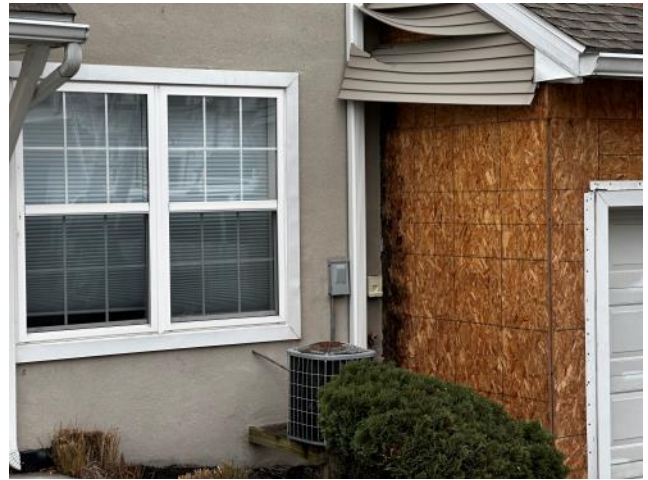
Photo #110: Overview of wood damaged running down the separation wall.

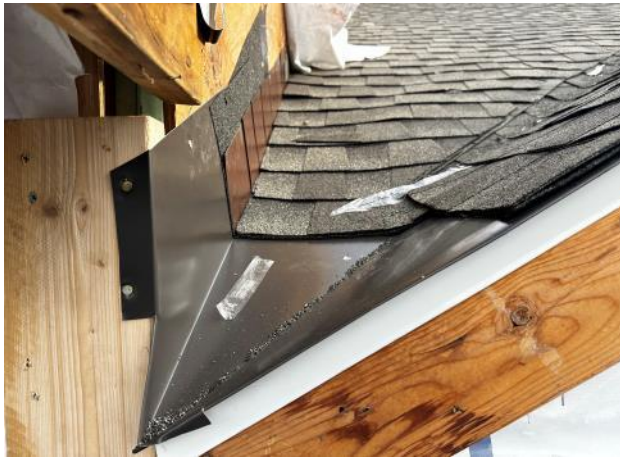
Photo #111: Overview of new metal gusset, and larger step flashing installed where a front roof gable meets a separation wall.

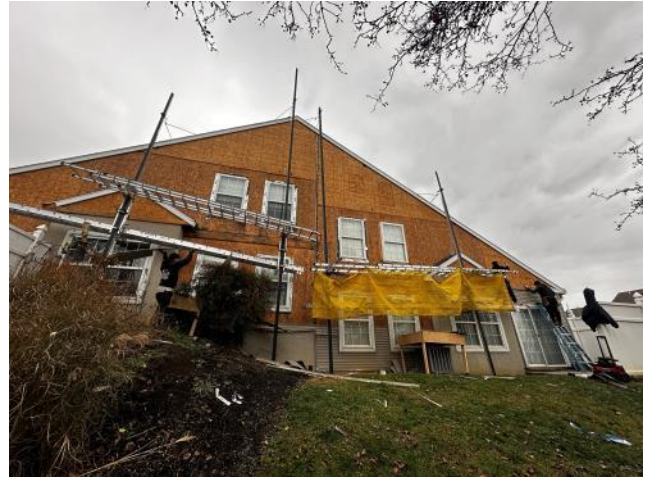
Photo #114: Overview of existing siding being removed. No Water Resistant Barrier was observed.

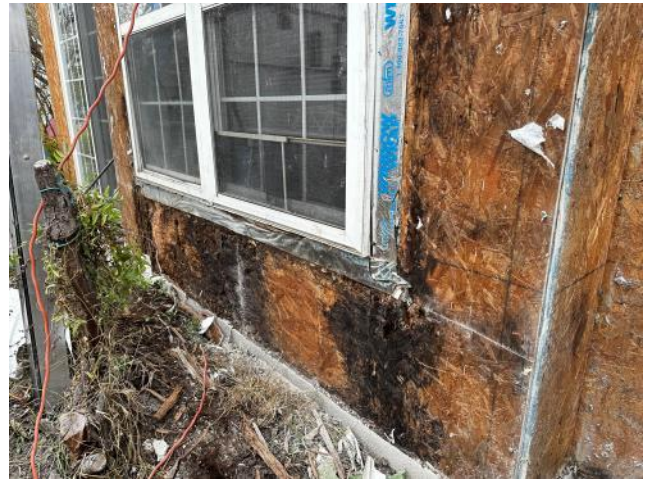
Photo #116: After the stucco was removed, the sheathing was observed to be damaged below the window at Unit 87.

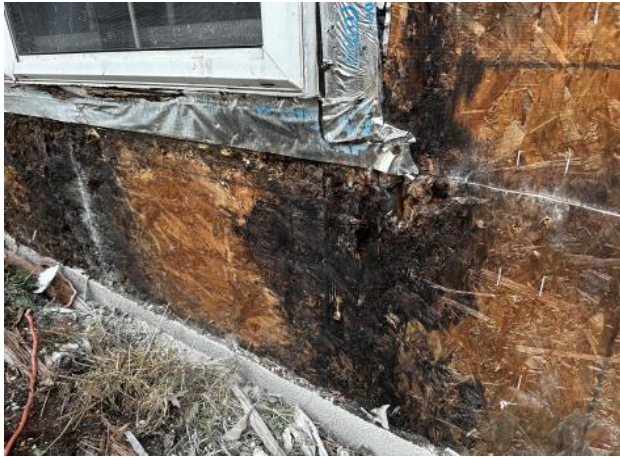
Photo #117: Overview of existing sheathing that was observed in poor condition at Unit 87.

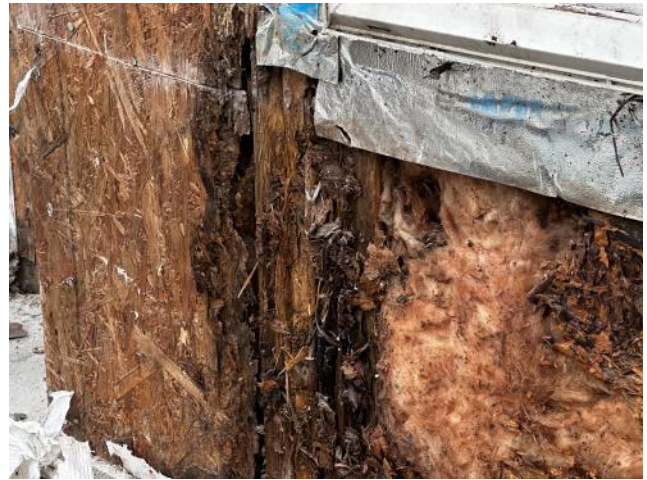
Photo #118: Framing studs were starting to get damaged as well.

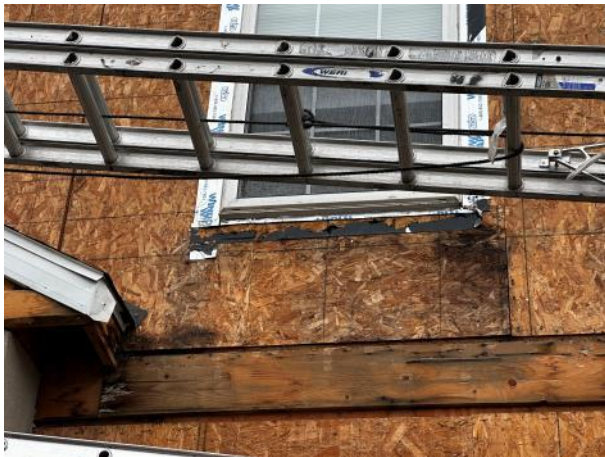
Photo #119: Overview of existing sheathing that was observed in poor condition below another window at Unit 87.

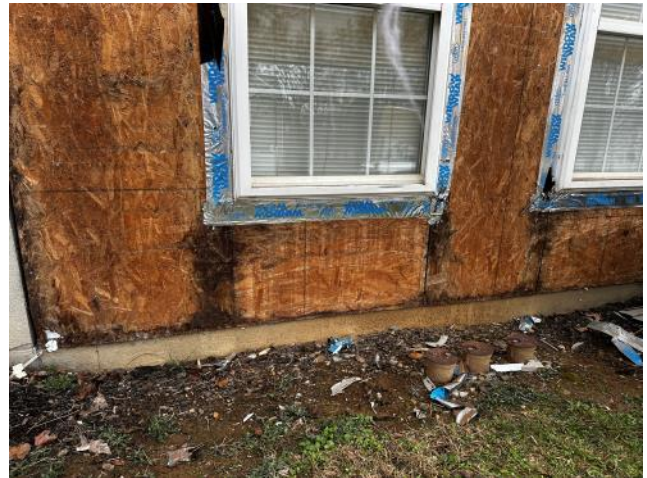
Photo #120: Overview of existing sheathing that was observed in poor condition below windows at Unit 81.

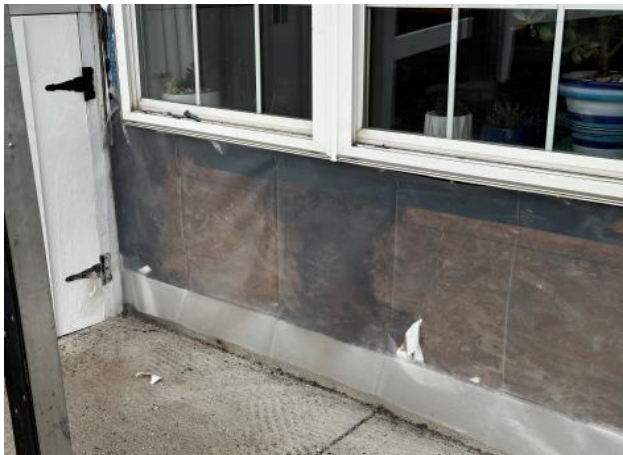
Photo #123: Overview of existing sheathing that was observed in poor condition below a window at Unit 89.

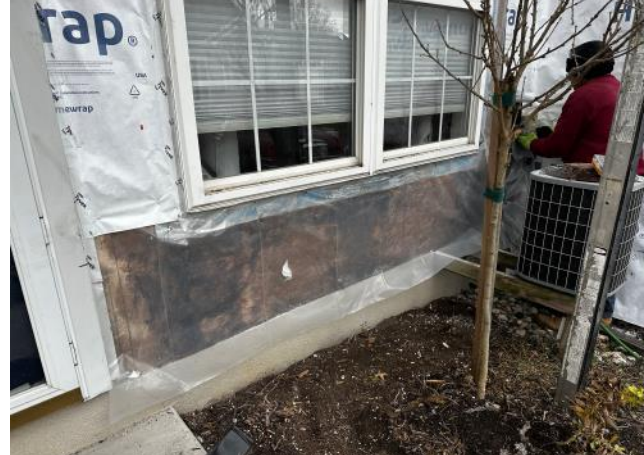
Photo #124: Overview of existing sheathing that was observed in poor condition below another window at Unit 89.

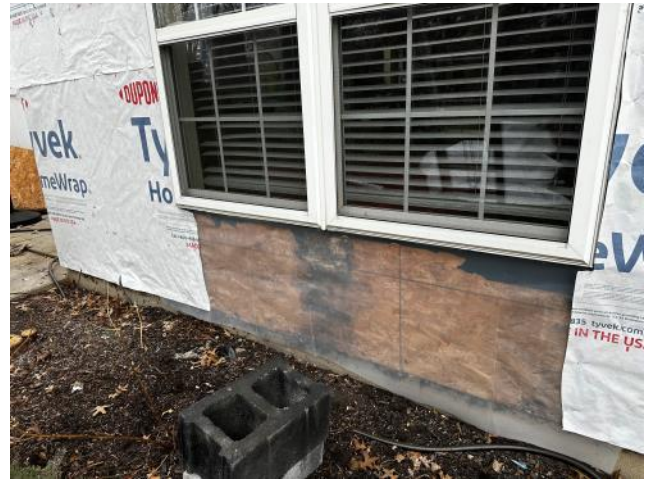
Photo #126: Overview of existing sheathing that was observed in poor condition below a window at Unit 91.

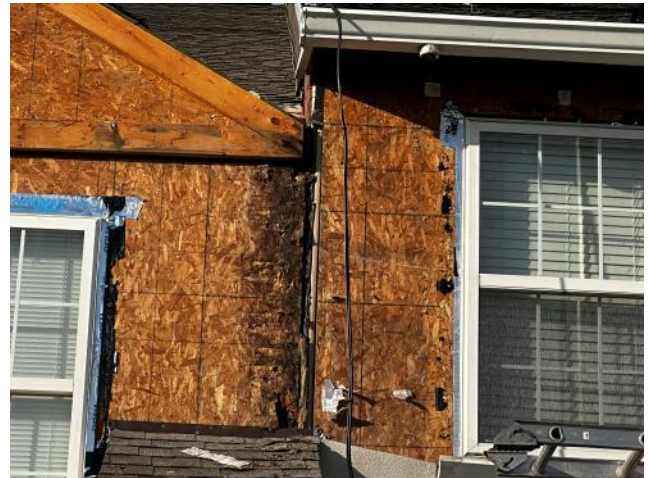
Photo #128: Overview of a section where roof gable meets a separation wall in poor condition due to the lack of flashing at the roofing valley.

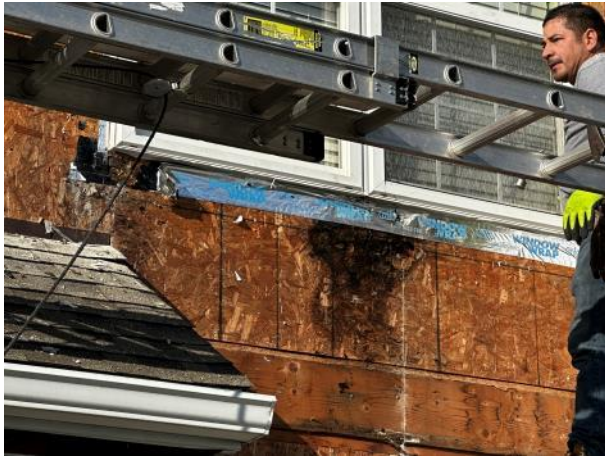
Photo #129: Overview of existing sheathing that was observed in poor condition below a window at Unit 83.

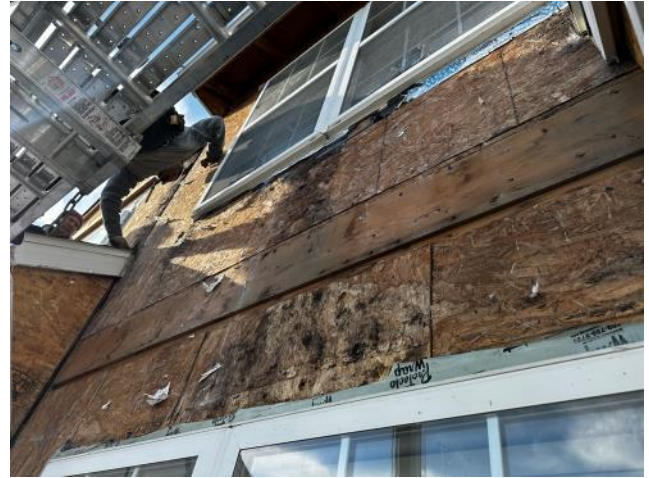
Photo #130: Overview of existing sheathing that was observed in poor condition below another window at Unit 83.

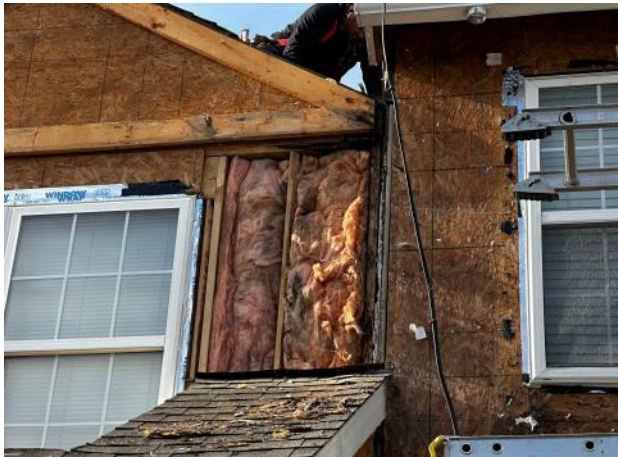
Photo #131: Overview of existing insulation observed that was starting to get damaged due to the water/moisture infiltration.

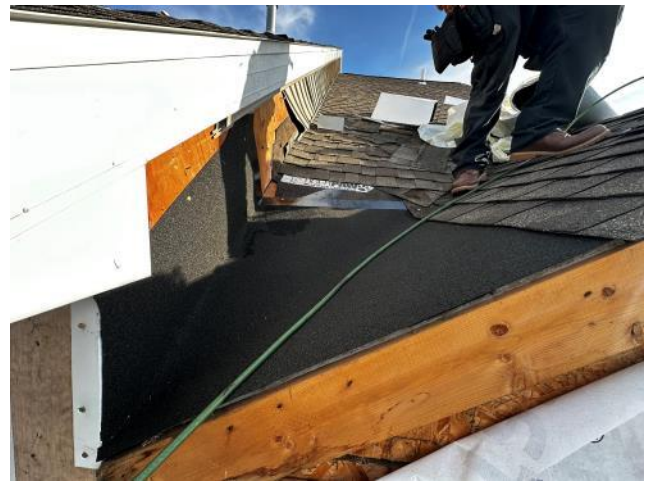
Photo #132: Overview of new leak barrier, new metal gusset, and larger step flashing being installed where a front roof gable meets a separation wall.

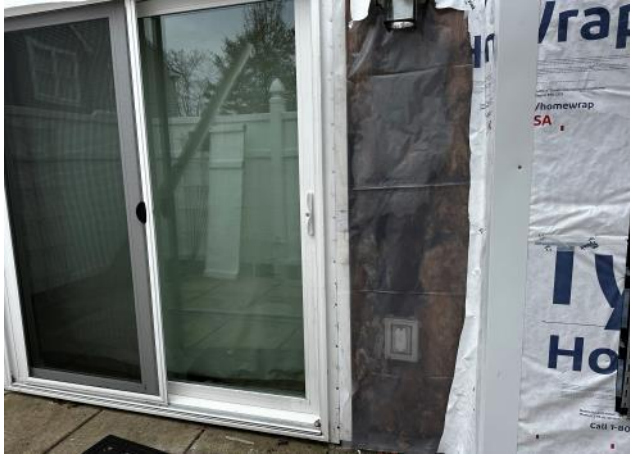
Photo #133: Overview of existing sheathing that was observed in poor condition at a sliding door of Unit 85.

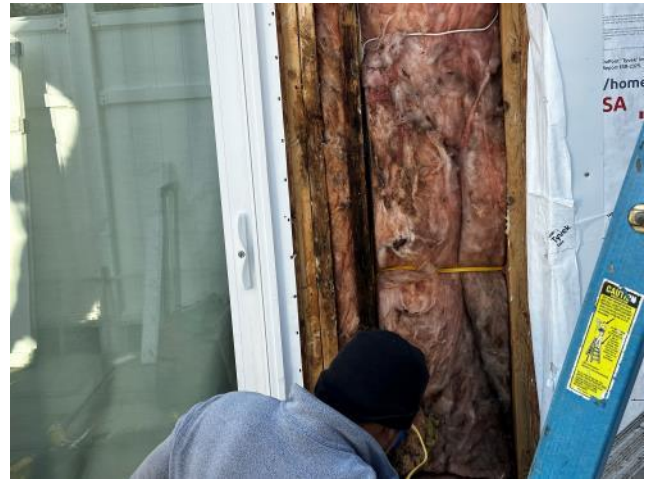
Photo #134: Overview of surface rot that was observed at the framing studs.

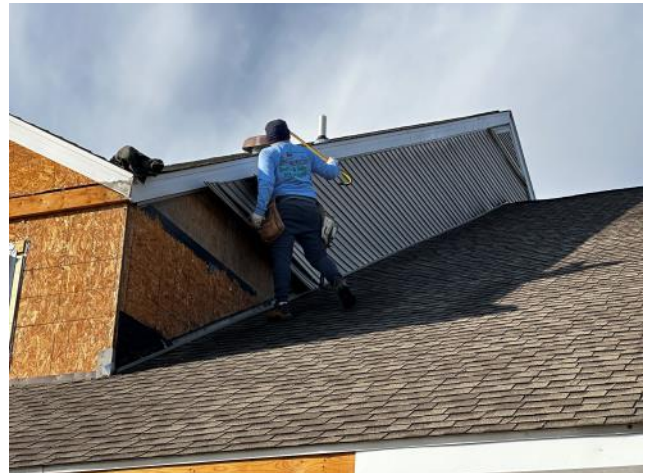
Photo #138: Overview of existing siding being removed at a roofing sidewall. No leak barrier and Water Resistant Barrier were observed.

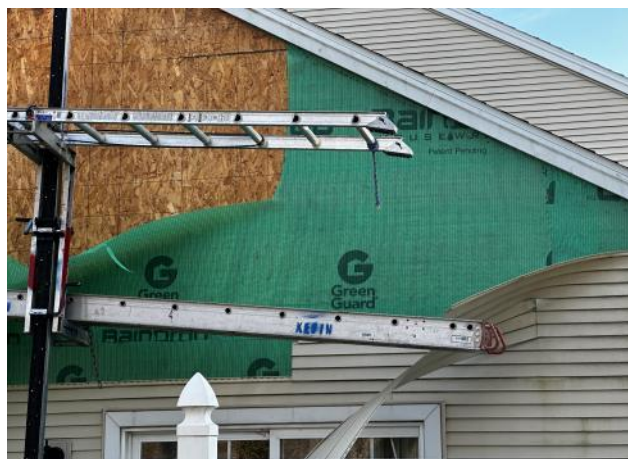
Photo #153: It should be noted that outdated Green Guard was observed to be installed at this Building 15.

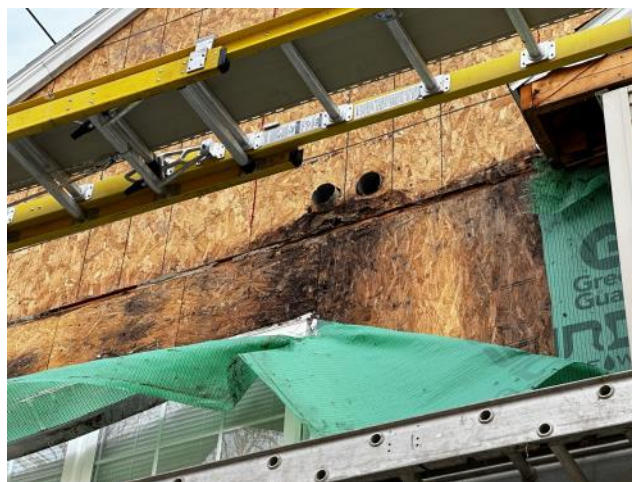
Photo #154: Existing sheathing still was observed to be in poor condition due to the lack flashing at the wall penetrations and the outdated material from Green Guard.

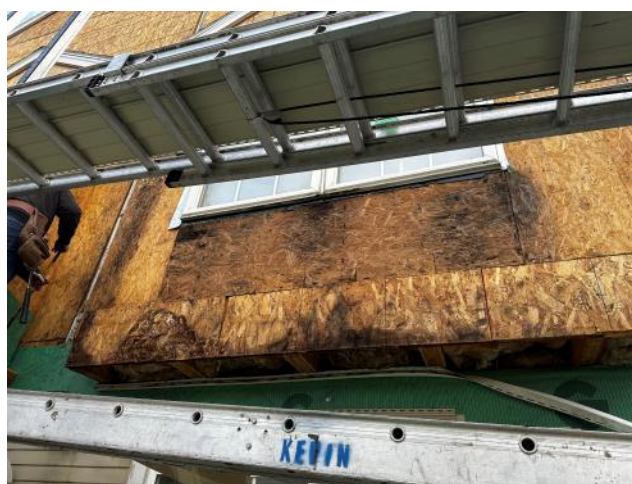
Photo #156: Overview of existing sheathing that was observed in poor condition below a box window at Unit 59.

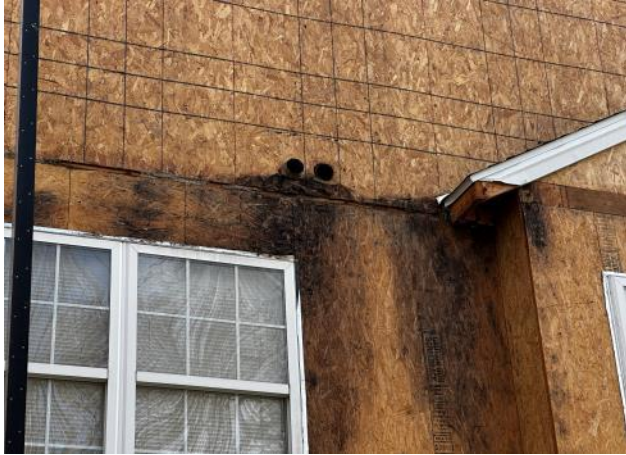
Photo #157: Overview of damaged sheathing that was observed at a section where a kick-out flashing is missing on the roof and lack of flashing at the wall penetrations at Unit 28.

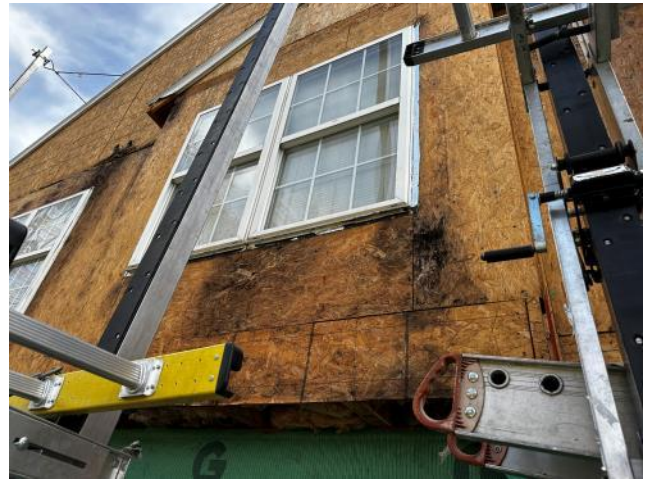
Photo #158: Overview of existing sheathing that was observed in poor condition below a box window at Unit 28.
