Project #: 14372-04 Date: Dec 11, 12, 14, 15, 2023 Inspector: Luis Sanchez Weather: Sunny & Cloudy, 40s°F

Field Report 4

Purpose of Visit: To oversee the progress of siding replacement

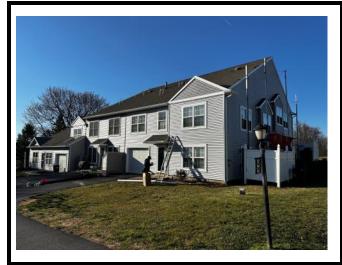
Photo #1: Overview of the gutter crew on-site completing the gutters installation at Buildings 9 & 10.

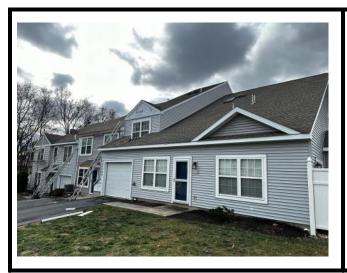
Photo #5: Overview of Lemus Siding Crew (Blue) working at Building 8 (80-90 Courtyard Drive).

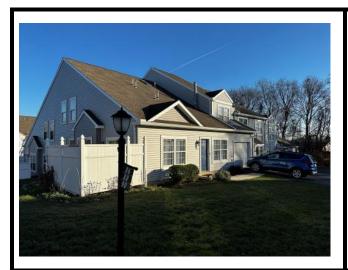
Photo #7: Overview of new gutters and downspouts installed at **Building 8**.

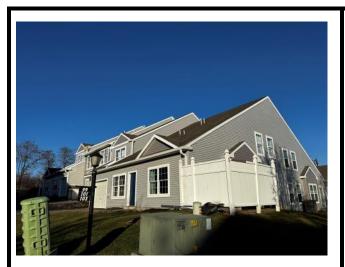
Photo #9: Overview of new gutters and downspouts installed at **Building 11**.

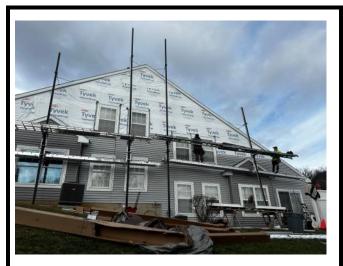
Photo #11: Overview of Lemus Siding Crew (Green) working at Building 14 (61-71 Courtyard Drive).

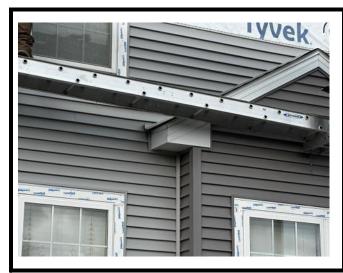
Photo #13: Overview of new kick-out flashing installed.

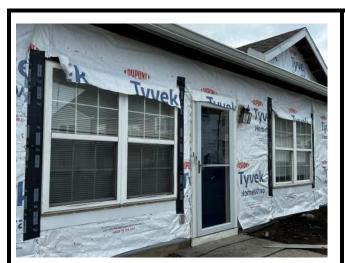
Photo #15: Overview of new metal flashing installed at the bottom of the windows.

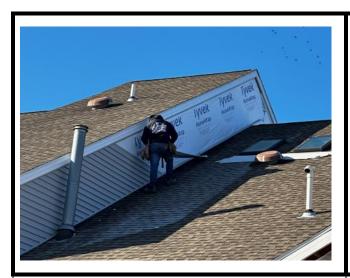
Photo #17: Overview of new vinyl siding being installed at a roofing sidewall section.

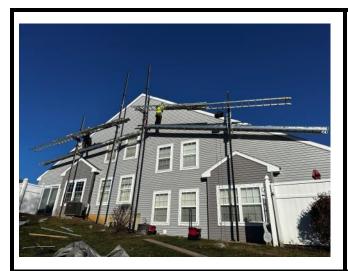
Photo #19: Overview of new vinyl siding installed at a main side of the Building.

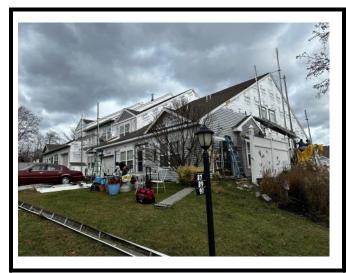
Photo #21: Overview of Lemus Siding Crew (Green) working at Building 12 (81-91 Courtyard Drive)

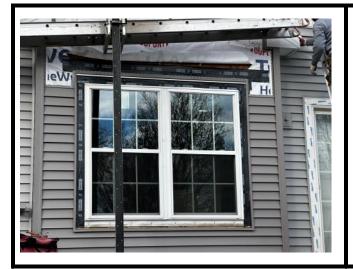
Photo #23: Overview of a new window installed.

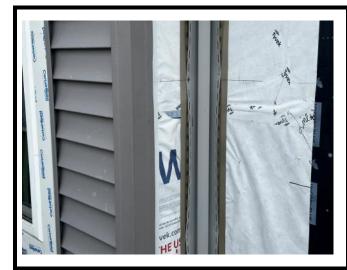
Photo #25: Overview of new metal flashing and vinyl corner installed.

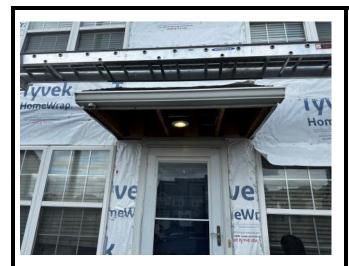
Photo #27: Overview of an entrance roof being reinforced with structural screws in order to eliminate the front brackets.

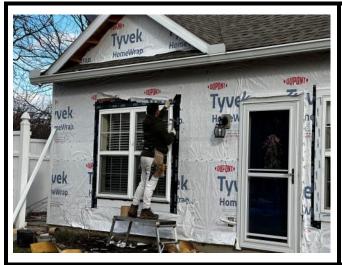
Photo #29: Overview of new flashing tape being installed at a window.

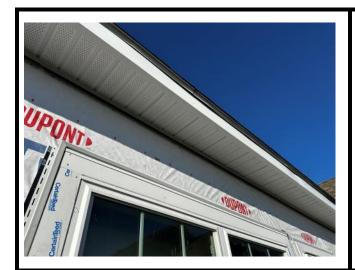
Photo #31: Overview of new intake soffit installed.

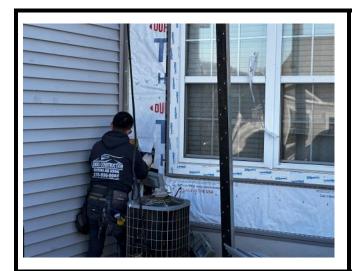
Photo #33: Overview of new flashing tape being installed at a wall penetration.

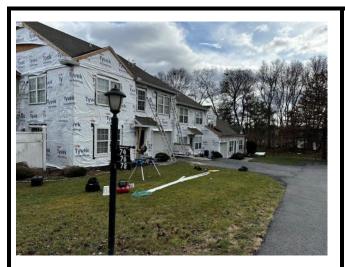
Photo #35: Overview of Lemus Siding Crew (Blue) working at Building 7 (68-78 Courtyard Drive)

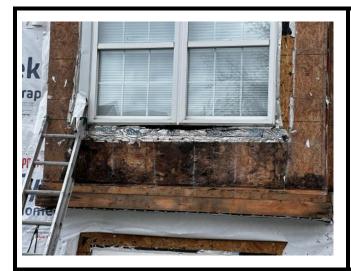
Photo #37: Overview of existing sheathing in poor condition after stucco was removed at the box window of Unit 68.

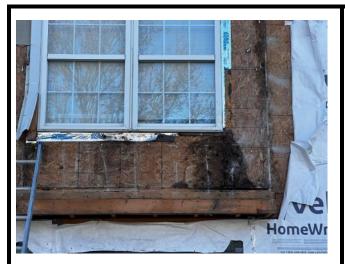
Photo #39: Overview of existing sheathing in poor condition after stucco was removed at the box window of Unit 74.

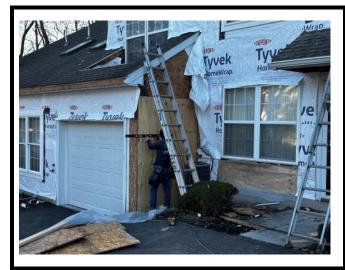
Photo #41: Overview of new sheathing being installed between Units 70 & 72.

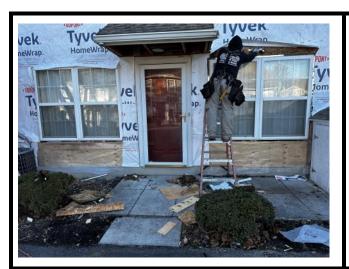
Photo #43: Overview of new sheathing installed below windows at Unit 70.

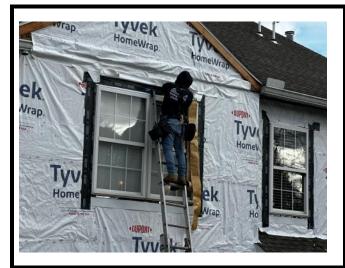
Photo #45: Overview of a window being properly flashed.

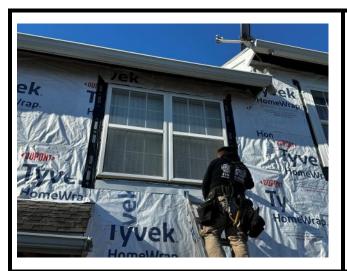
Photo #47: Overview of another window being properly flashed.

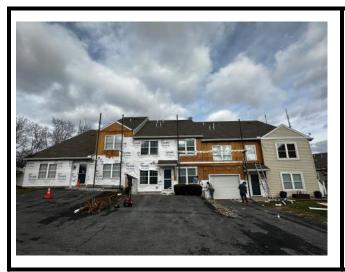
Photo #49: Overview of Lemus Siding Crew (Yellow) working at Building 15 (24-28, 55-59 Courtyard Drive).

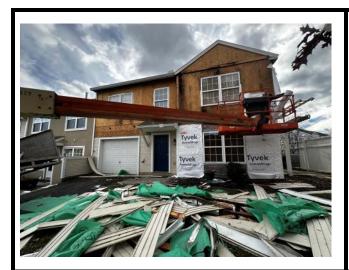
Photo #51: Overview of the existing siding being removed at a front section of the Building.

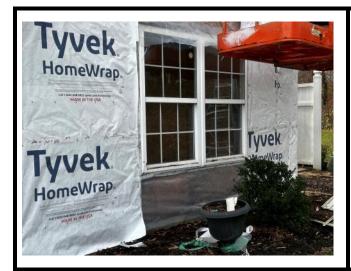
Photo #53: Overview of existing sheathing in poor condition below a lower window at Unit 28.

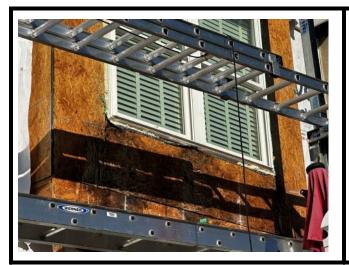
Photo #59: Overview of damaged sheathing below the box window at Unit 55.

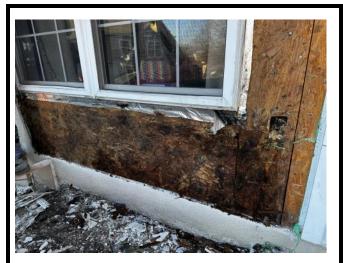
Photo #63: Overview of damaged sheathing below a window at Unit 26.

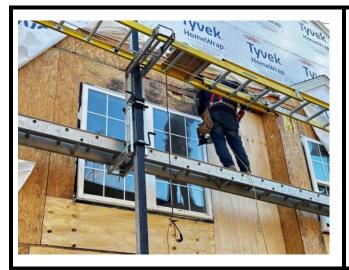
Photo #65: Overview of new sheathing being installed below a window.

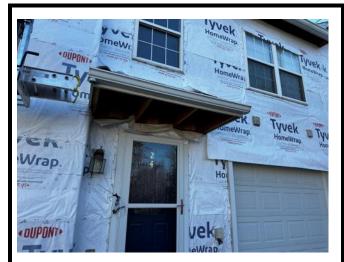
Photo #67: Overview of an entrance roof being reinforced with structural screws in order to eliminate the front brackets.

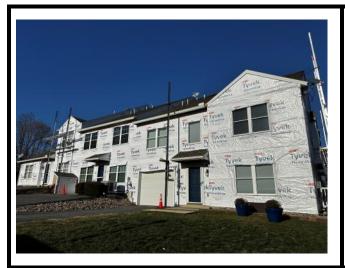
Photo #69: Overview of new Water Resistant Barrier (Tyvek) installed at a front section of the Building.

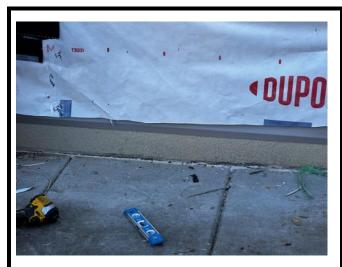
Photo #71: Overview of new metal flashing being installed before installing the starter strip.

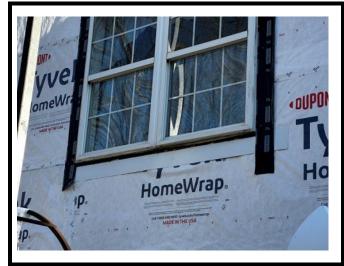
Photo #73: Overview of new metal flashing being installed at the bottom of a window.

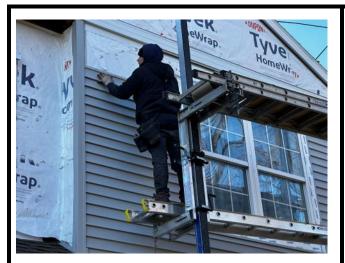
Photo #75: Overview of new vinyl siding being installed.

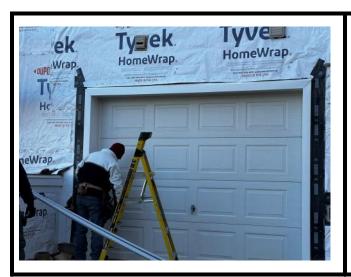
Photo #77: Overview of new aluminum wrap installed at a garage door.

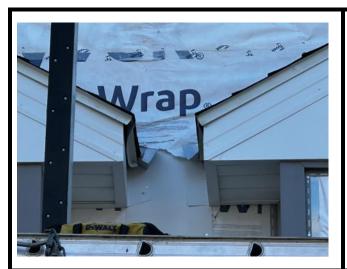
Photo #79: Overview of new kick-out flashings installed.

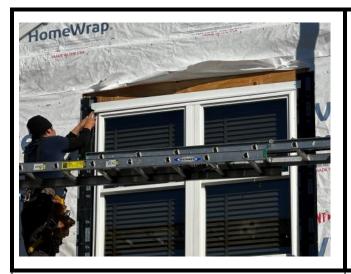
Photo #81: Overview of new flashing tape and metal drip cap being installed at a window.

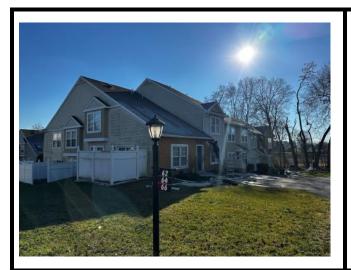
Photo #83: Overview of Lemus Siding Crew (Blue) working at Building 6 (56-66 Courtyard Drive).

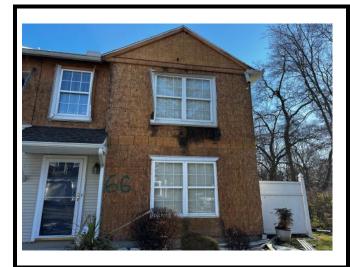
Photo #85: Overview of existing sheathing in poor condition below an upper window at Unit 66.

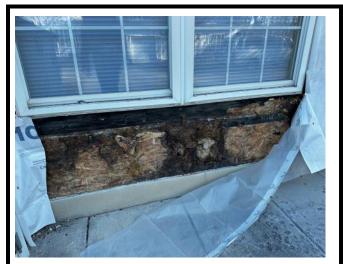
Photo #87: Overview of existing sheathing in poor condition below a lower window at Unit 64.

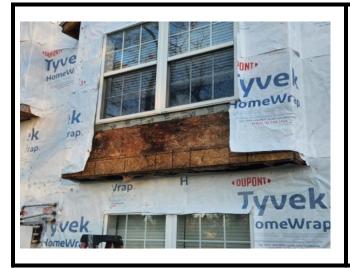
Photo #89: Overview of existing sheathing in poor condition below a box window at Unit 60.

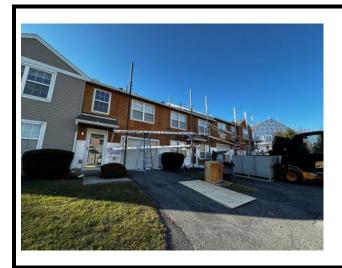
Photo #93: Overview of Lemus Siding Crew (Blue) working at Building 16 (43-53 Courtyard Drive).

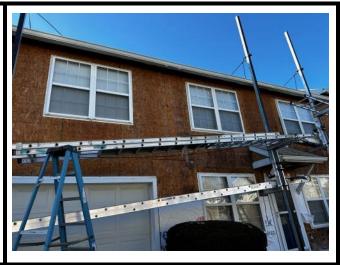
Photo #94: Overview of existing siding and stucco being removed.

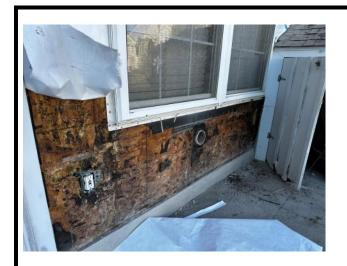
Photo #95: Overview of existing sheathing that was observed in poor condition below a lower window at Unit 45.

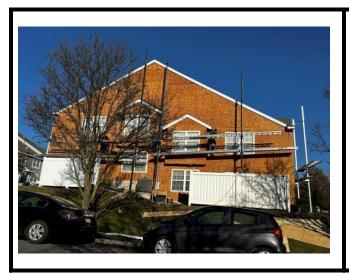
Photo #97: Overview of existing siding being removed at a main side section of the Building. No water resistant Barrier was observed.

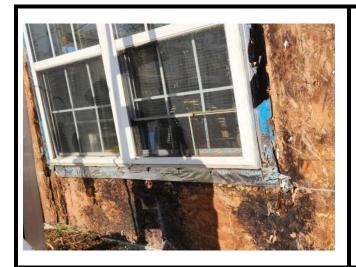
Photo #101: Overview of existing sheathing that was observed in poor condition below a lower window at Unit 47.

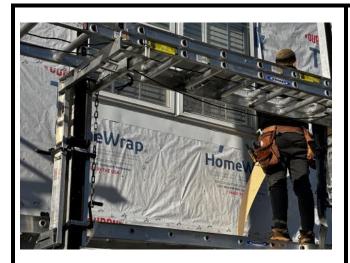
Photo #103: Overview of new metal flashing being installed below a window.

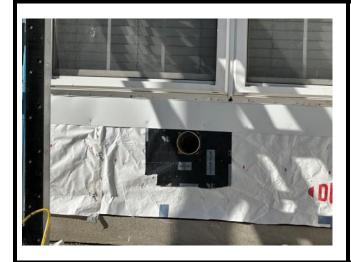
Photo #105: Overview of new flashing tape installed at a wall penetration (bathroom/dryer vent).
