Project #: 14372-04 **Date:** Dec 19, 20, 2023

Field Report 5

Purpose of Visit: To oversee the progress of siding replacement

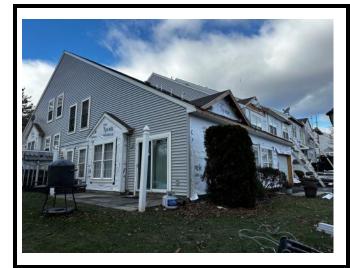
Photo #1: Overview of Lemus Siding Crew (Blue) working at Building 7 (68-78 Courtyard Drive).

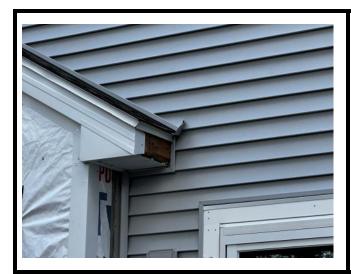
Photo #3: Overview of a new kick-out flashing installed.

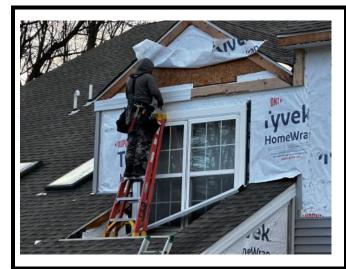
Photo #5: Overview of new metal flashing being installed at a front gable.

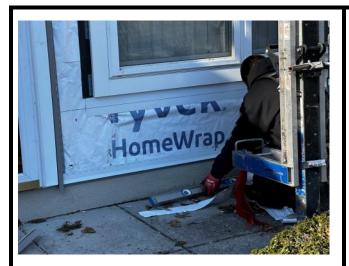
Photo #7: Overview of new starter strip being installed.

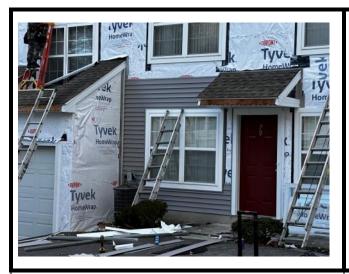
Photo #9: Overview of new vinyl siding being installed at the front of the Building.

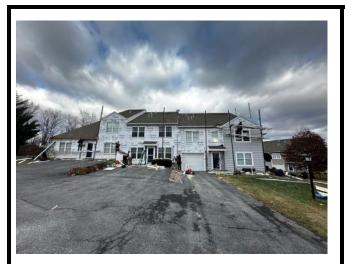
Photo #11: Overview of Lemus Siding Crew (Green) working at Building 15 (24-28, 55-59 Courtyard Drive).

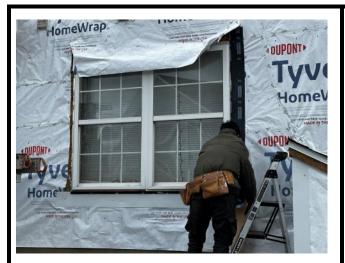
Photo #13: Overview of new flashing tape being installed at a window.

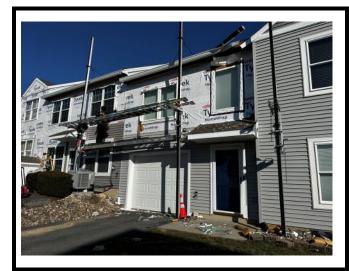
Photo #17: Overview of new vinyl siding being installed at another front section.

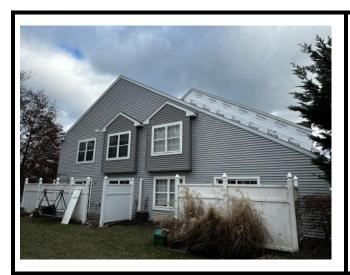
Photo #19: Overview of new vinyl siding installed at a main side of the Building.

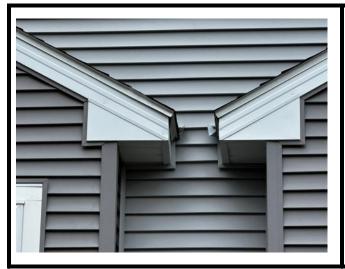
Photo #21: Overview of new kick-out flashings installed.

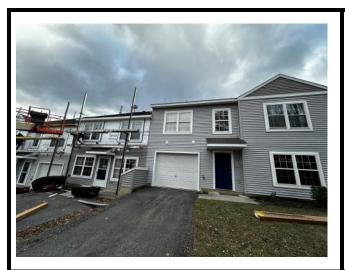
Photo #23: Overview of new vinyl siding being installed.

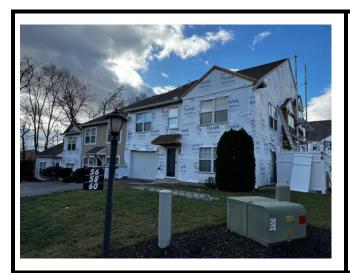
Photo #25: Overview of Lemus Siding Crew (Blue) working at Building 6 (56-66 Courtyard Drive).

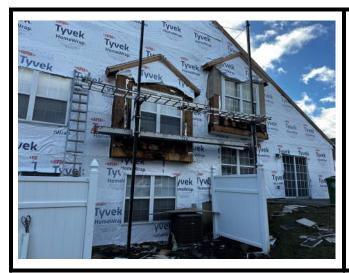
Photo #29: Overview of existing stucco being removed at the box windows.

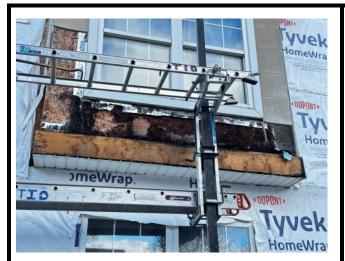
Photo #31: Overview of existing sheathing in poor condition below a box window at Unit 62.

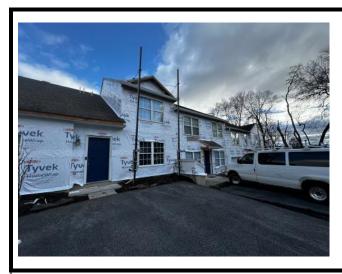
Photo #33: Overview of new Water Resistant Barrier (Tyvek) installed.

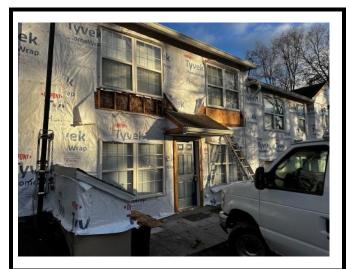
Photo #35: Overview of new sheathing being installed.

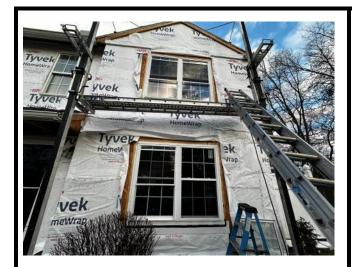
Photo #37: Overview of new windows being installed at Unit 66.

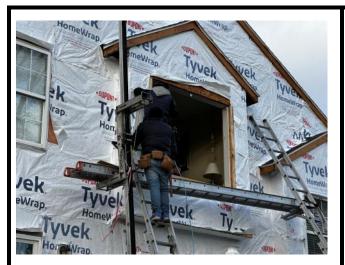
Photo #39: Overview of a new window being installed.

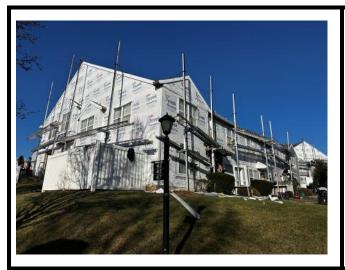
Photo #41: Overview of Lemus Siding Crew (Yellow) working at Building 16 (43-53 Courtyard Drive).

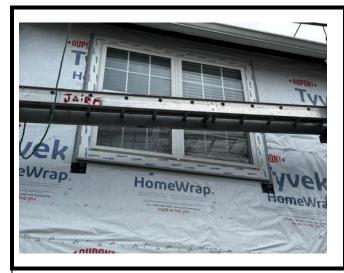
Photo #45: Overview of new pvc trim installed at a window.

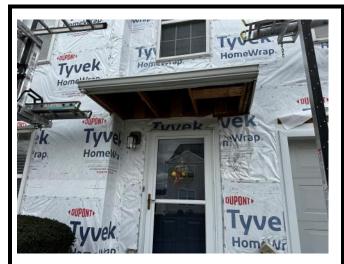
Photo #47: Overview of an entrance roof being reinforced with structural screws in order to eliminate the front brackets.

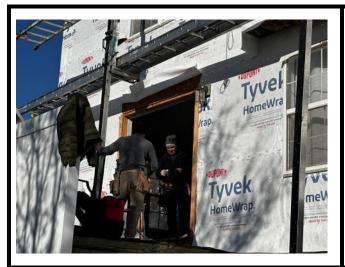
Photo #49: Overview of a new sliding door being installed at Unit 49.

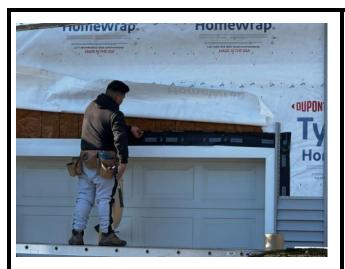
Photo #51: Overview of new flashing tape being installed over the new metal flashing at a garage door.

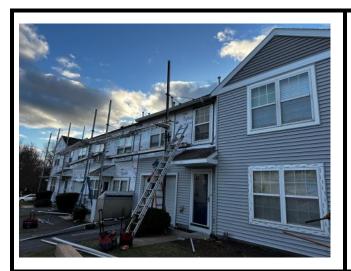
Photo #53: Overview of new vinyl siding installed at a front section of the Building.

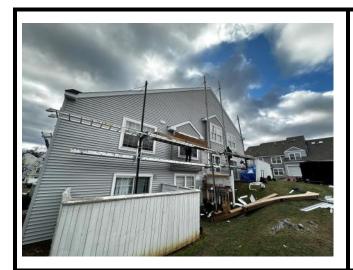
Photo #55 Overview of new vinyl siding installed at a main side of the Building.

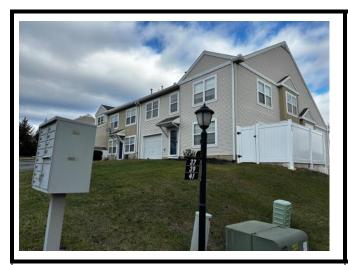
Photo #57: Overview of Lemus Siding Crew (Green) working at Building 17 (2-4, 37-41 Courtyard Drive).

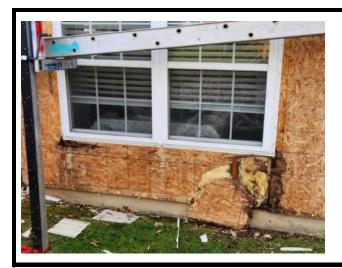
Photo #59: Overview of existing sheathing in poor condition below a lower window at Unit 41.

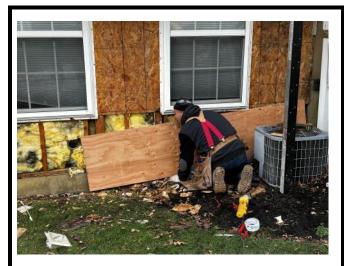
Photo #63: Overview of new sheathing being installed.

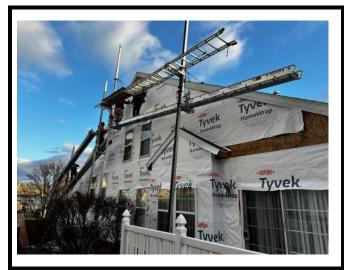
Photo #65: Overview of new Water Resistant Barrier (Tyvek) being installed.

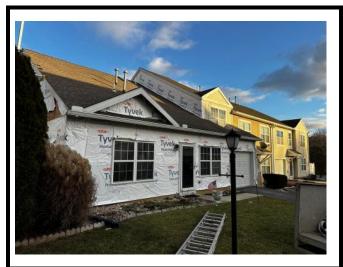
Photo #67: Overview of new Water Resistant Barrier (Tyvek) installed at a front section.

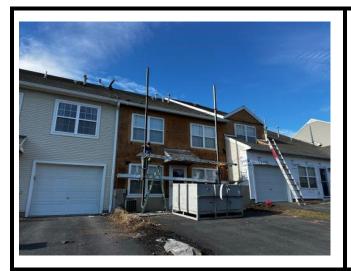
Photo #69: Overview of the existing siding/stucco being removed at the front of the Building.

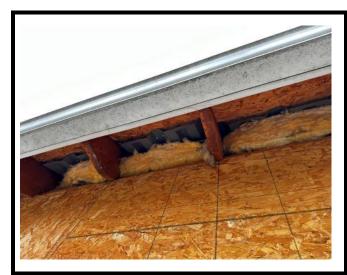
Photo #73: Overview of existing baffles that were observed in the Building.

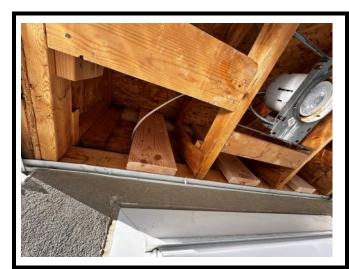
Photo #75: Overview of new structural screws and brackets to reinforced the small entrance roof.
