**Project:** Courtyards of Carlisle CA – Siding Project

**Project #:** 14372-04

**Date:** Jan 3, 4, 5, 2024

## Field Report 6

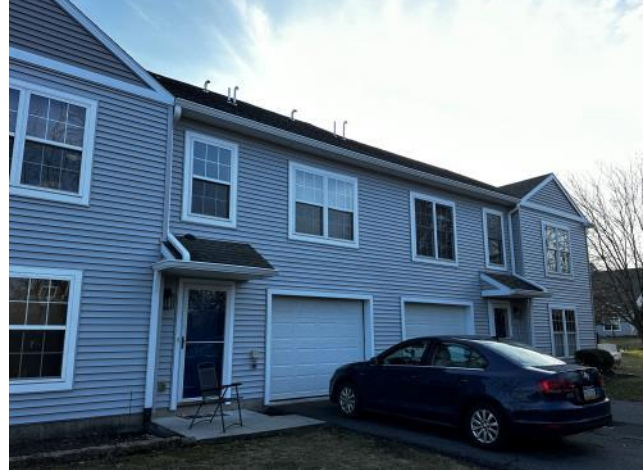
Photo #1: Overview of new gutters and downspouts installed at a front section of **Building 13**. A small section between units still needs to be completed.

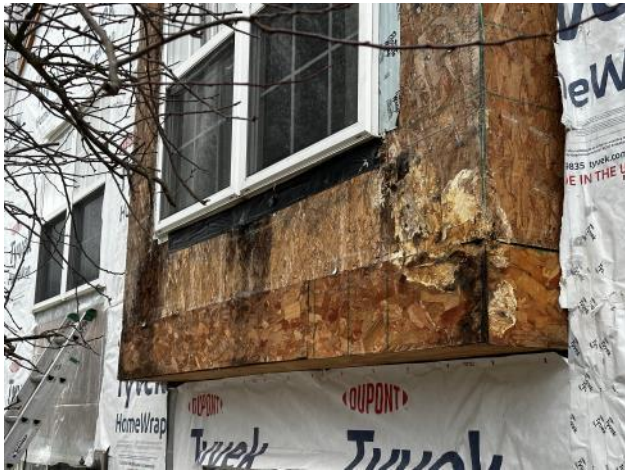
Photo #39: Overview of existing sheathing in poor condition below a box window at Unit 44.

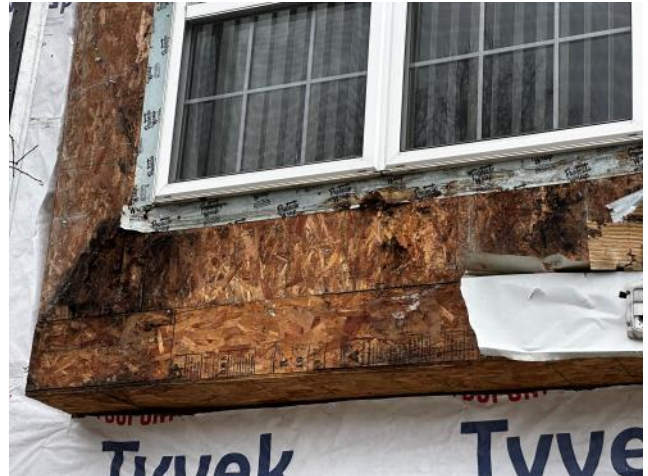
Photo #40: Overview of existing sheathing in poor condition below a box window at Unit 50.

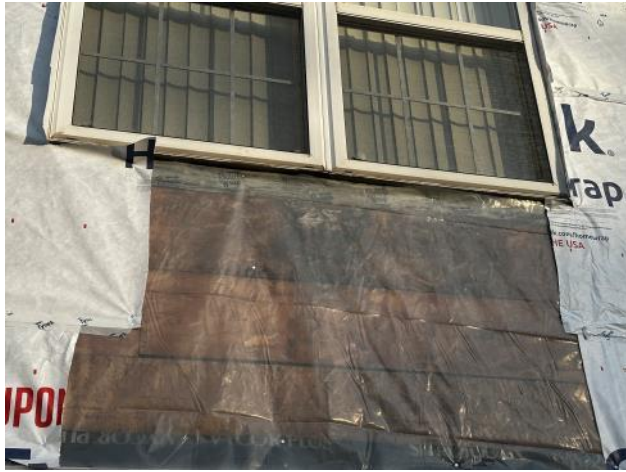
Photo #41: Overview of existing sheathing in poor condition below an upper window at Unit 50.

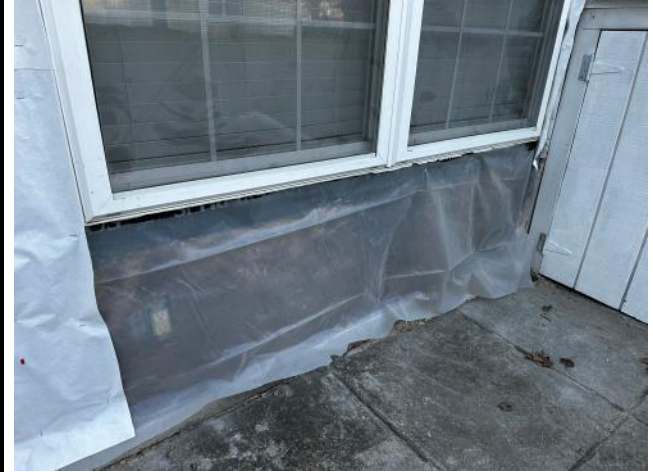
Photo #42: Overview of existing sheathing in poor condition below a lower window at Unit 46.

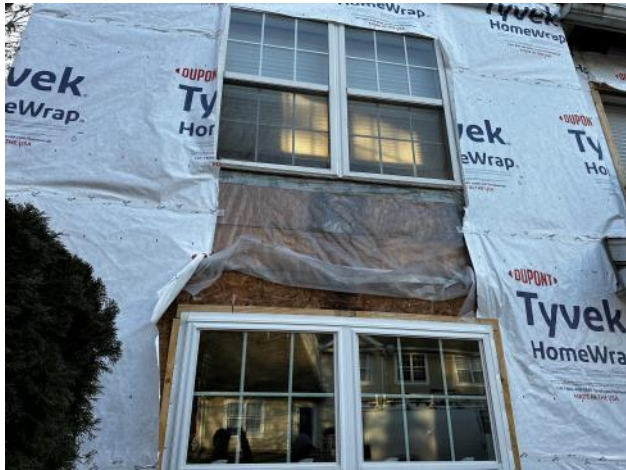
Photo #43: Overview of existing sheathing in poor condition below a lower window at Unit 48.

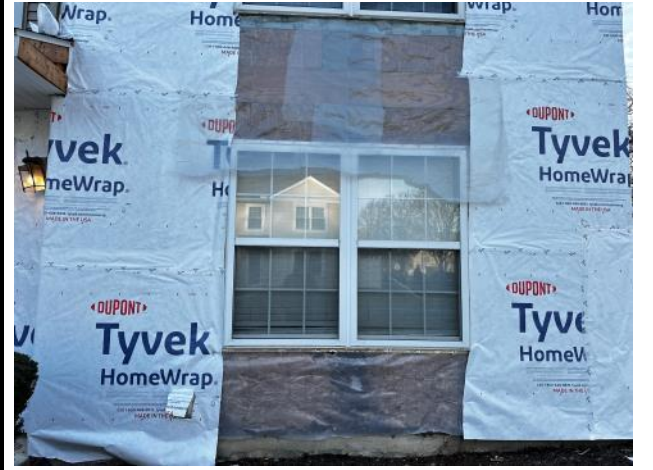
Photo #44: Overview of existing sheathing in poor condition below a lower and an upper window at Unit 44.

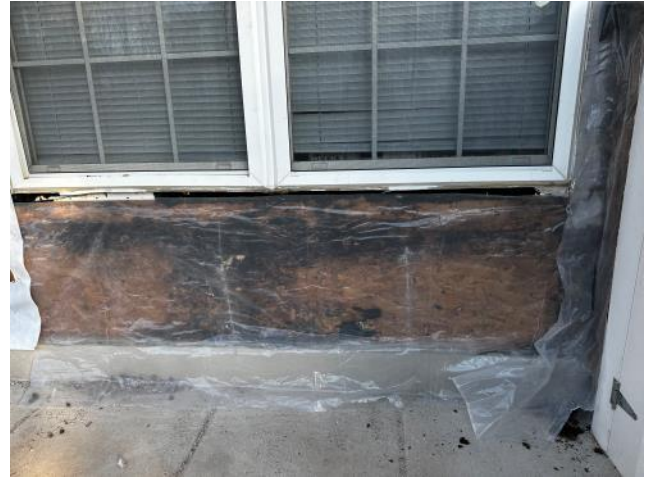
Photo #54: Overview of existing sheathing in poor condition below a lower window at Unit 18.

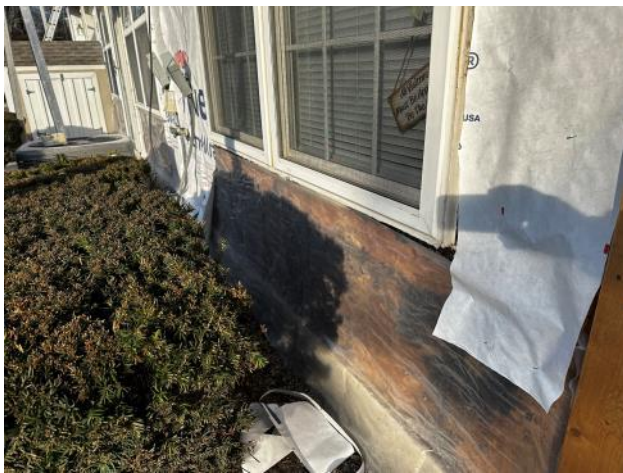
Photo #55 Overview of existing sheathing in poor condition below another lower window at Unit 18.

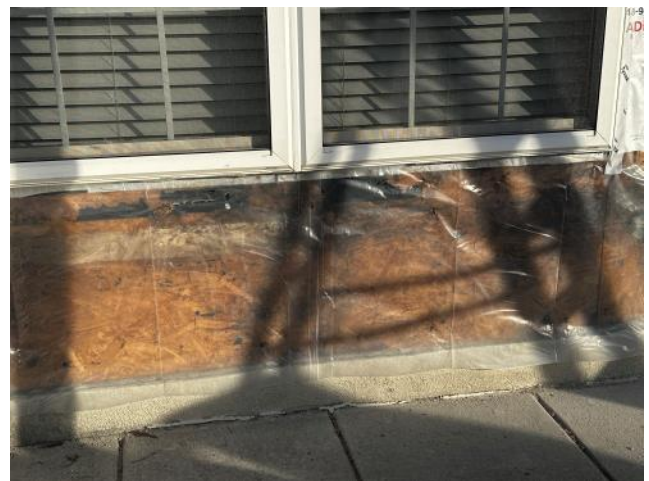
Photo #56: Overview of existing sheathing in poor condition below a lower and an upper window at Unit 20.

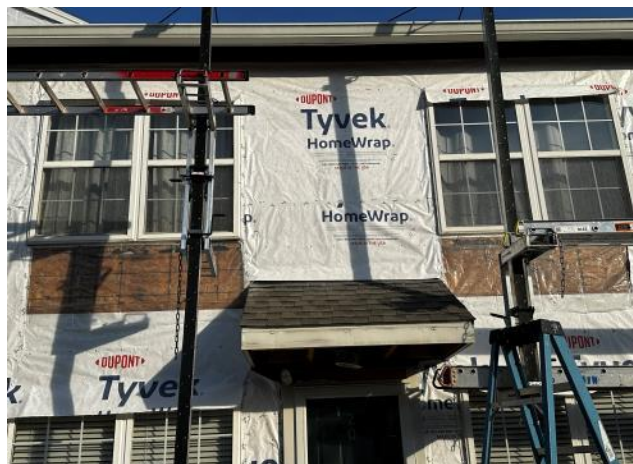
Photo #57: Overview of existing sheathing in poor condition below upper windows at Unit 20.

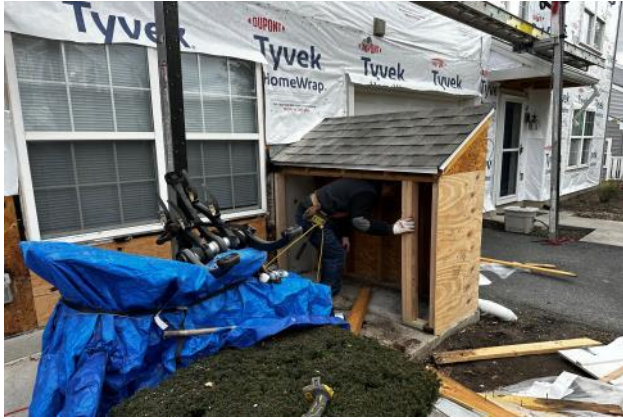
Photo #61: Overview of an existing shed being reconstructed due to it was in poor condition.

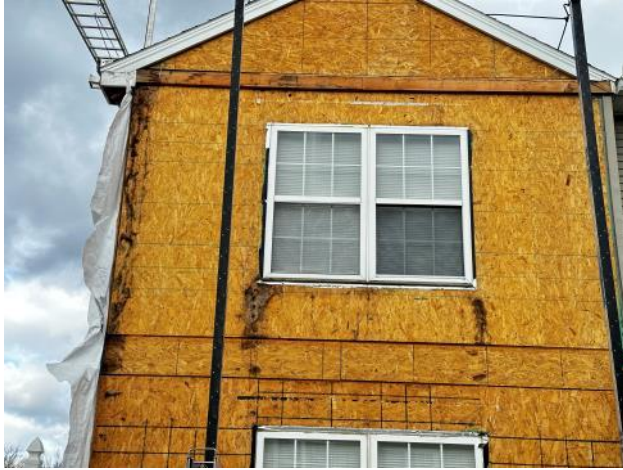
Photo #77: Overview of existing sheathing in poor condition below an upper window at Unit 19.

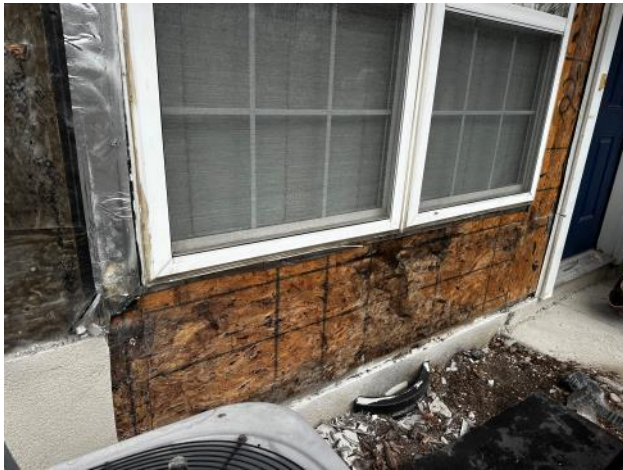
Photo #79: Overview of existing sheathing in poor condition below a lower window at Unit 21.

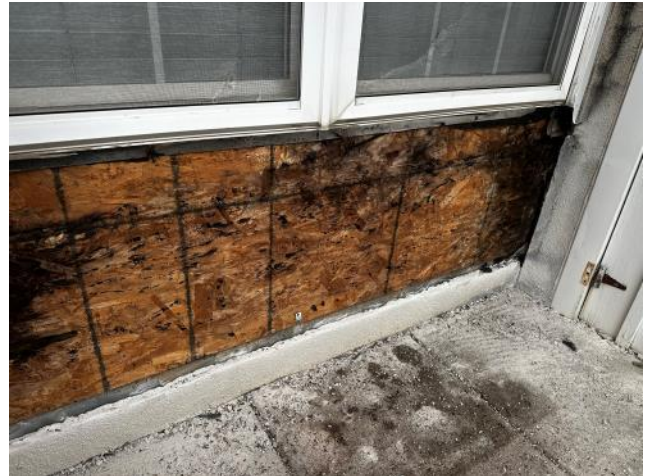
Photo #80: Overview of existing sheathing in poor condition below another lower window at Unit 21.

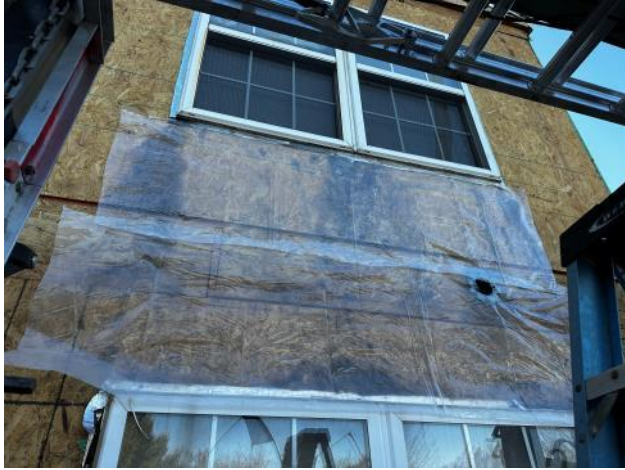
Photo #81: Overview of existing sheathing in poor condition below an upper window at Unit 25.

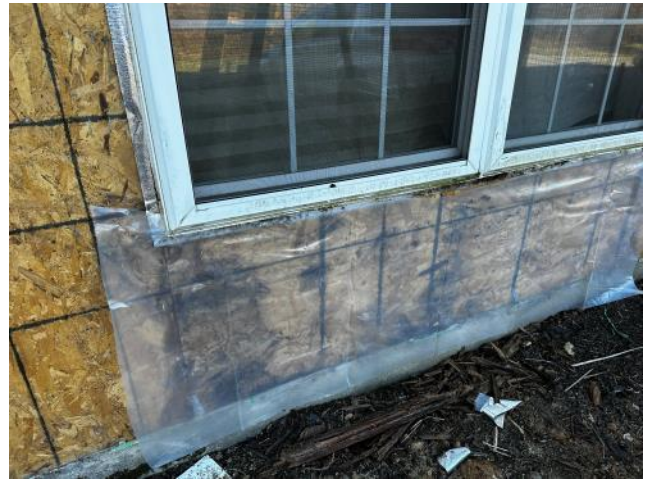
Photo #82: Overview of existing sheathing in poor condition below a lower window at Unit 25.

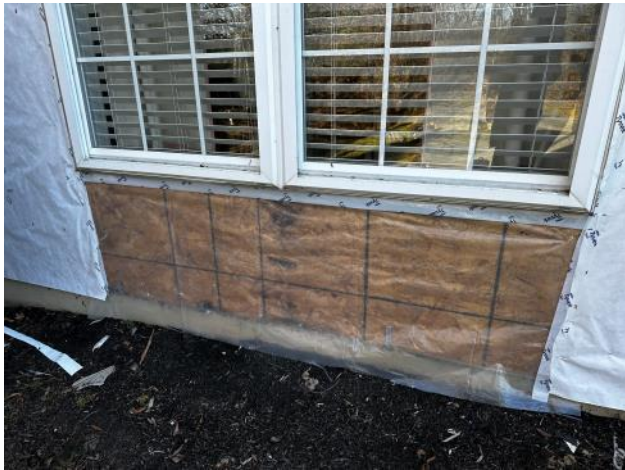
Photo #83: Overview of existing sheathing in poor condition below a lower window at Unit 29.

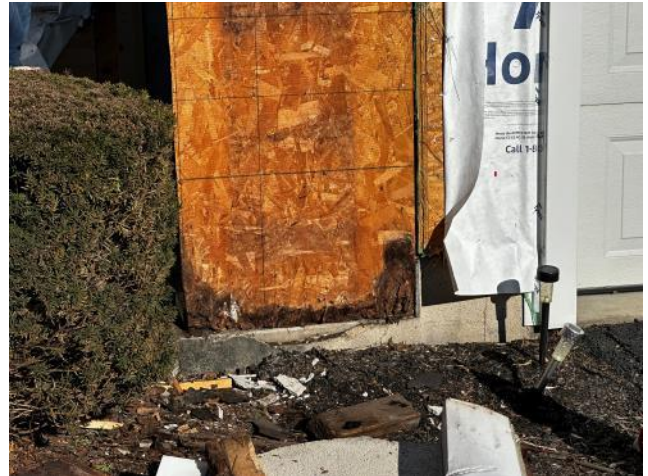
Photo #84: Overview of existing sheathing in poor condition at a exterior shed.

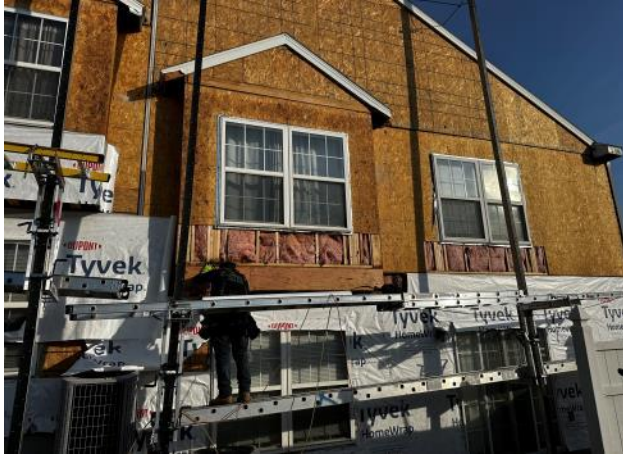
Photo #85: Existing sheathing below a box window at Unit 19 was previously observed in poor condition. Overview of new sheathing being installed below the box window.

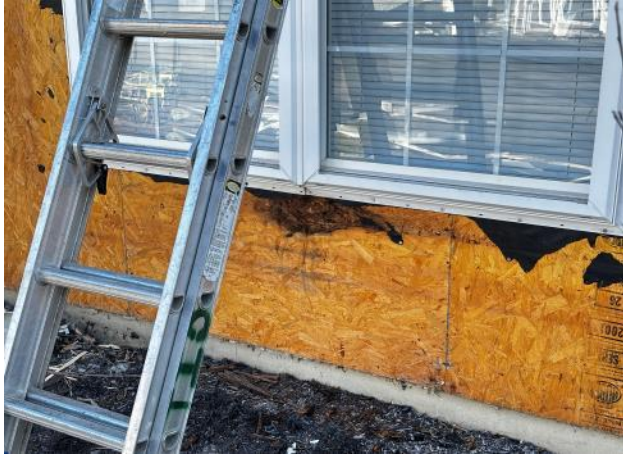
Photo #105: Overview of existing sheathing in poor condition below a lower window at Unit 42.

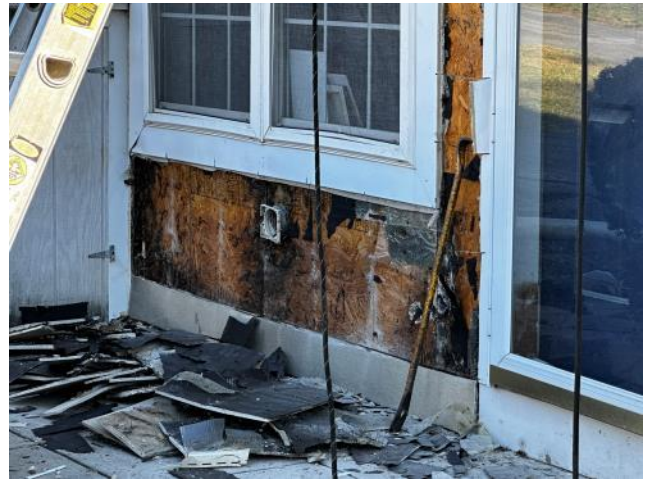
Photo #106: Overview of existing sheathing in poor condition below a lower window at Unit 40.
