**Project #:** 14372-04 **Date:** Jan 11, 12, 2024

#### Field Report 7

Purpose of Visit: To oversee the progress of siding replacement

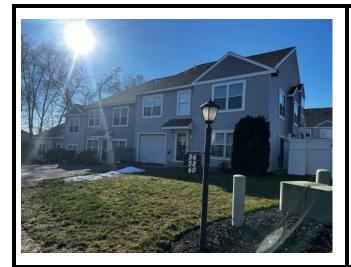
Photo #1: Overview of Lemus Siding Crew (Blue) completing Building 6 (56-66 Courtyard Drive).

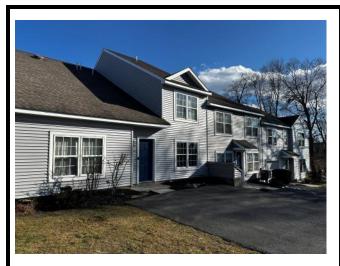
Photo #3: Overview of new vinyl siding installed at a front section of the Building.

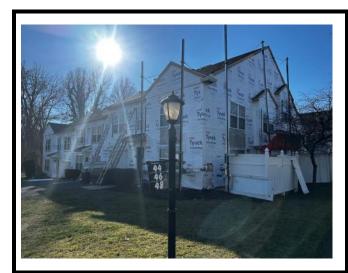
Photo #5: Overview of Lemus Siding Crew (Blue) working at Building 5 (44-54 Courtyard Drive).

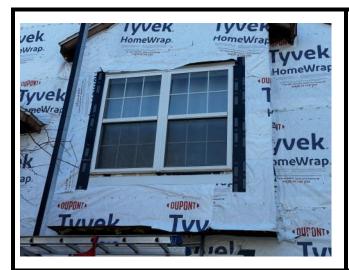
Photo #7: Overview of a window being properly flashed.

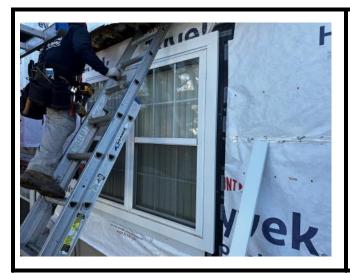
Photo #9: Overview of new pvc trim being installed at a window.

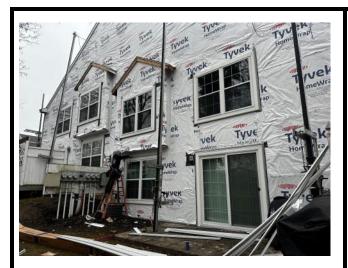
Photo #11: Overview of new details and siding accessories being installed at a main side of the Building.

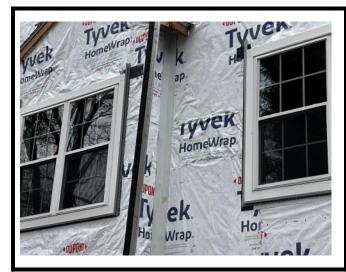
Photo #13: Overview of new metal flashing installed at an inside corner.

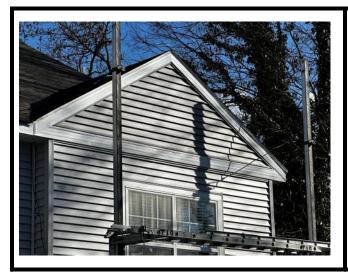
Photo #17: Overview of new metal wrap at the rake board and new vinyl siding being installed at a front gable.

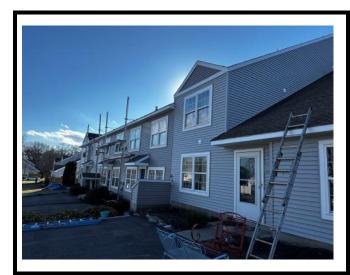
Photo #21: Overview of new vinyl siding installed at a front section.

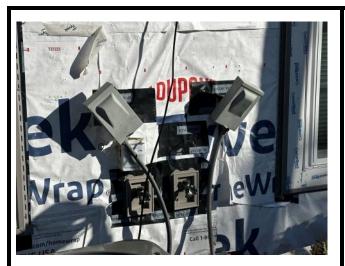
Photo #23: Overview of wall penetrations properly flashed.

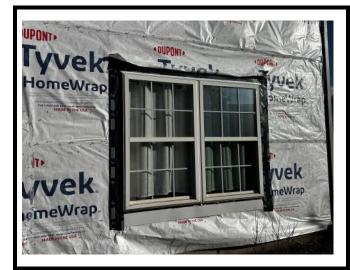
Photo #25: Overview of a window properly flashed.

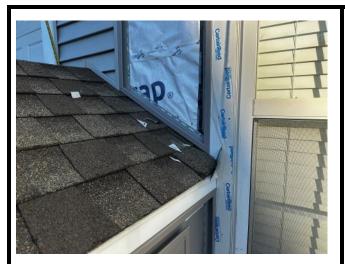
Photo #27: Overview of a new kick-out flashing installed at an exterior shed.

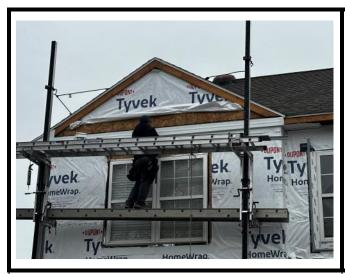
Photo #29: Overview of new metal wrap being installed at a front gable.

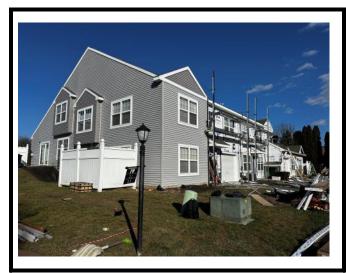
Photo #33: Overview of Lemus Siding Crew (Yellow) working at Building 19 (19-29 Courtyard Lane).

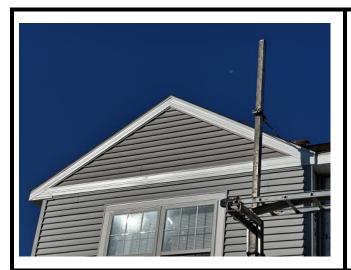
Photo #35: Overview of new metal wrap installed at the rake boards and new vinyl siding installed at a front gable.

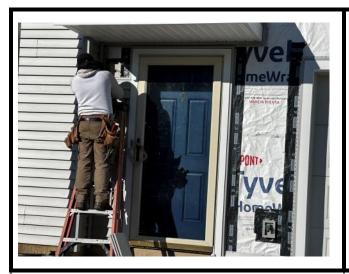
Photo #37: Overview of a front door being properly flashed.

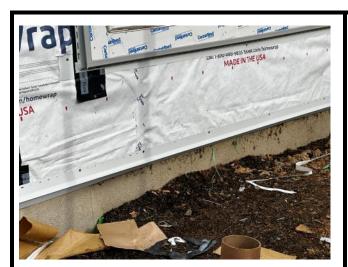
Photo #39: Overview of new starter strip installed.

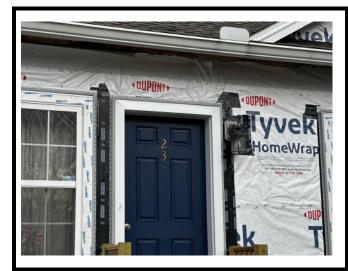
Photo #41: Overview of a front door properly flashed and new j-channel being installed.

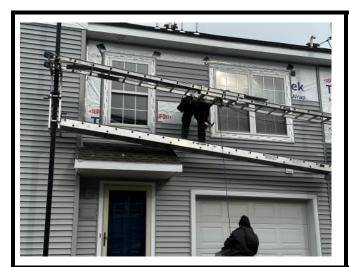
Photo #43: Overview of new vinyl siding being installed at a front section of the Building.

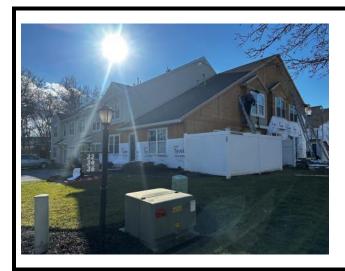
Photo #45: Overview of Lemus Siding Crew (Blue) working at Building 4 (32-42 Courtyard Drive).

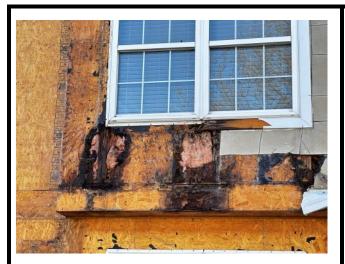
Photo #47: Overview of existing sheathing in poor condition below a box window at Unit 32.

The demo & carpentry crews continued with the existing siding/stucco removal and replacing any existing damaged wood at Buildings 4 and 20. It should be noted that just like the others Buildings, water resistant barrier material was not observed throughout the walls after the siding and stucco was removed and some existing windows were not properly flashed in the past. Also some existing windows were observed to be failing. Existing sheathing and framing at some sections were observed to be damaged at the bottom of those windows, including the box windows with stucco and sections where kick-out flashings are missing on the roofs.

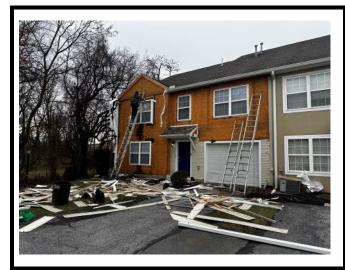
Photo #49: Overview of existing siding being removed.

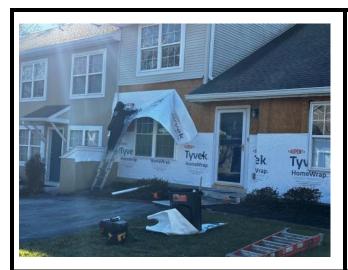
Photo #51: Overview of new Water Resistant Barrier (Tyvek) being installed.

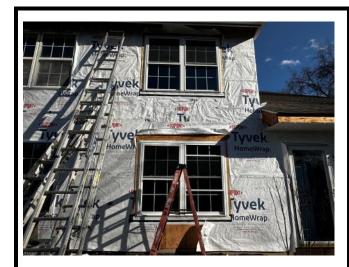
Photo #53: Overview of new windows installed at Unit 42.

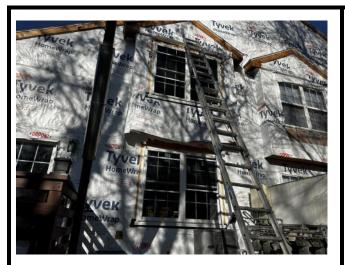
Photo #55 Overview of a new box window installed at Unit 42.

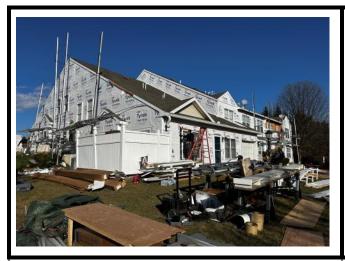
Photo #57: Overview of Lemus Siding Crew (Green) working at Building 20 (7-17 Courtyard Lane).

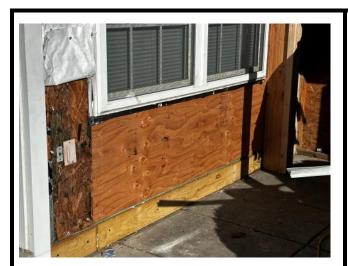
Photo #63: Overview of new sheathing being installed below a window at Unit 9.

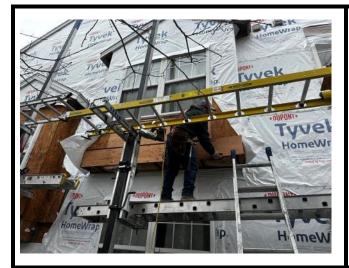
Photo #65: Overview of new sheathing being installed below a box window.

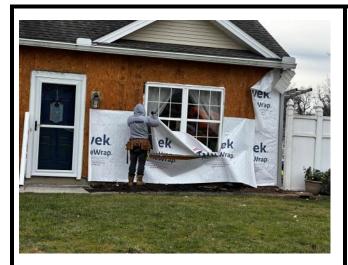
Photo #67: Overview of new Water Resistant Barrier (Tyvek) being installed at a front section.

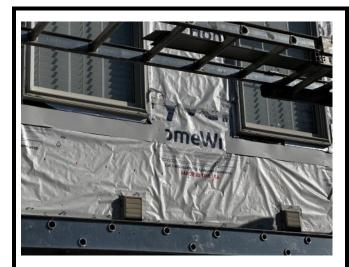
Photo #69: Overview of new metal flashing installed at the bottom of the windows.

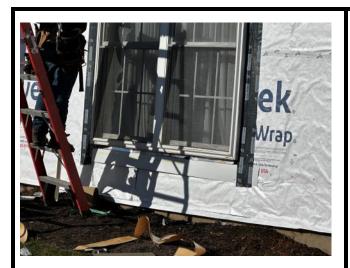
Photo #71: Overview of new flashing tape being installed at a window.

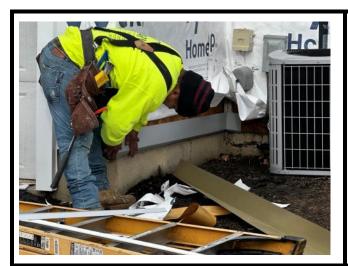
Photo #75: Overview of new metal flashing being installed before installing the new starter strip.

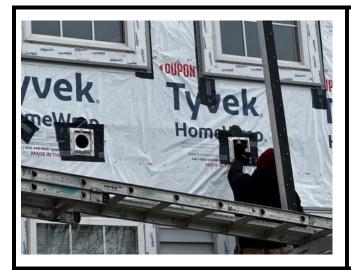
Photo #77: Overview of wall penetrations being properly flashed.

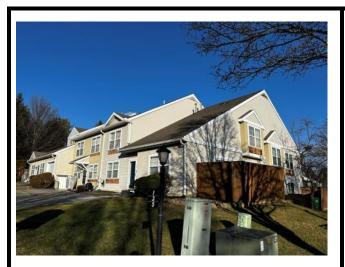
Also at the request of Lemus, small sections of the existing siding/stucco were removed below the existing windows at Building 24 (1-5, 1326-1330). This was done in order to identify which windows are failing due to this type of windows are smaller compared to the majority of the windows throughout the community. This way Lemus can communicate to the Homeowners if they opt to replace their damaged windows and Lemus can order them. The majority of the windows were observed to be failing, see photos below in the report.

Photo #79: Overview of Lemus removing small sections of the existing siding/stucco below the existing windows at **Building 24 (1-5, 1326-1330)**.

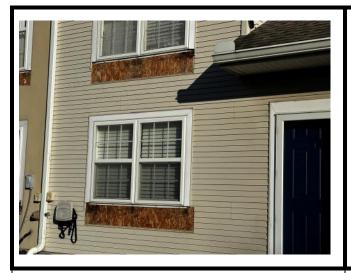
Photo #81: Overview of existing sheathing in poor condition below an upper and lower window at Unit 1.

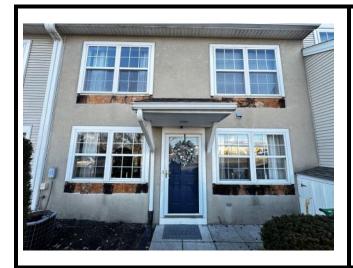
Photo #85: Overview of existing sheathing in poor condition below the four windows at Unit 1328.

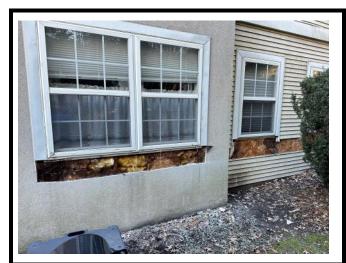
Photo #87: Overview of existing sheathing in poor condition below other lower windows at Unit 1330.

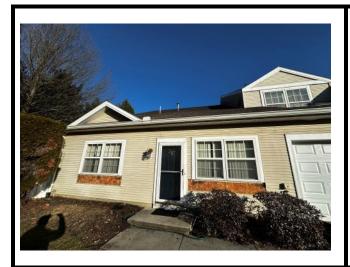
Photo #89: Overview of existing siding removed to inspect the windows at Unit 5.
