Project #: 14372-04 Date: Jan 29, 30, Feb 1, 2, 5, 2024 Inspector: Luis Sanchez Weather: Sunny & Cloudy, 40s°F

Field Report 10

Purpose of Visit: To oversee the progress of siding replacement

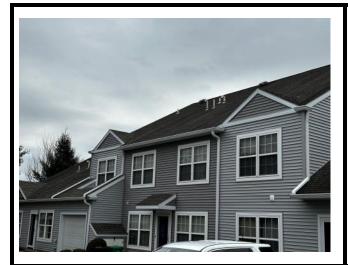
Photo #1: Overview of new gutters and downspouts installed at **Building 19 (19-29 Court Lane)**.

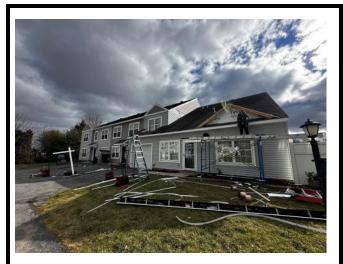
Photo #3: Overview of Lemus Siding Crew (Green) working at Building 20 (7-17 Courtyard Lane).

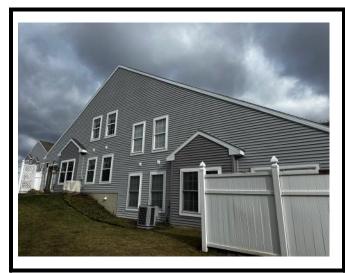
Photo #5: Overview of new vinyl siding installed at a main side of the Building.

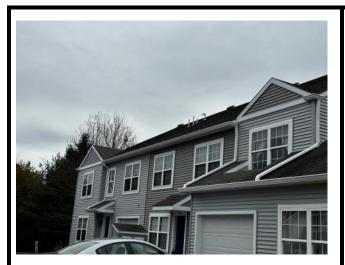
Photo #7: Overview of new gutters and downspouts installed at a front side of the Building.

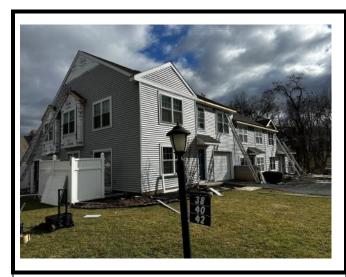
Photo #9: Overview of Lemus Siding Crew (Blue) working at Building 4 (32-42 Courtyard Drive).

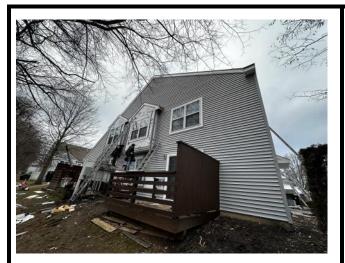
Photo #11: Overview of new details and siding accessories being installed at a main side of the Building.

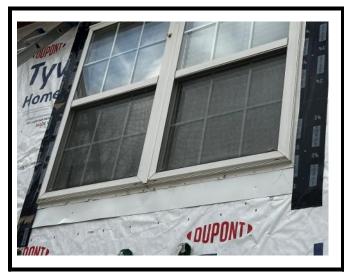
Photo #13: Overview of new metal flashing installed at the bottom of a window.

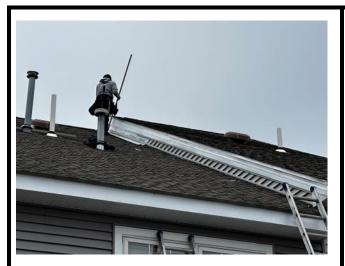
Photo #15: Overview of new vinyl siding being installed at a roofing sidewall section of the Building.

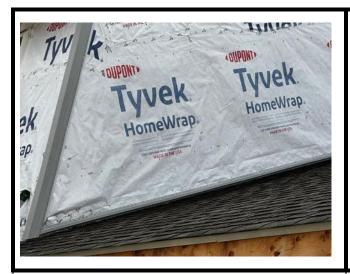
Photo #17: Overview of new j-channel being installed along the roof line.

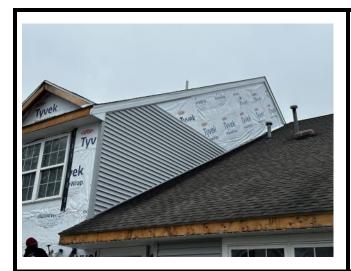
Photo #19: Overview of new vinyl siding being installed at a roofing sidewall section of the Building.

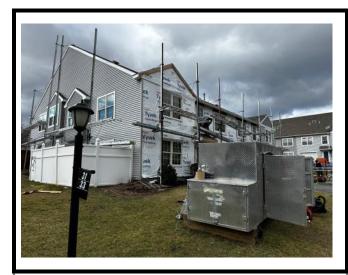
Photo #21: Overview of Lemus Siding Crew (Yellow) working at Building 21 (1-3, 31-33 Court Lane/Courtyard Drive).

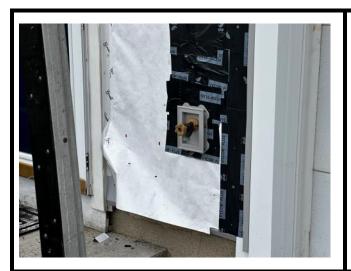
Photo #23: Overview of wall penetrations properly flashed.

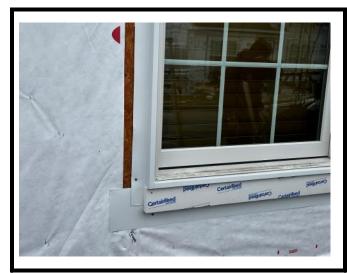
Photo #25: Overview of the custom window flange that had to be installed at the windows of Unit 31.

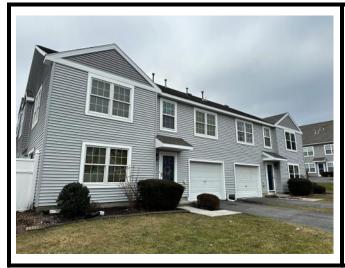
Photo #29: Overview of new vinyl siding installation completed at a front side of the Building.

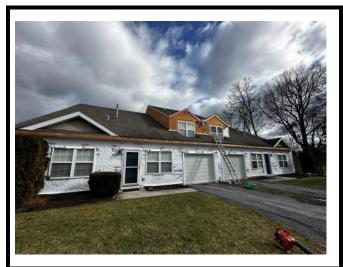
Photo #31: Overview of Lemus Siding Crew (Blue) working at Building 3 (20-22,26-28 Courtyard Drive).

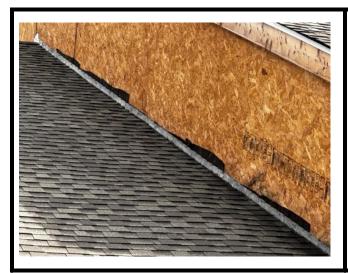
The demo & carpentry crews continued with the existing siding/stucco removal and replacing any existing damaged wood at Buildings 3, 2, 22, 23, and 24. It should be noted that just like the others Buildings, water resistant barrier material was not observed throughout the walls after the siding and stucco was removed and some existing windows were not properly flashed in the past. Also some existing windows were observed to be failing. Existing sheathing and framing at some sections were observed to be damaged at the bottom of those windows, including the box windows with stucco and sections where kick-out flashings are missing on the roofs.

Photo #33: No signs of Water Resistant Barrier nor leak barrier were observed at the roofing sidewalls.

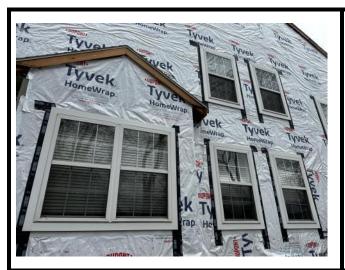
Photo #35: Overview of new pvc trims installed at the windows.

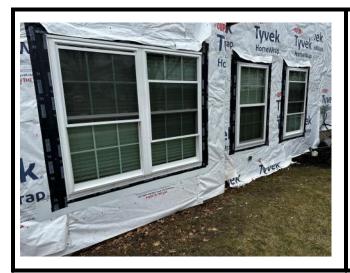
Photo #37: Overview of new metal flashing installed at the bottom of the windows and new flashing tape installed at the sides and headers.

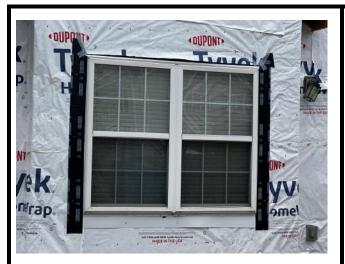
Photo #39: Overview of new metal flashing installed at the bottom of another window.

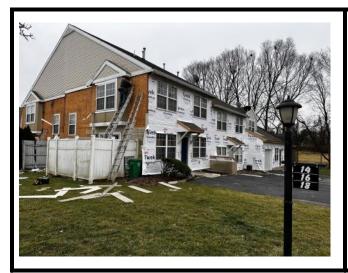
Photo #41: Overview of Lemus Siding Crew (Blue) working at Building 2 (8-18 Courtyard Drive).

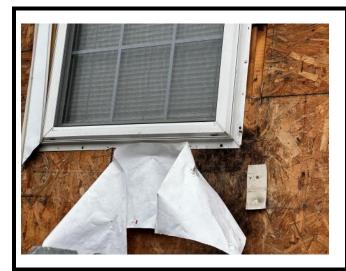
Photo #45: Overview of existing sheathing in poor condition below an upper window at Unit 8.

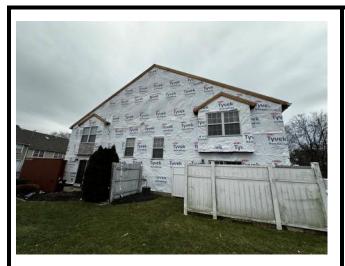
Photo #47: Overview of new Water Resistant Barrier (Tyvek) installed.

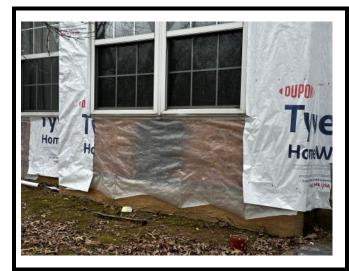
Photo #49: Overview of existing sheathing in poor condition below a box window at Unit 12.

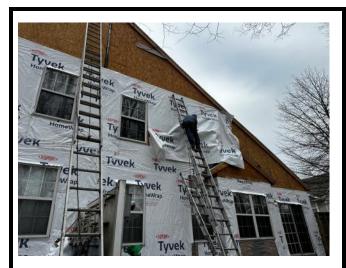
Photo #51: Overview of new Water Resistant Barrier (Tyvek) being installed.

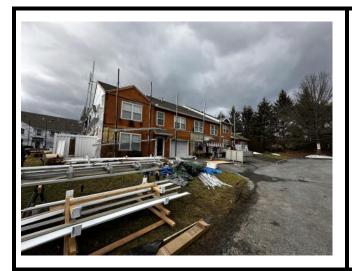
Photo #53: Overview of Lemus Siding Crew (Green) working at Building 22 (19-29 Courtyard Drive).

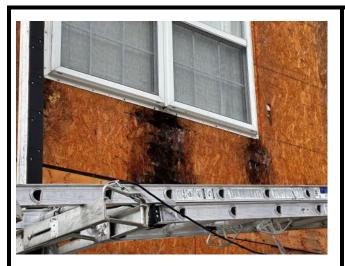
Photo #55: Overview of existing sheathing in poor condition below an upper window at Unit 19.

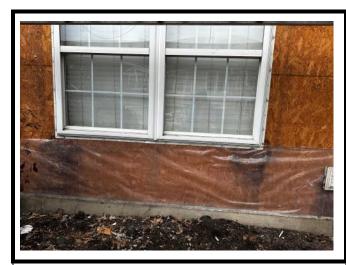
Photo #57: Overview of existing sheathing in poor condition below a lower window at Unit 23.

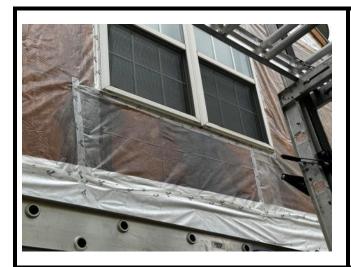
Photo #61: Overview of existing sheathing in poor condition below an upper window at Unit 29.

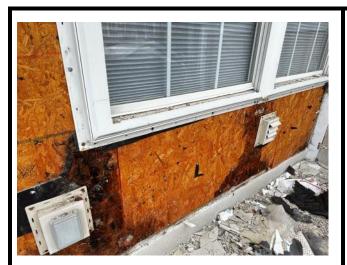
Photo #63: Overview of existing sheathing in poor condition below a lower window at Unit 21.

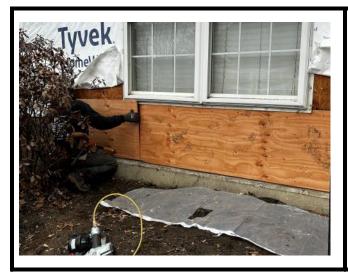
Photo #65: Overview of new sheathing being installed below a box window.

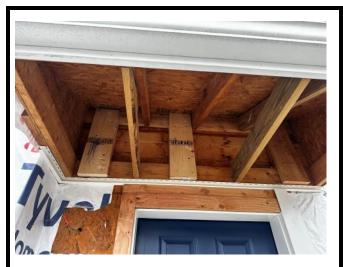
Photo #67: Overview of an entrance roof being reinforced with structural screws in order to eliminate the front brackets.

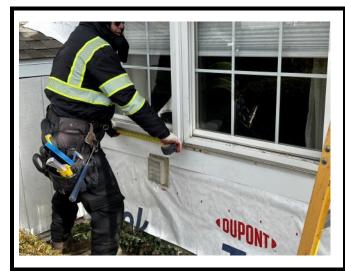
Photo #69: Overview of new metal flashing being installed at the bottom of a window.

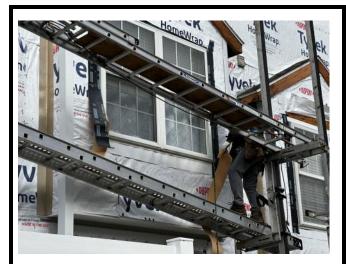
Photo #71: Overview of new flashing tape being installed at a window.

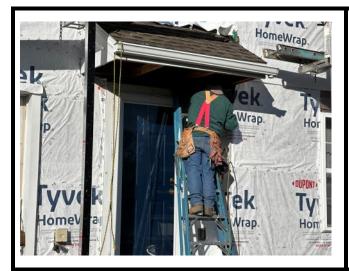
Photo #73: Overview of an entrance roof being reinforced with structural screws in order to eliminate the front brackets.

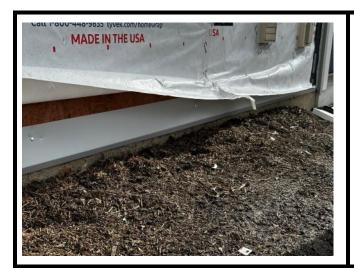
Photo #75: Overview of new metal flashing being installed before installing the new starter strip.

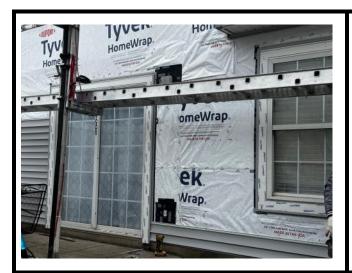
Photo #77: Overview of wall penetrations being properly flashed.

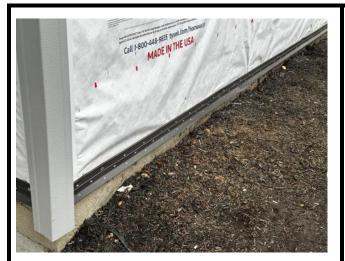
Photo #79: Overview of new starter strip installed.

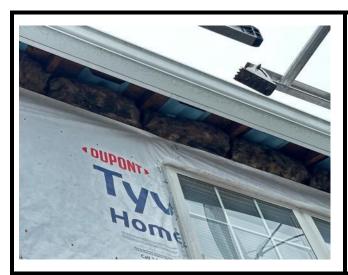
Photo #81: Overview of existing baffles observed in the Building.

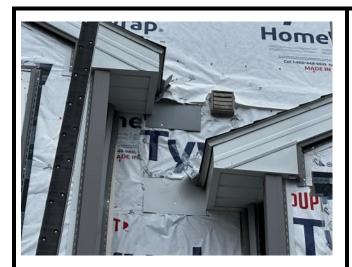
Photo #83: Overview of new metal flashing and kick-out flashings installed.

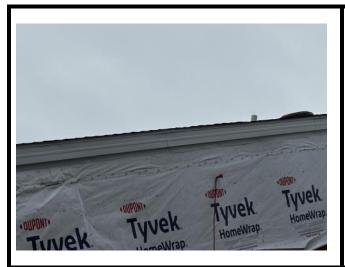
Photo #85: Overview of new metal wrap installed at a rake board section.

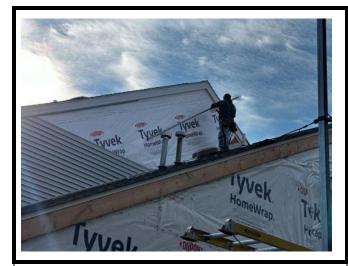
Photo #87: Overview of new vinyl siding being installed at a roofing sidewall.

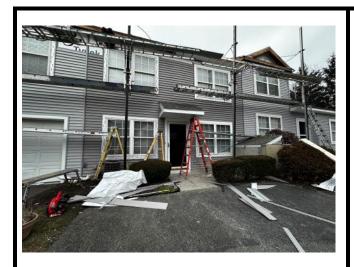
Photo #89: Overview of new vinyl siding being completed at a front section.

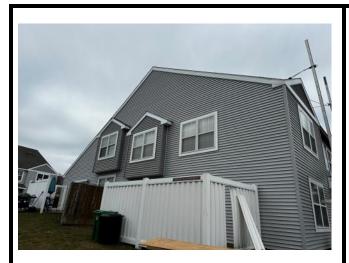
Photo #91: Overview of new vinyl siding installation completed at a main side of the Building.

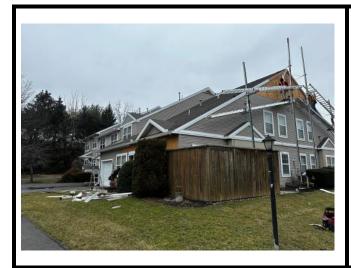
Photo #93: Overview of Lemus Siding Crew (Yellow) working at Building 23 (7-17 Courtyard Drive).

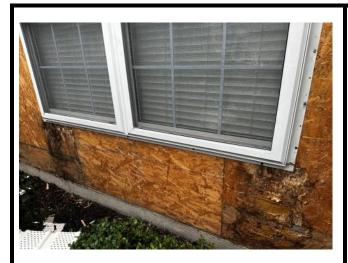
Photo #95: Overview of existing sheathing in poor condition below a lower window at Unit 13.

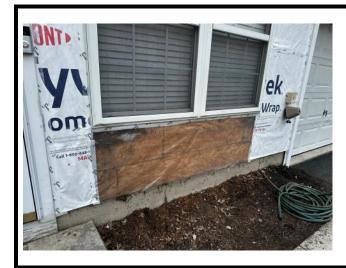
Photo #97: Overview of existing sheathing in poor condition below a lower window at Unit 7.

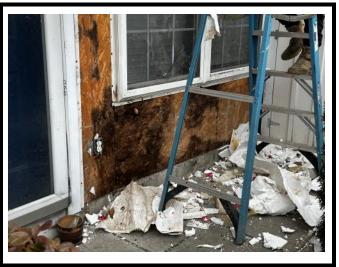
Photo #98: Overview of existing sheathing in poor condition below a lower window at Unit 9.

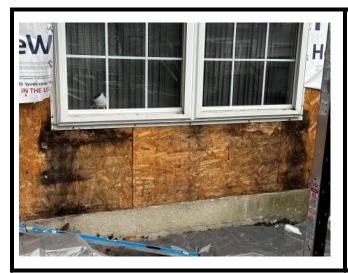
Photo #101: Overview of existing sheathing in poor condition below a lower window at Unit 17.

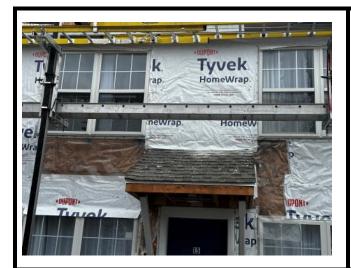
Photo #103: Overview of existing sheathing in poor condition below an upper window at Unit 15.

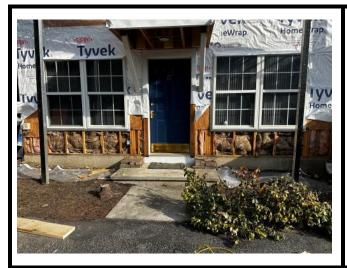
Photo #105: Overview of new insulation being installed.

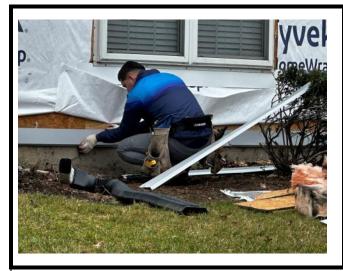
Photo #109: Overview of new metal flashing being installed before installing the new starter strip.

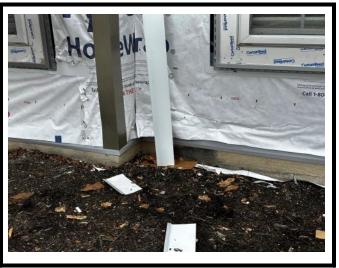
Photo #110: Overview of new metal flashings being installed at the wall corners.

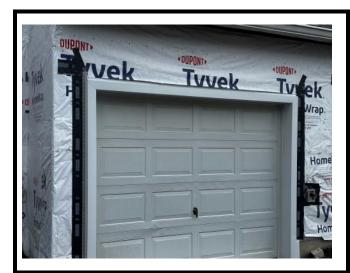
Photo #113: Overview of new metal trim and flashing tape at a garage door.

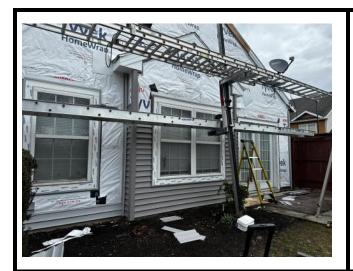
Photo #115: Overview of new vinyl being installed.

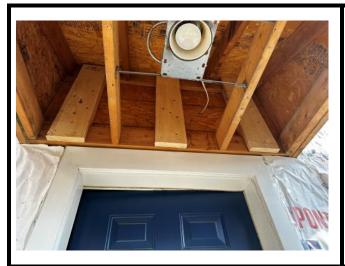
Photo #117: Overview of an entrance roof being reinforced with structural screws in order to eliminate the front brackets.

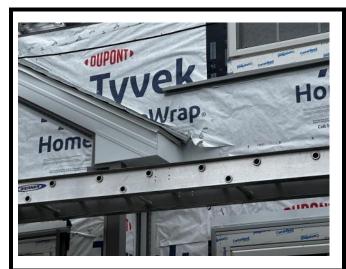
Photo #119: Overview of new kick-out flashing installed.

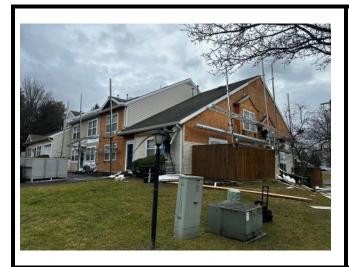
Photo #121: Overview of Lemus Siding Crew (Green) working at Building 24 (1-5, 1326-1330 Courtyard Drive).

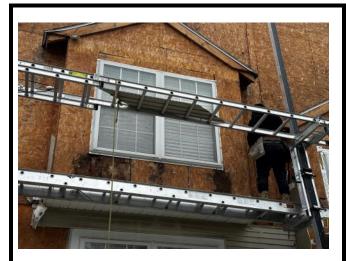
Photo #123: Overview of existing sheathing that was observed in poor condition below a box window.
