July 21, 2020

Reference: The Courtyards of Carlisle
Moisture Testing and Water Infiltration Investigation
Becht Project Number 20-0338

Moisture Probe Summary Tables and Photographs

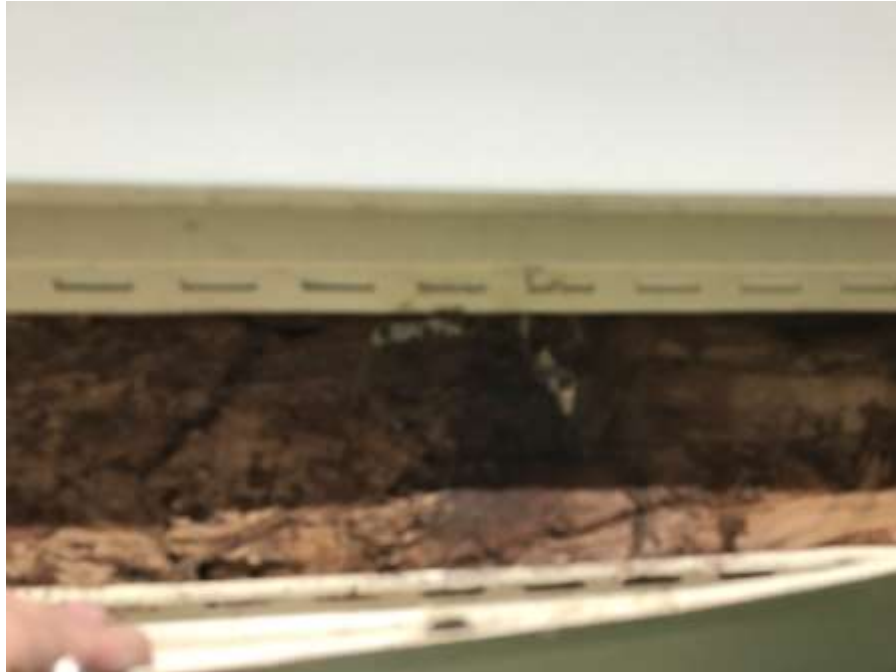
Building 6 - 60 Courtyard. Sheathing rotted under window.
