Project: Courtyards of Carlisle CA – Siding Project

Project #: 14372-04

Date: Nov 6, 8, 9, 2023

Field Report 1

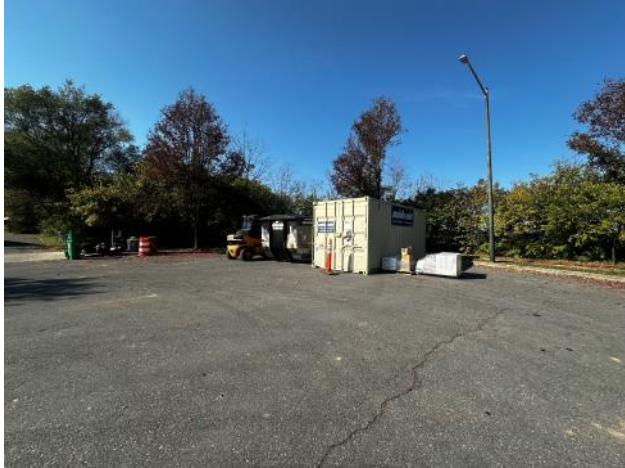
Photo #1: Onsite operations showing the staging area at the big cul-de-sac on Court Lane.

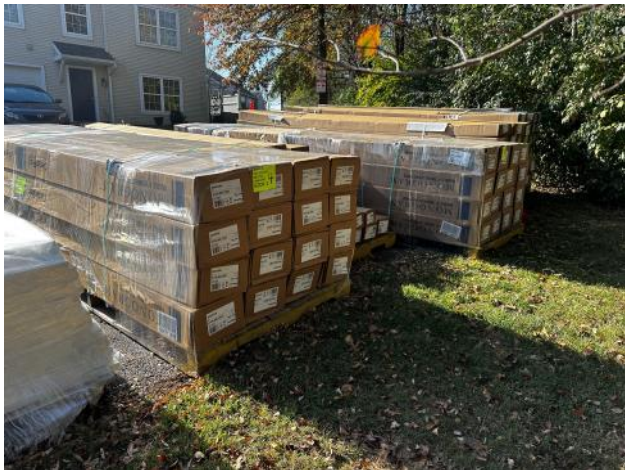
Photo #3: Overview of specified CertainTeed Monogram vinyl siding, Sterling Gray.

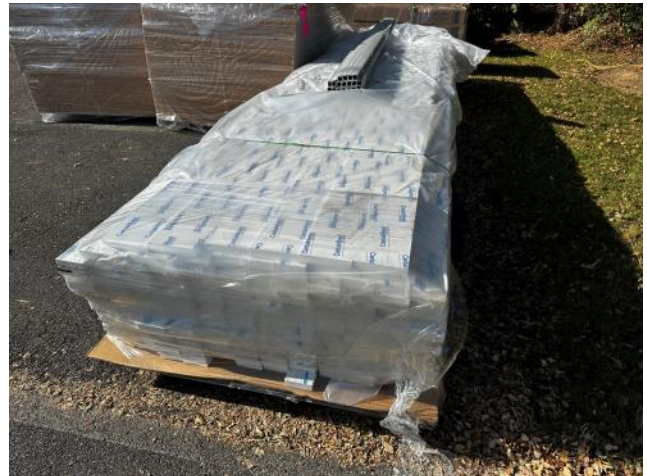
Photo #4: Overview of new pvc trim material, Azek.

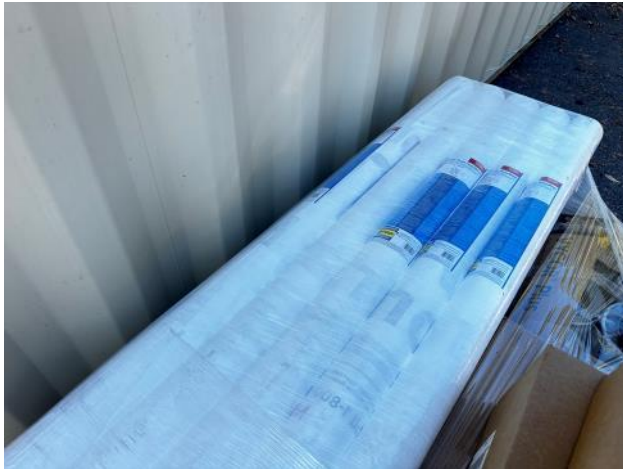
Photo #5: Overview of new Water Resistant Barrier, Tyvek.

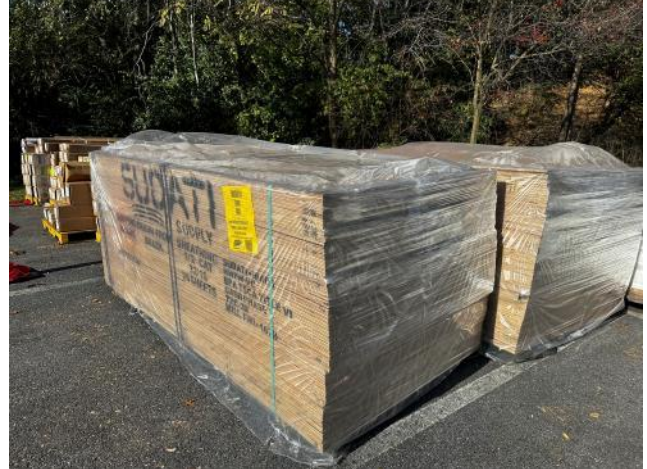
Photo #6: Overview of new sheathing.

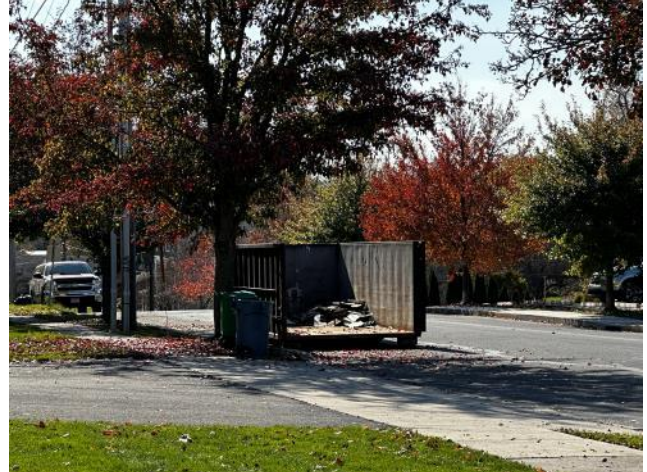
Photo #8: Overview of another dumpster on Franklin Street.

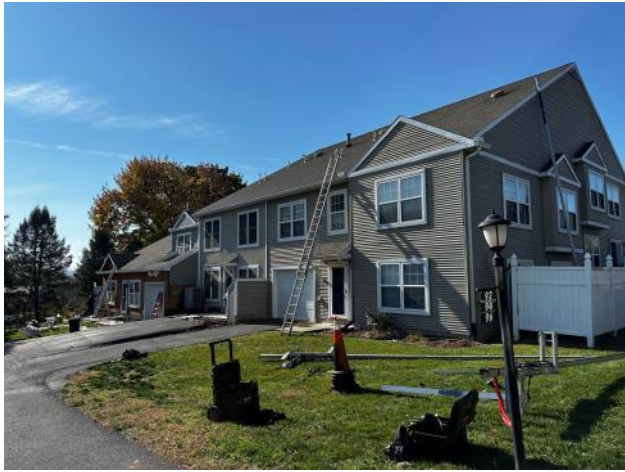
Photo #9: Overview of Lemus Siding Crew (Blue) working at Building 9 (1239-1243/92-96 Courtyard Drive).

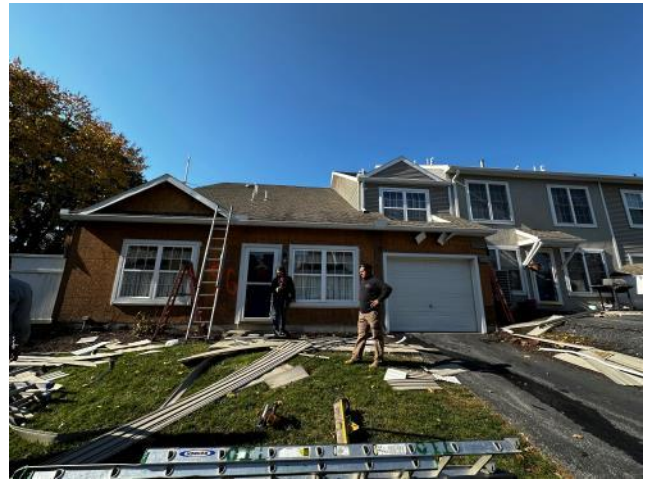
It should be noted that existing windows were not properly flashed in the past and water resistant barrier material was not observed throughout the walls after the siding and stucco was removed. Also many existing windows were observed to be failing. Existing sheathing and framing was observed to be damaged at the bottom of those windows, including the box windows with stucco and sections where kick-out flashings are missing on the roofs.

Photo #10: Overview of existing siding being removed at the front of the Building. No Water Resistant Barrier was observed.

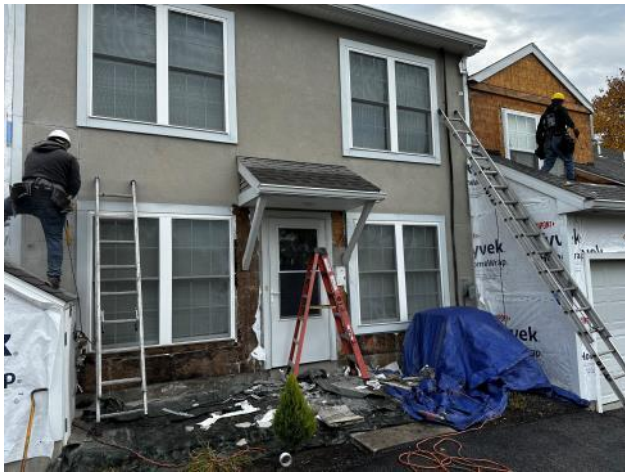
Photo #19: Overview of existing stucco being removed at the front of Unit 1241.

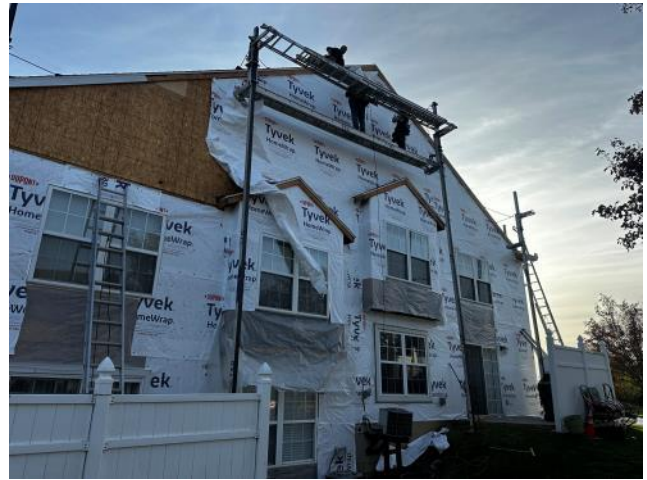
Photo #22: Overview of new Water Resistant Barrier (Tyvek) being installed.

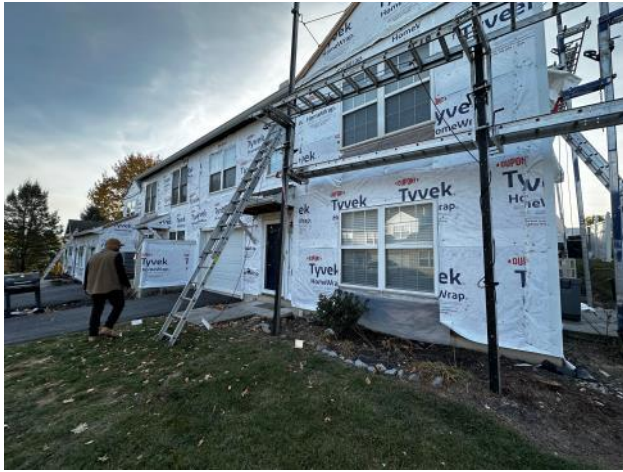
Photo #25: Overview of new Water Resistant Barrier (Tyvek) being installed.

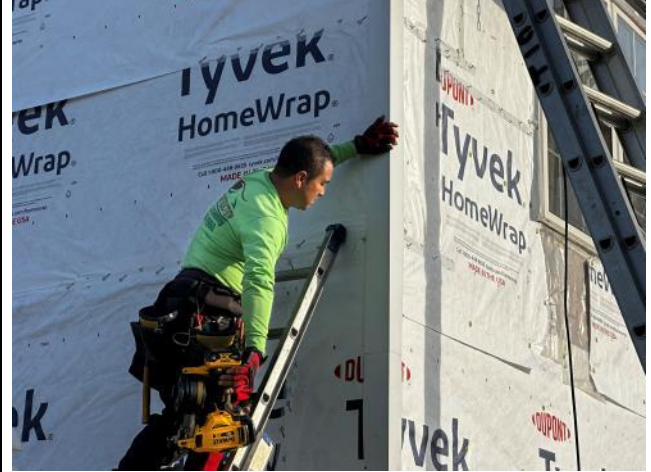
Photo #26: New metal flashing is being installed at the outside corners before installing the new siding.

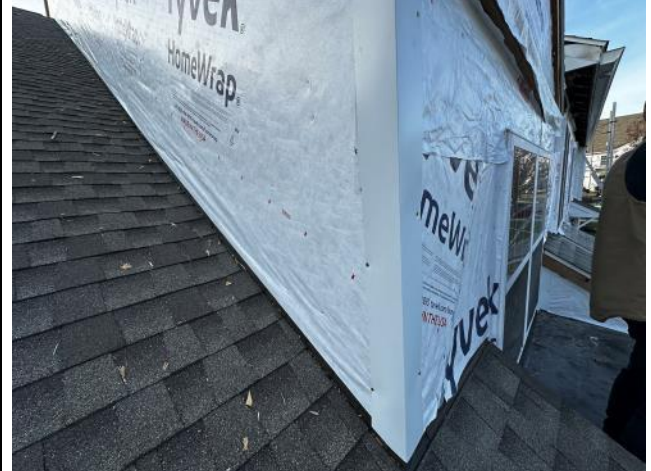
Photo #28: Overview of new metal flashing installed at an outside corner.

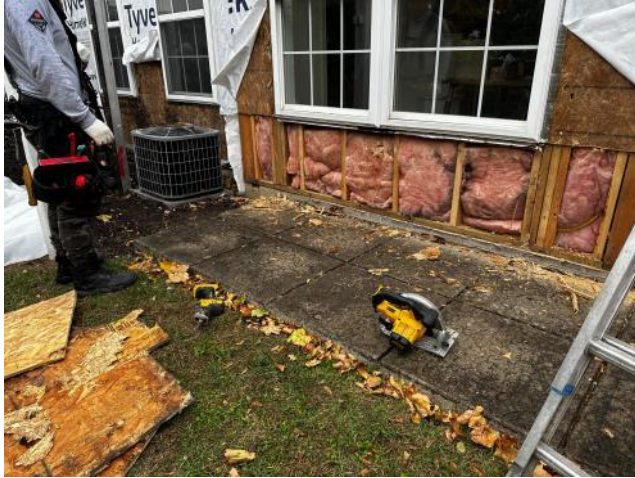
Photo #29: Overview of damaged sheathing being replaced.

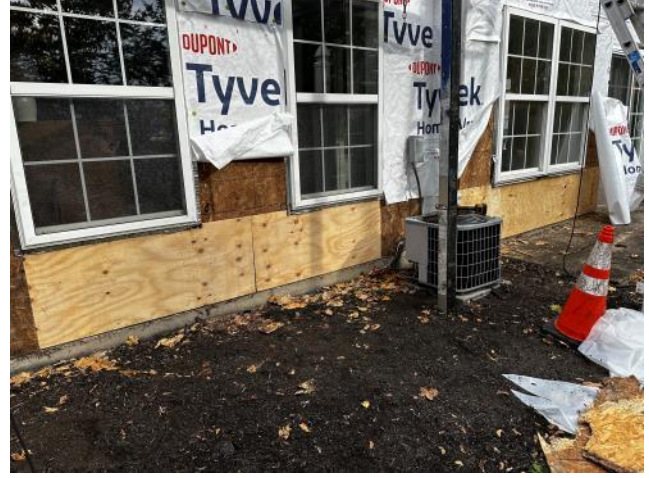
Photo #30: Overview of new sheathing installed.

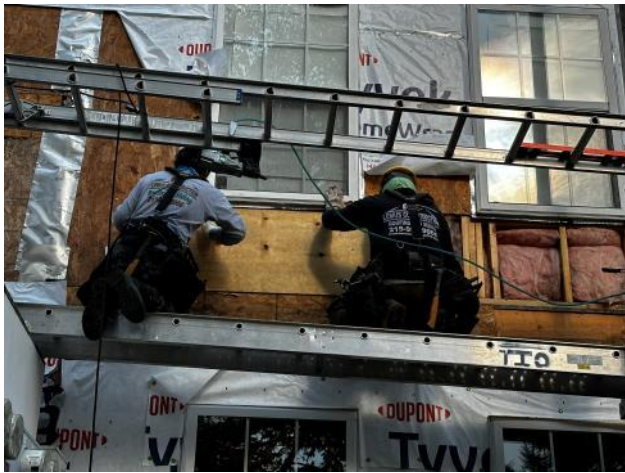
Photo #31: Overview of new sheathing being installed.

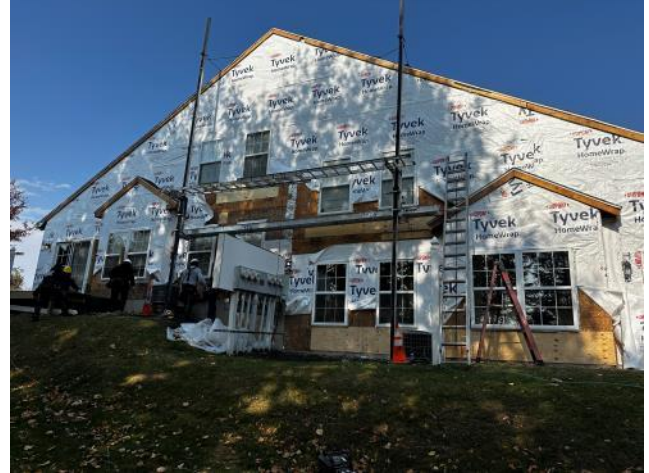
Photo #32: Overview of new sheathing being installed.

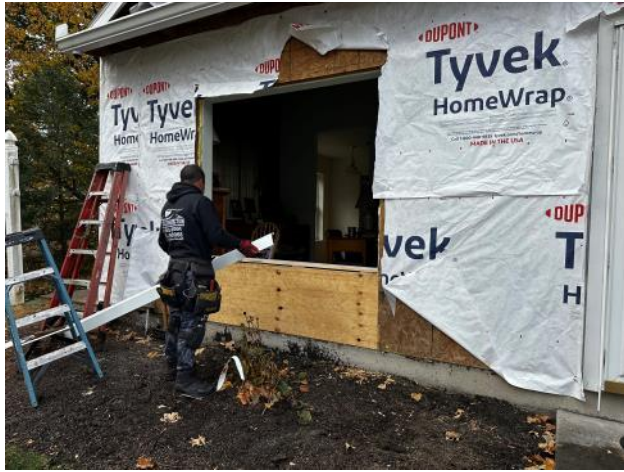
Photo #33: Overview of a new window being installed after damaged sheathing was replaced at Unit 96.

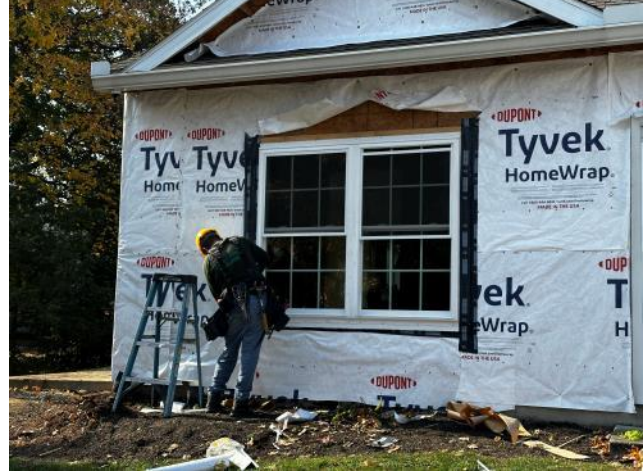
Photo #34: Overview of a new window being installed and properly flashed.

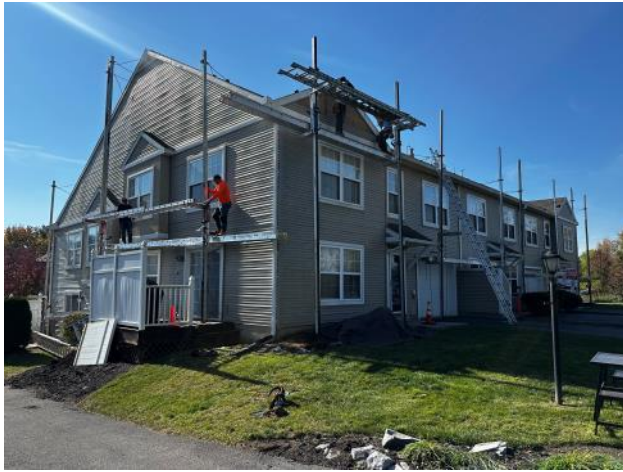
Photo #37: Overview of Lemus Siding Crew (Green) working at Building 10 (105-109/111-115 Courtyard Drive).

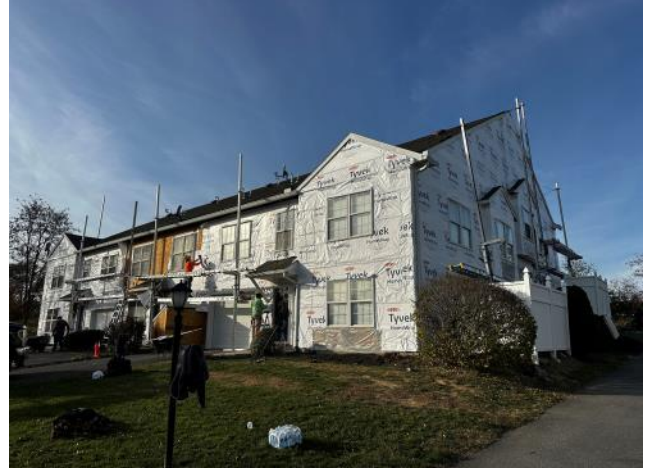
Photo #48: Overview of new Water Resistant Barrier (Tyvek) being installed.

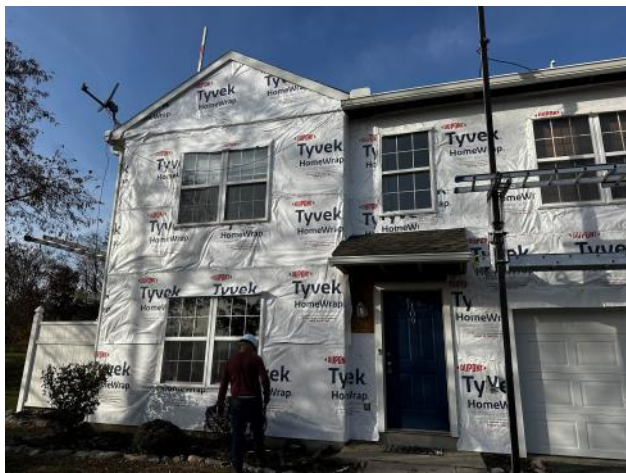
Photo #51: Overview of new Water Resistant Barrier (Tyvek) installed.

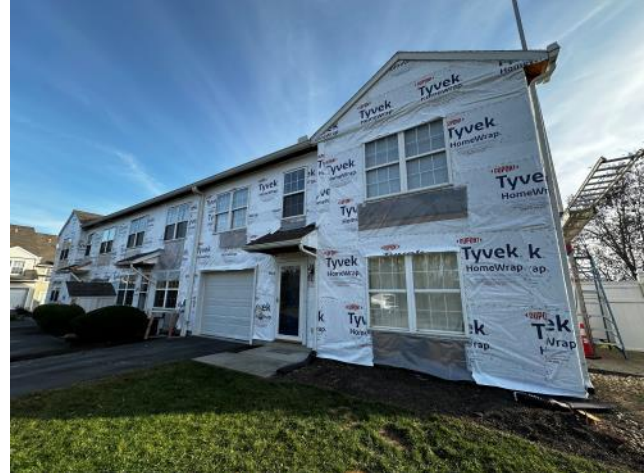
Photo #52: Overview of new Water Resistant Barrier (Tyvek) installed.

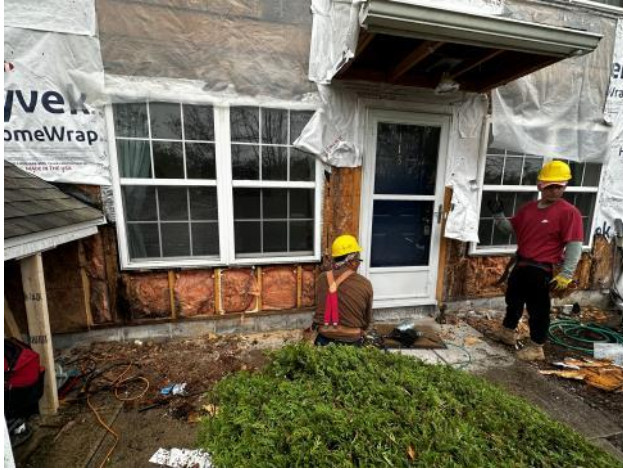
Photo #53: Overview of damaged sheathing being replaced.

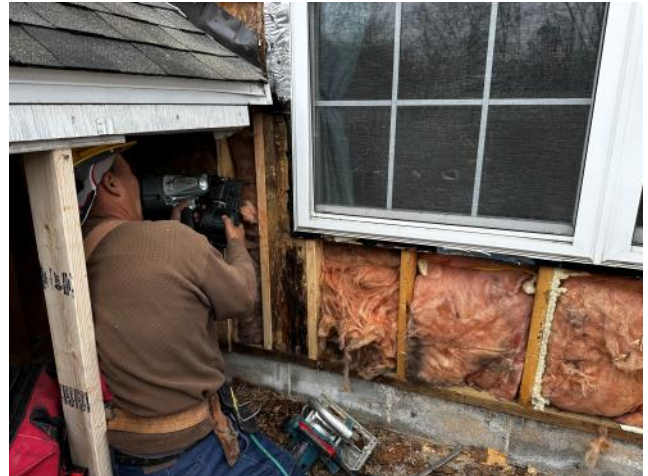
Photo #56: Overview of new studs being installed to reinforce the existing studs.

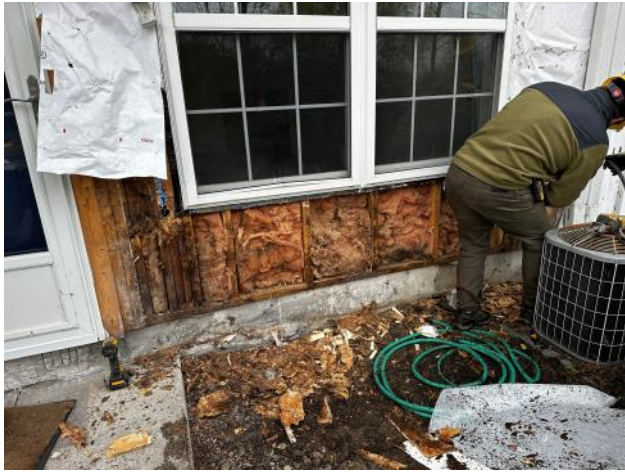
Photo #57: Overview of another section where damaged sheathing is being replaced.

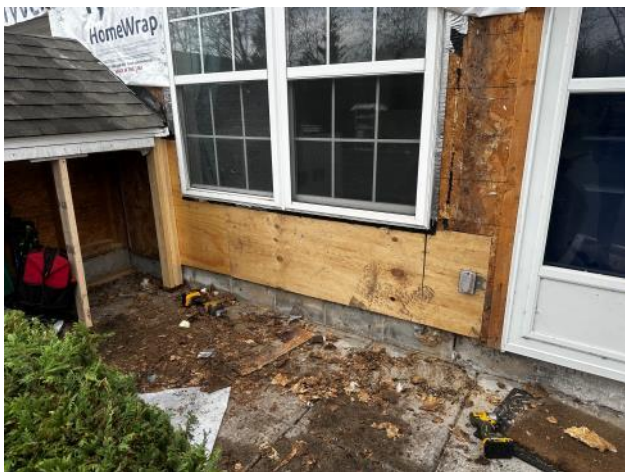
Photo #59: Overview of new sheathing installed.

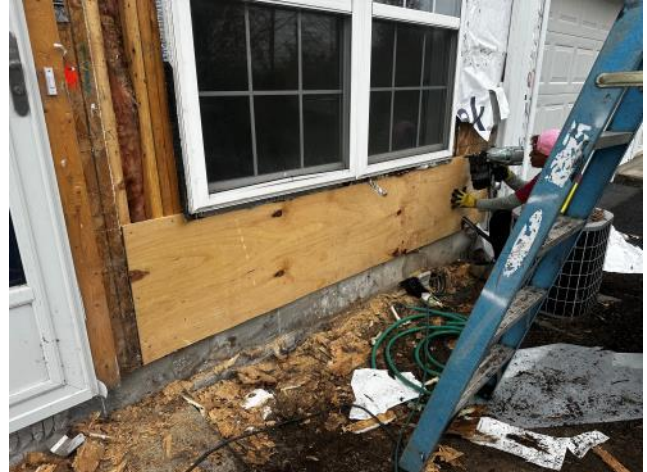
Photo #60: Overview of new sheathing being installed.

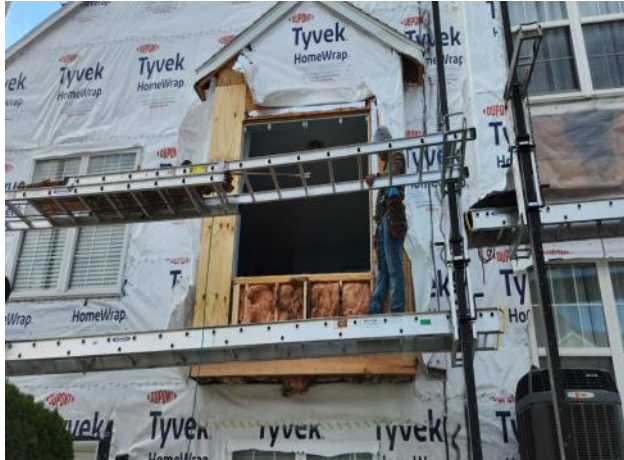
Photo #61: Overview of new sheathing installed and studs being reinforced.

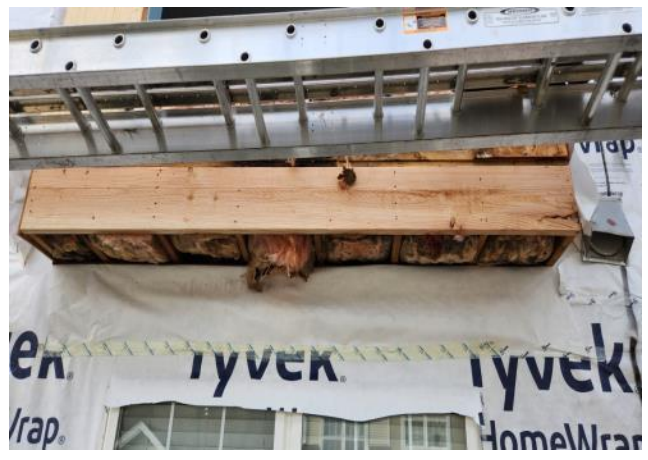
Photo #62: Overview of new 2x10 installed.

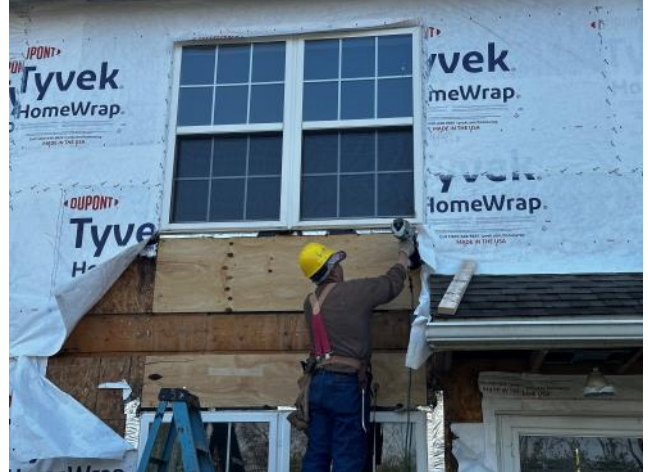
Photo #64: Overview of new sheathing being installed.

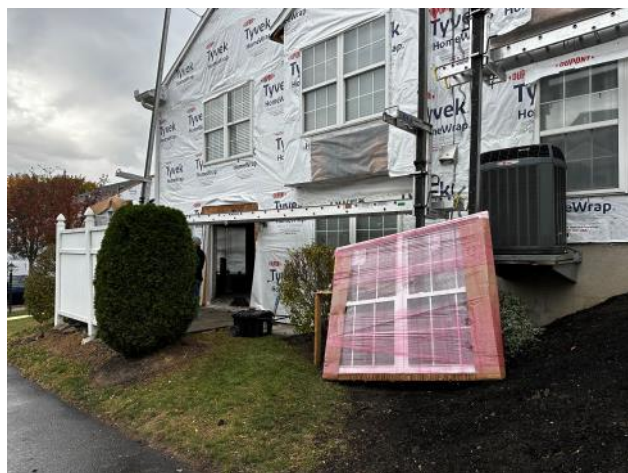
Photo #65: Overview of a new sliding door being installed at Unit 105.

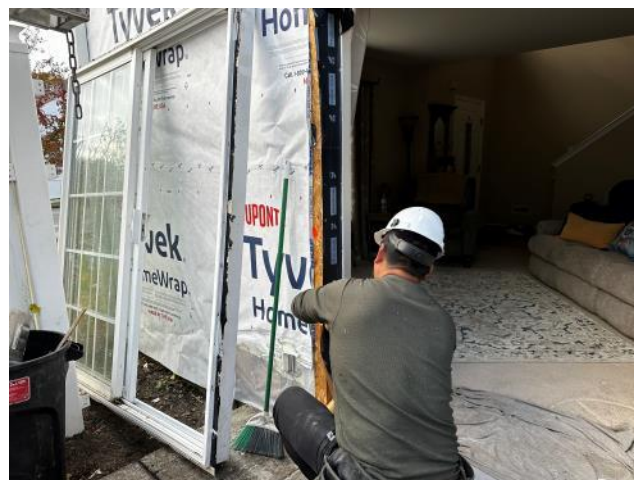
Photo #66: Overview of flashing tape being installed.

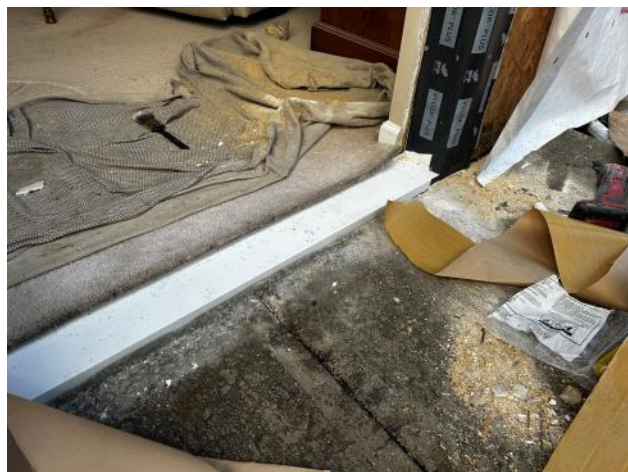
Photo #67: Overview of new metal pan installed before installing new door.

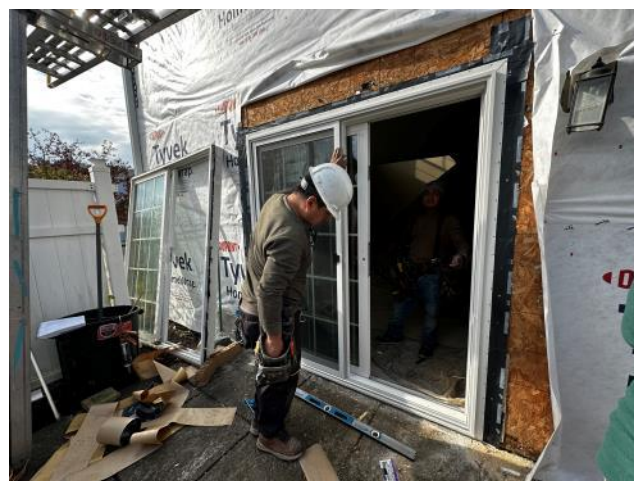
Photo #68: Overview of new sliding door being installed and properly flashed.

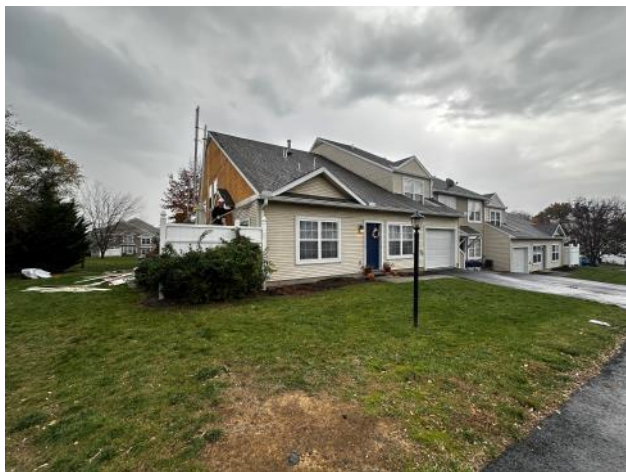
Photo #71: Overview of Lemus Siding Crew (Green) working at Building 11 (99-103/93-97 Courtyard Drive).

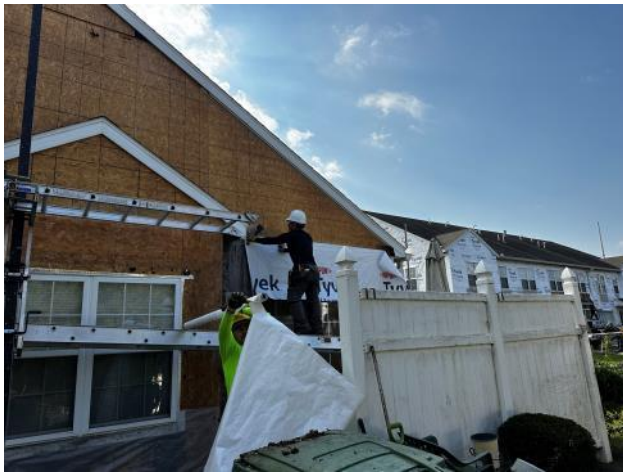
Photo #83: Overview of new Water Resistant Barrier (Tyvek) being installed.

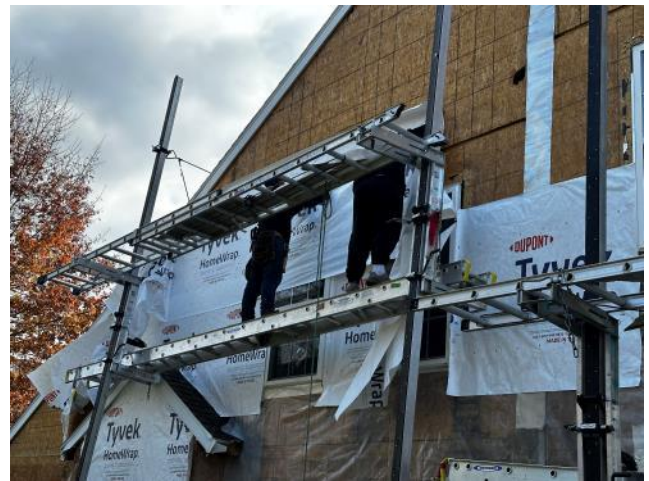
Photo #84: Overview of new Water Resistant Barrier (Tyvek) being installed.

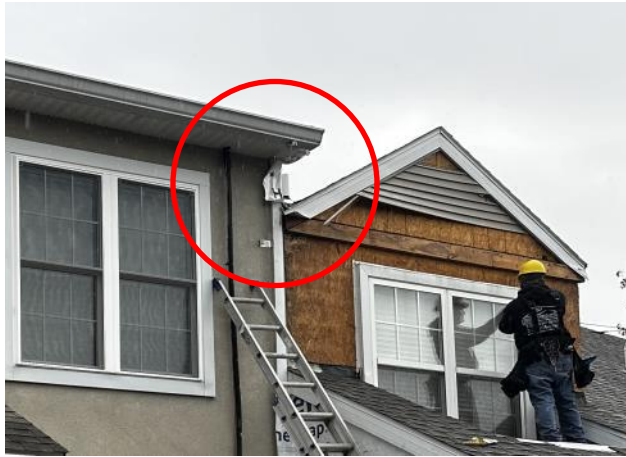
Photo #85: Another closed section to point out is where a front gable meets a separation wall.
