**Project:** Courtyards of Carlisle CA – Siding Project

**Project #:** 14372-04

## Field Report 2

Purpose of Visit: To oversee the progress of siding replacement

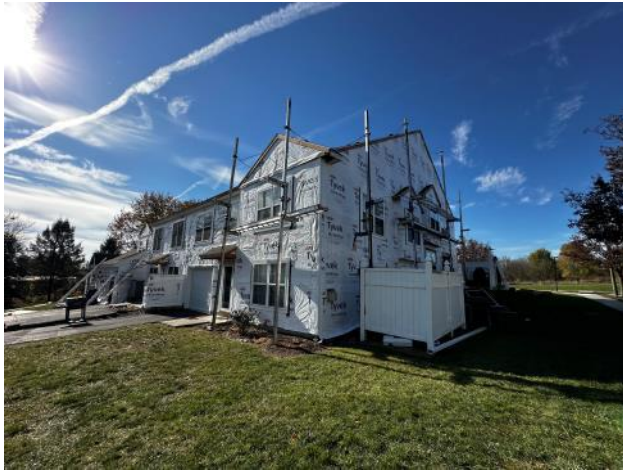
Photo #1: **Overview of Lemus Siding Crew (Blue) working at Building 9 (1239-1243/92-96 Courtyard Drive).**

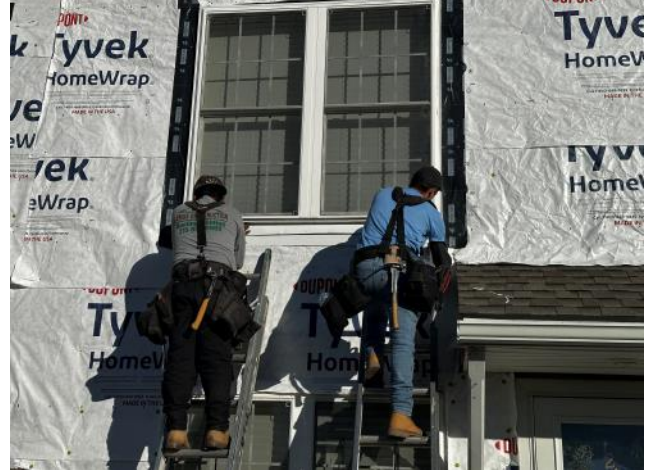
Photo #2: **Overview of a window being properly flashed.**

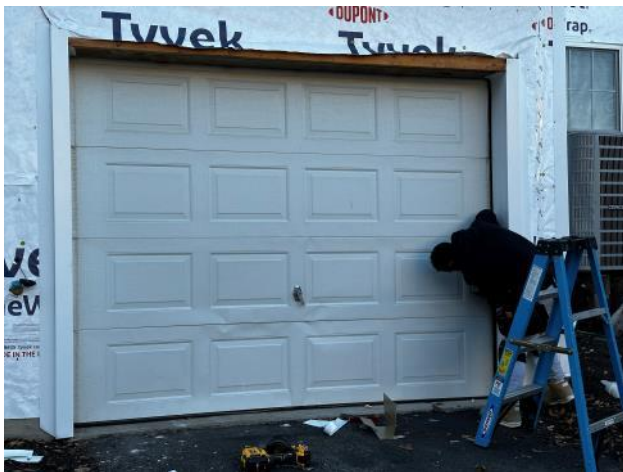
Photo #3: **Overview of new aluminum wrap being installed at a garage door.**

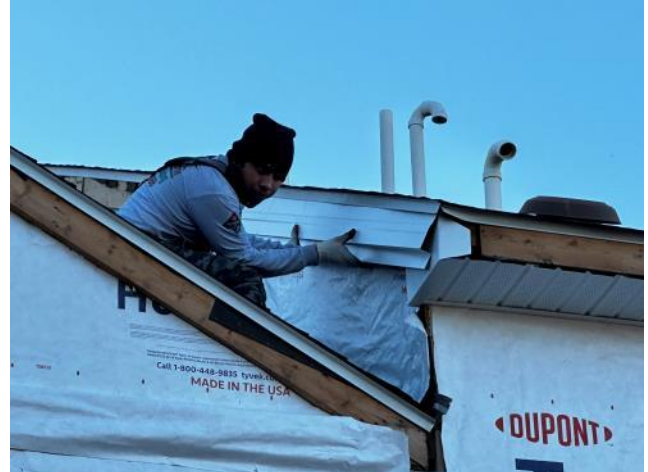
Photo #4: **Overview of new aluminum wrap being installed at a rake board.**

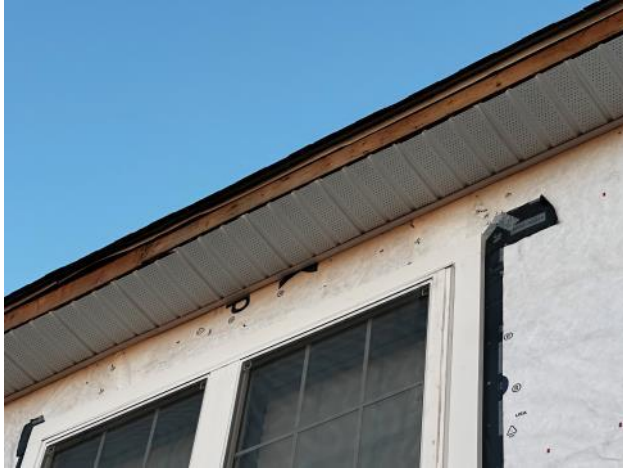
Photo #5: Overview of new intake soffit installed.

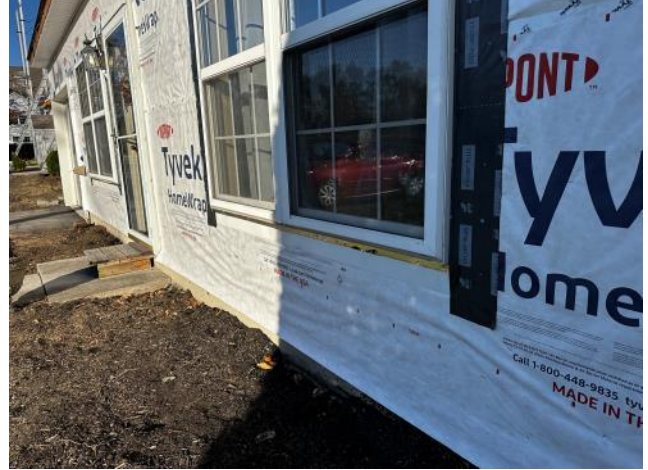
Photo #6: Overview of new metal flashing installed at the bottom of a window.

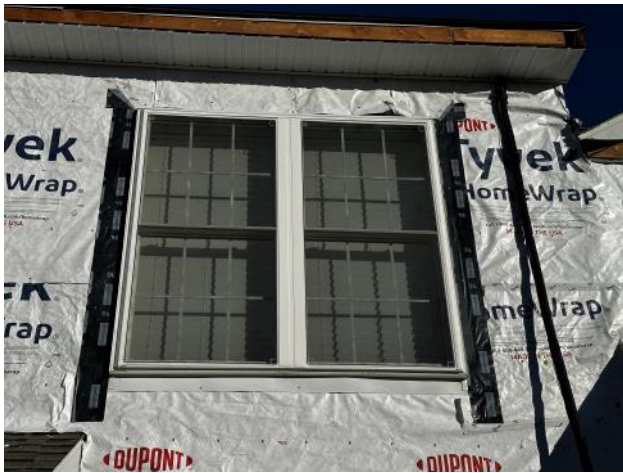
Photo #7: Overview of new flashing tape installed at a window.

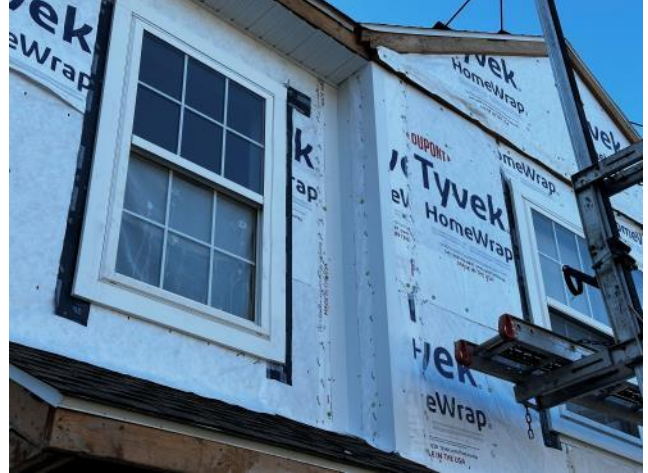
Photo #8: Overview of new metal flashing installed at an inside and an outside corners.

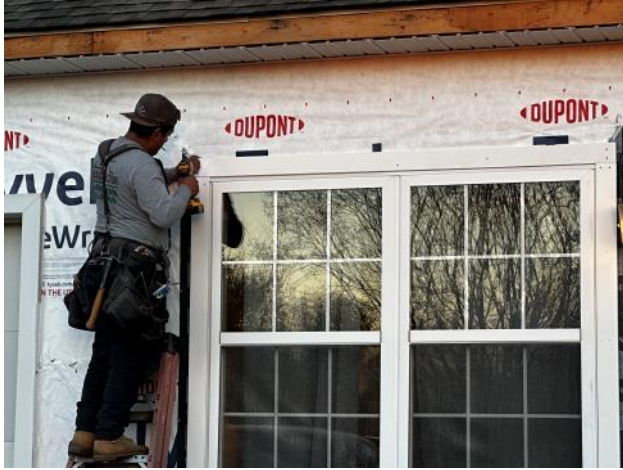
Photo #9: Overview of new azek trim being installed at a window.

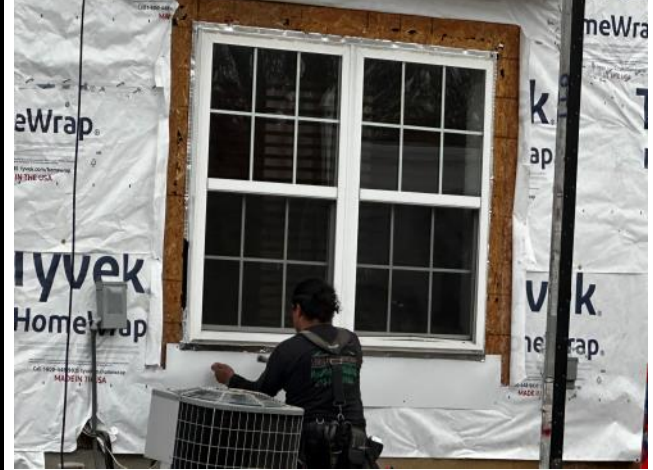
Photo #10: Overview of new metal flashing being installed at the bottom of a window.

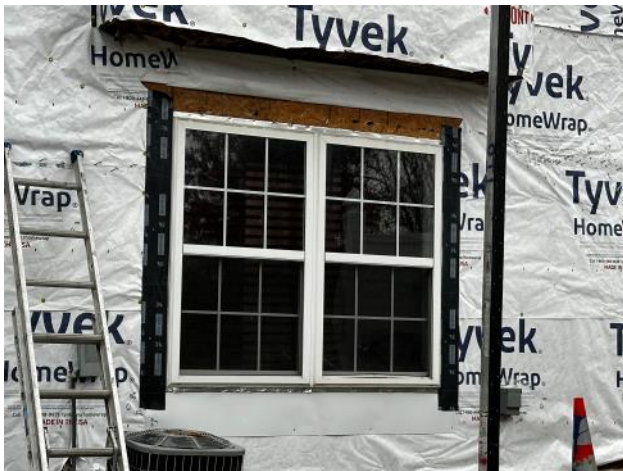
Photo #11: Overview of new flashing tape being installed at a window.

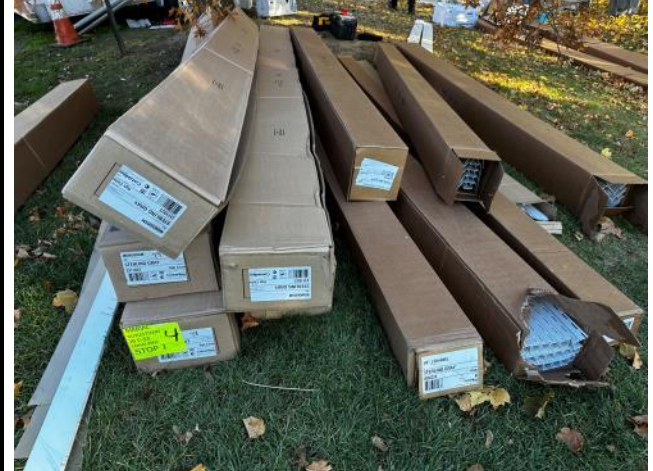
Photo #12: Overview of new vinyl siding, Monogram Sterling Gray.

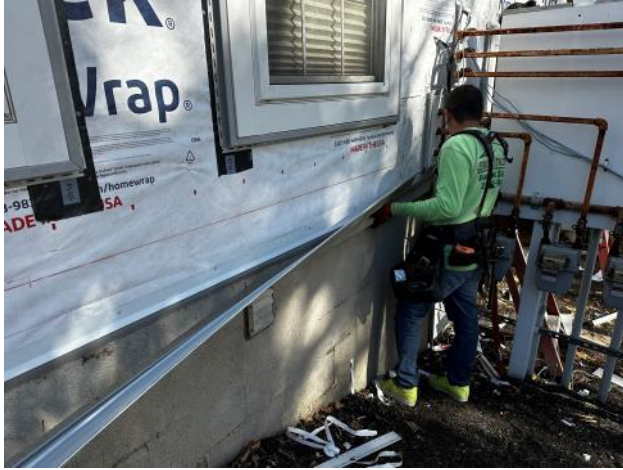
Photo #13: Overview of new starter strip installed and new vinyl siding being installed.

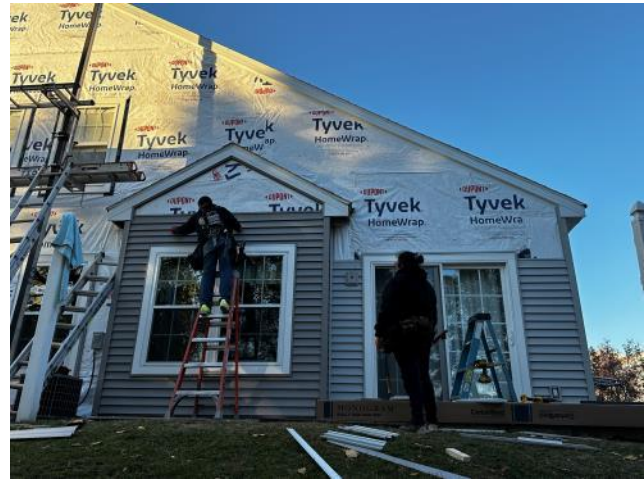
Photo #14: Overview of new vinyl siding being installed at a main side of the Building.

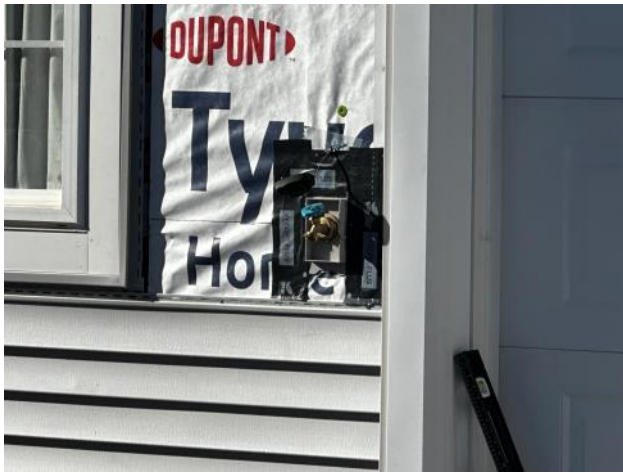
Photo #15: All wall penetrations are being properly flashed with flashing tape.

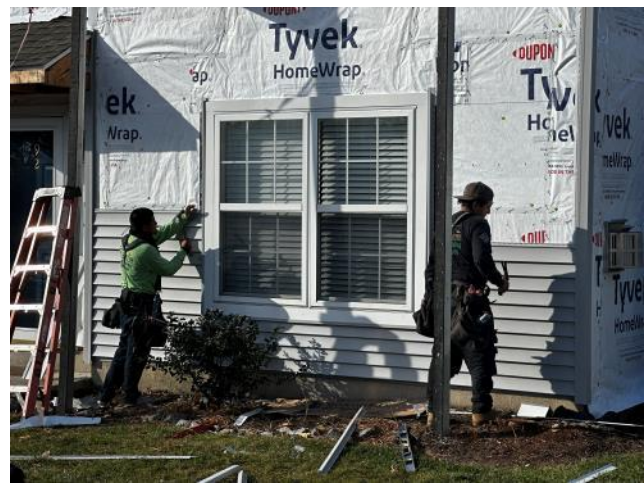
Photo #16: Overview of new vinyl siding being installed at a front section.

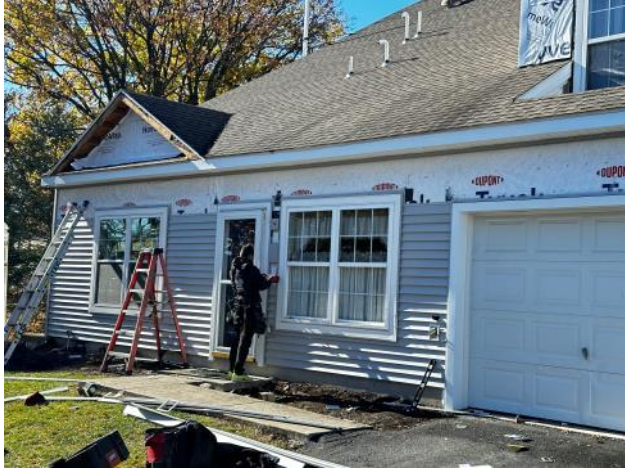
Photo #17: Overview of new vinyl siding being installed.

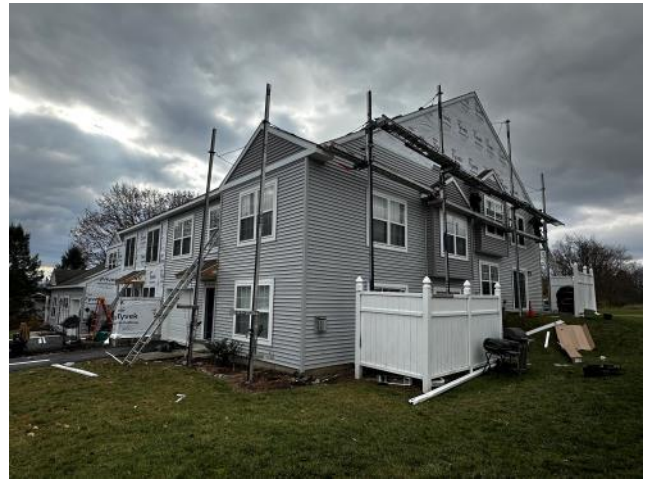
Photo #18: Overview of new vinyl siding being installed at the other main side of the Building.

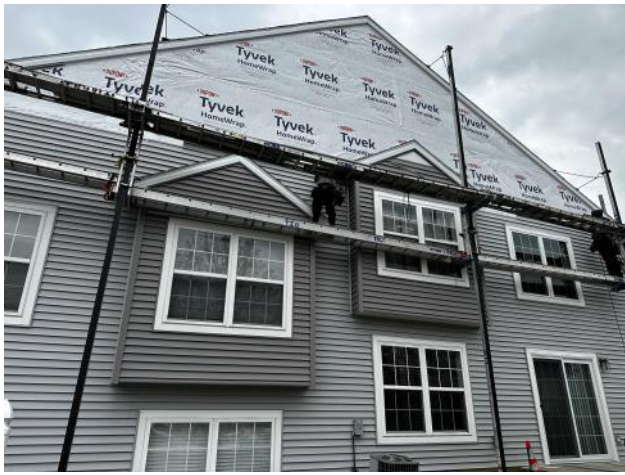
Photo #19: Overview of new vinyl siding Granite Gray being installed at the box windows.

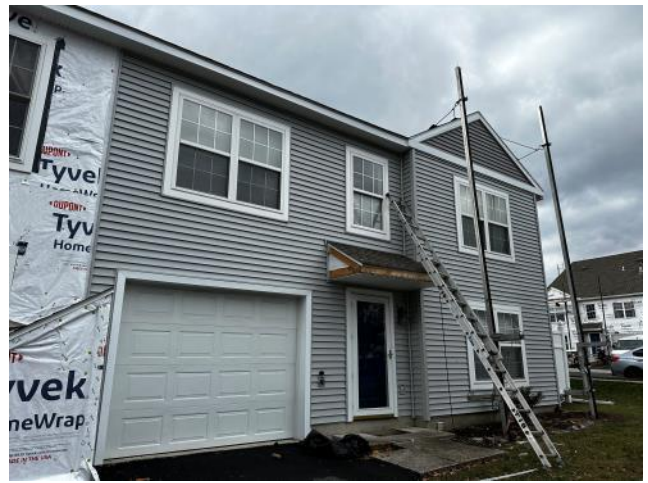
Photo #20: Overview of new vinyl siding being installed at another front section.

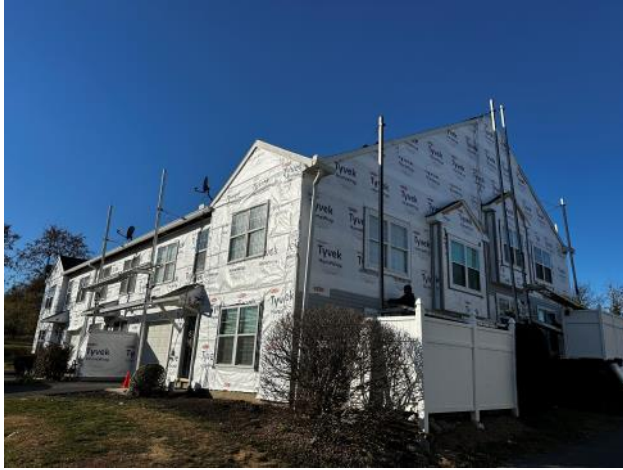
Photo #21: Overview of Lemus Siding Crew (Green) working at Building 10 (105-109/111-115 Courtyard Drive).

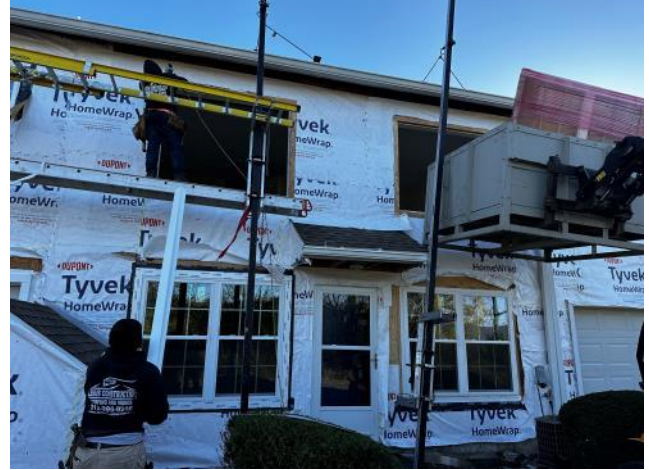
Photo #22: Overview of new windows being installed at Unit 113.

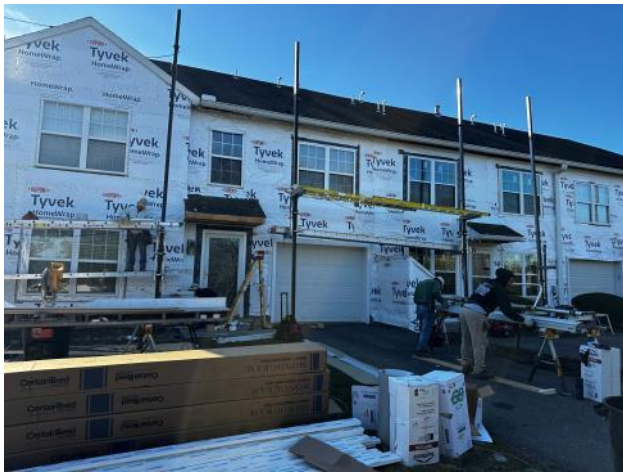
Photo #23: Overview of new windows installed at Unit 113 and windows being properly flashed.

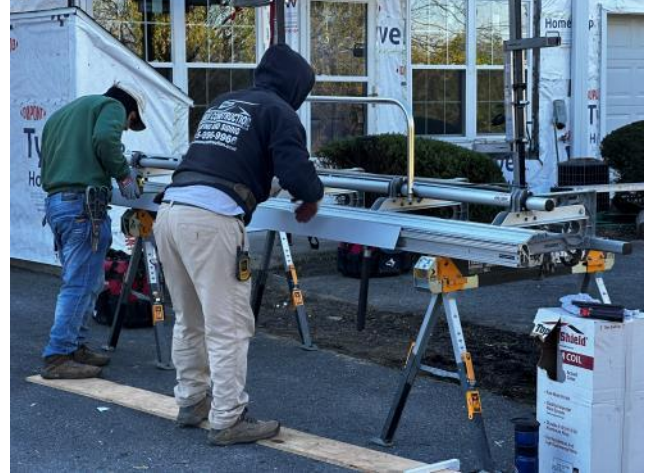
Photo #24: All trim work and metal flashings are being field measured and cut.

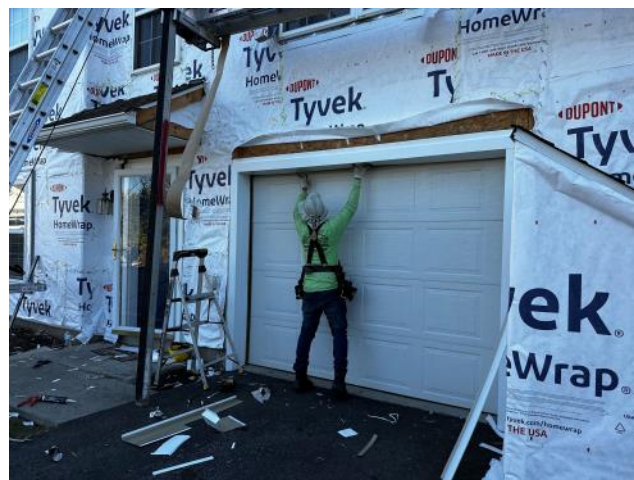
Photo #26: Overview of new aluminum wrap being installed at a garage door.

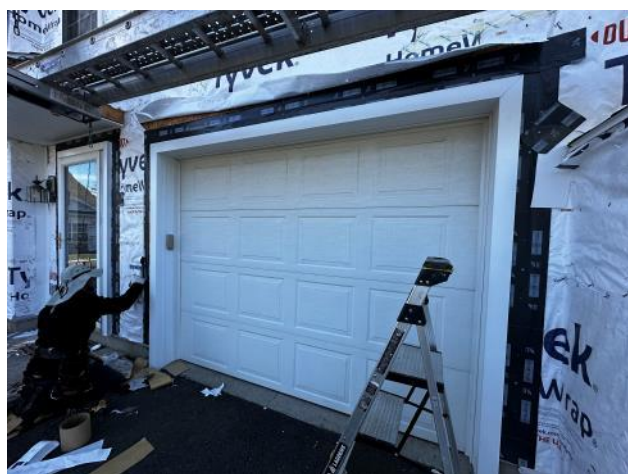
Photo #27: Overview of new flashing tape being installed at a garage door.

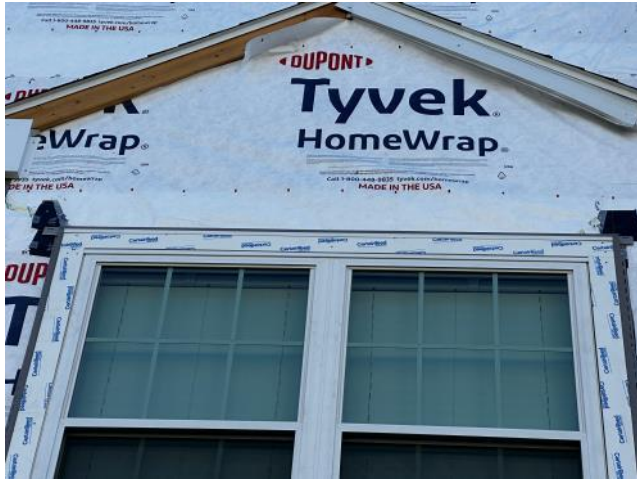
Photo #29: Overview of a new metal drip cap being installed.

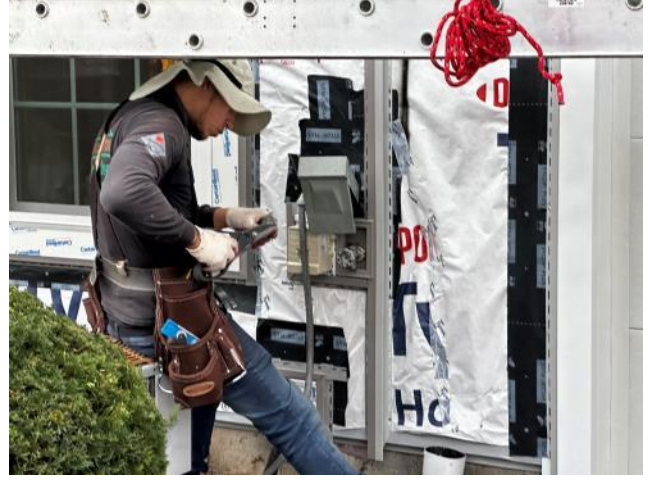
Photo #30: Overview of a wall penetration being properly flashed.

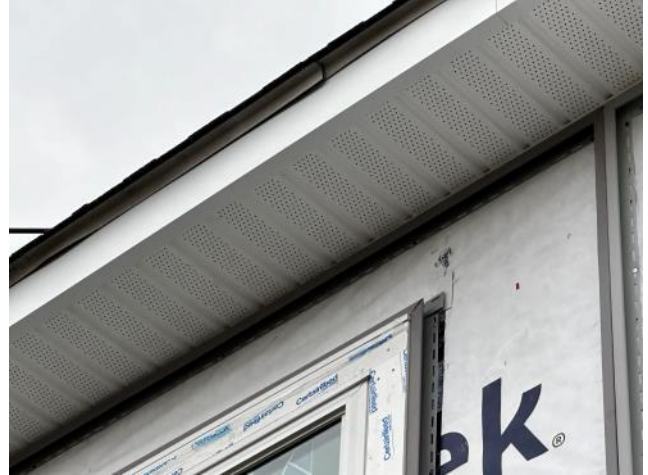
Photo #32: Overview of new intake soffit being installed.

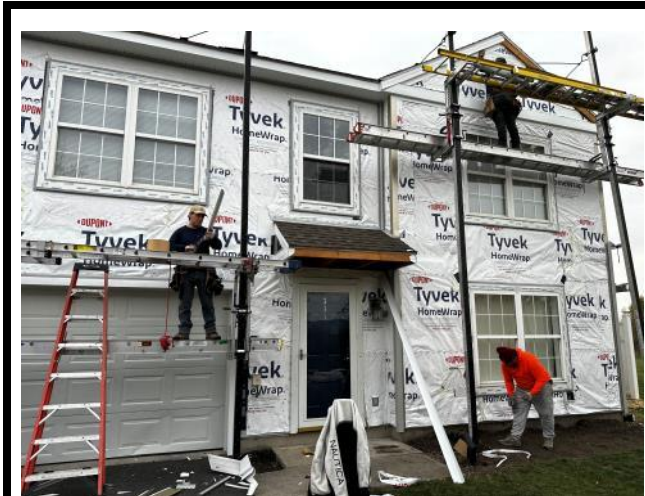
Photo #33: Overview of windows being flashed and new azek trim being installed as well.

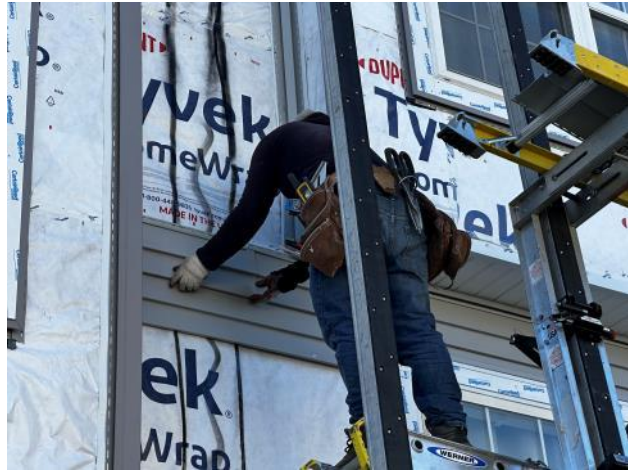
Photo #37: Overview of new vinyl siding being installed.

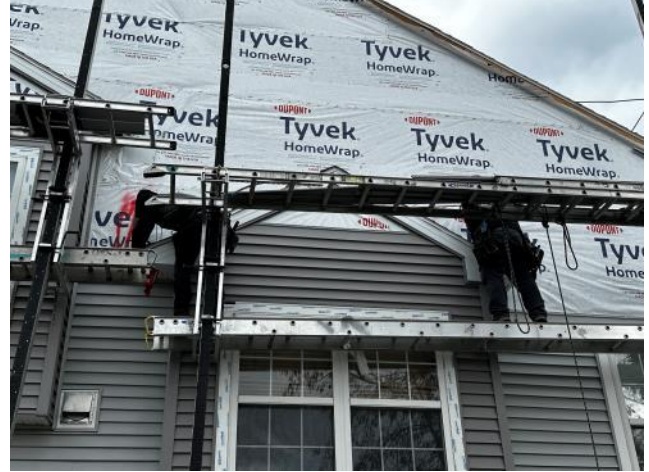
Photo #38 Overview of new vinyl siding being installed at a main side of the Building.

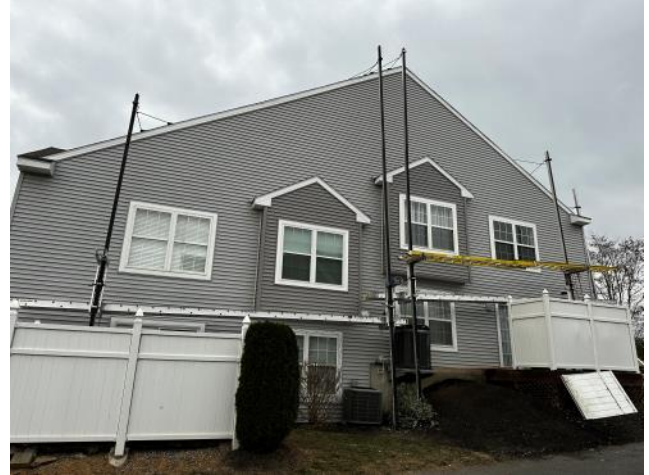
Photo #40: Overview of new vinyl siding installed at a main side of the Building.

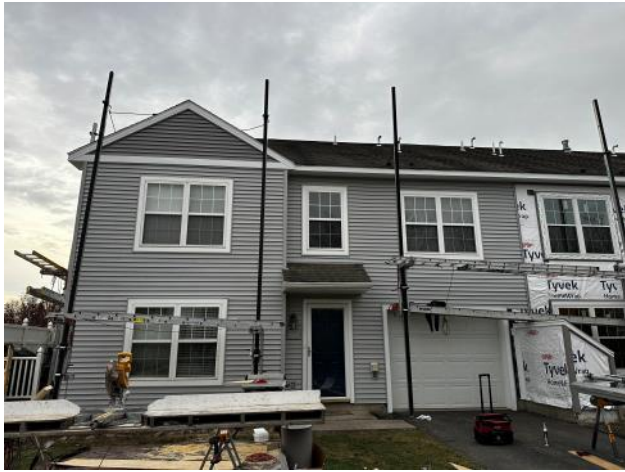
Photo #41: Overview of new vinyl siding being installed at a front section.

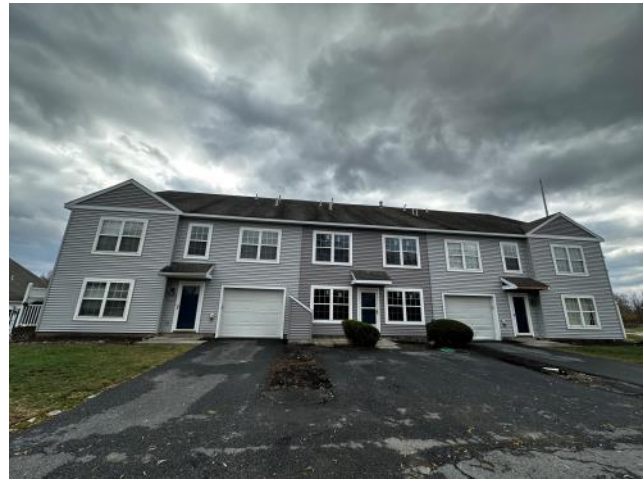
Photo #42: Overview of new vinyl siding installed at the front of the Building.

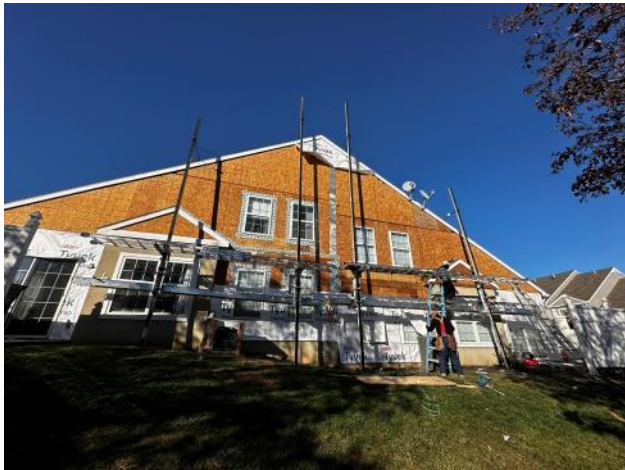
Photo #43: **Overview of Lemus Siding Crew (Yellow) working at Building 11 (99-103/93-97 Courtyard Drive).**

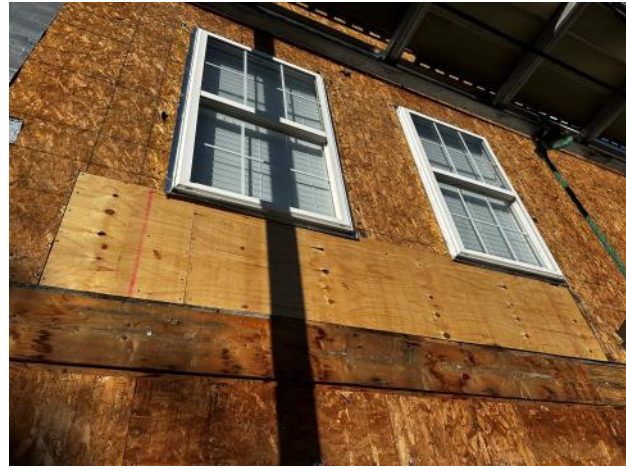
Photo #44: Overview of new sheathing installed.

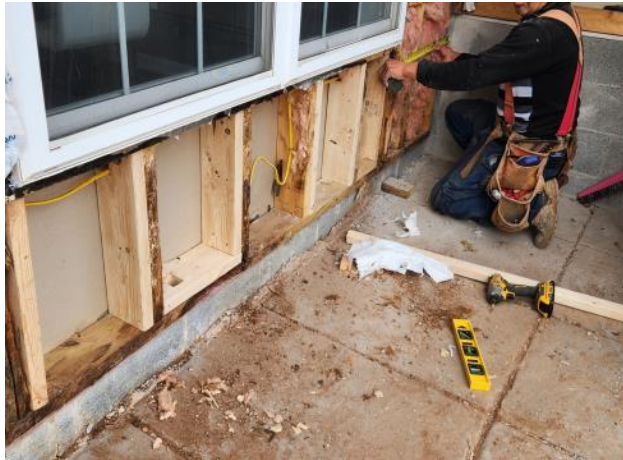
Photo #57: Overview of new studs being installed to reinforce the existing studs.

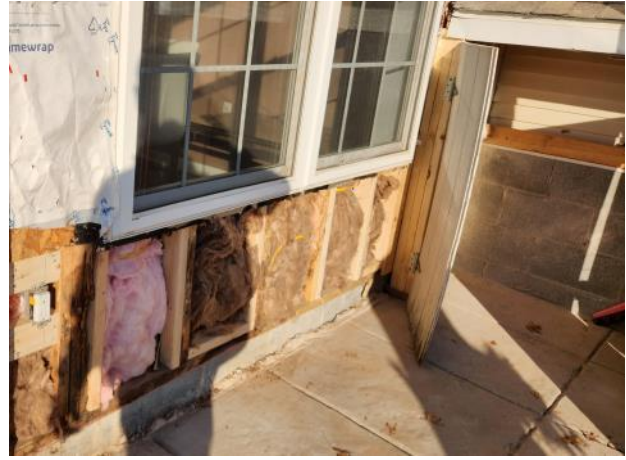
Photo #58: Overview of new insulation installed.

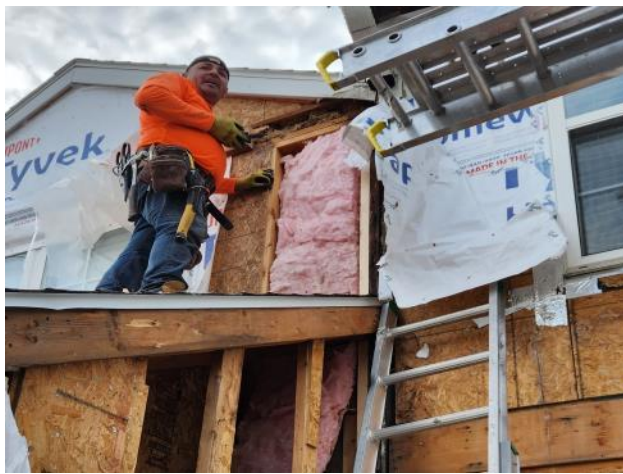
Photo #59: Overview of new studs being installed to reinforce the existing studs and new insulation installed as well.

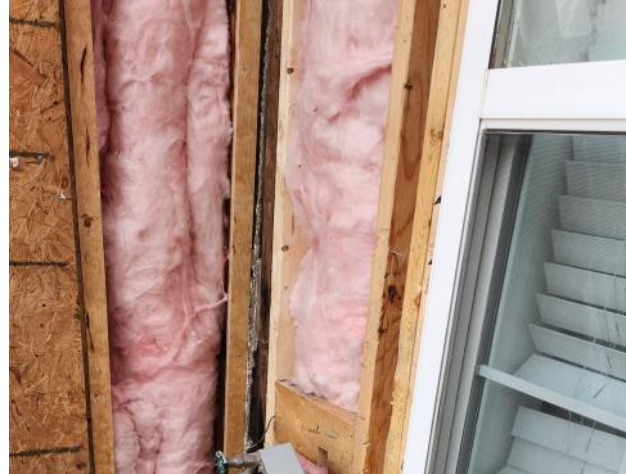
Photo #60: Overview of new studs being installed to reinforce the existing studs and new insulation installed as well.

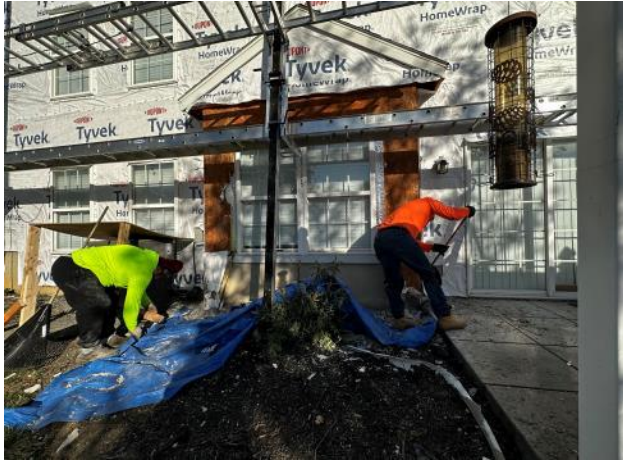
Photo #61: Overview of existing stucco at a box window being removed at Unit 93.

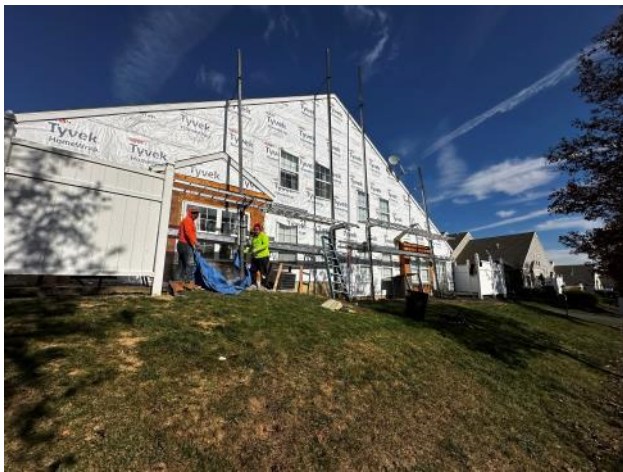
Photo #63: Overview of existing stucco at a box window being removed at Unit 99.

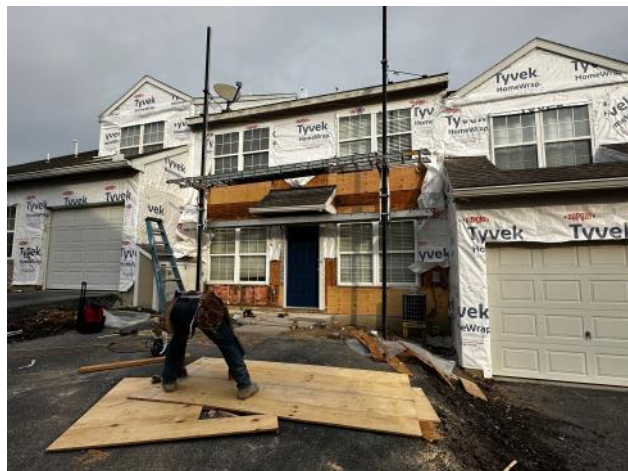
Photo #65: Overview of new sheathing installed being installed at Unit 101.

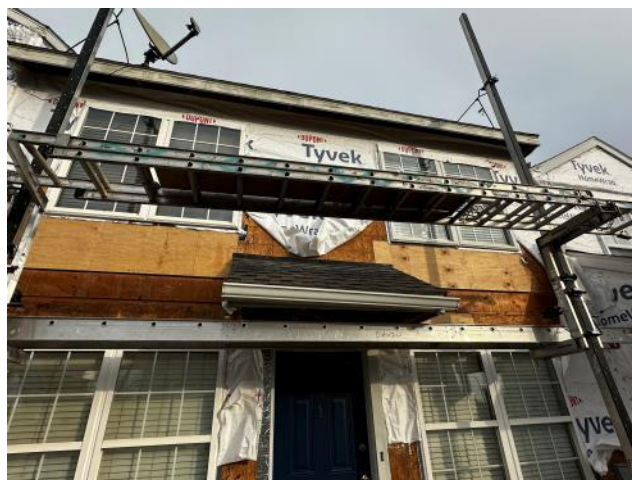
Photo #66: Overview of new sheathing installed below the upper windows.

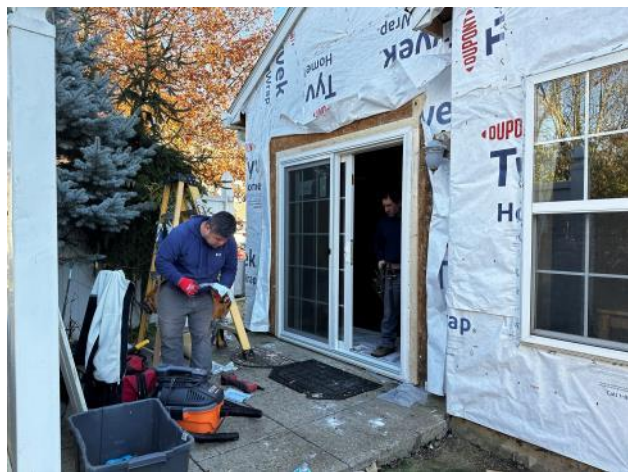
Photo #67: Overview of a new sliding door being installed at Unit 97.

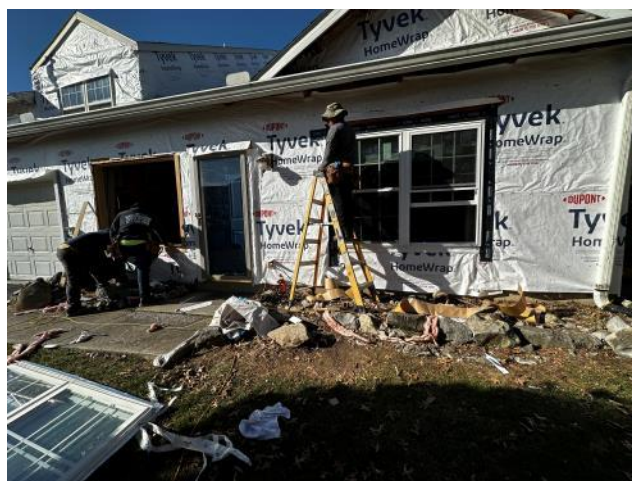
Photo #68: Overview of new windows being installed and properly flashed at Unit 97.

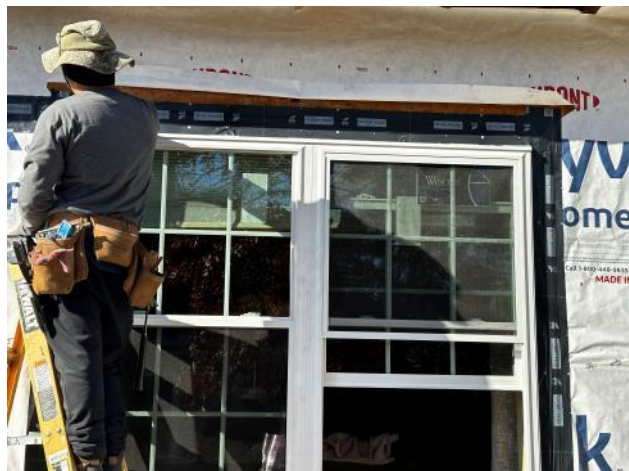
Photo #69: Overview of new flashing tape being installed at a window.

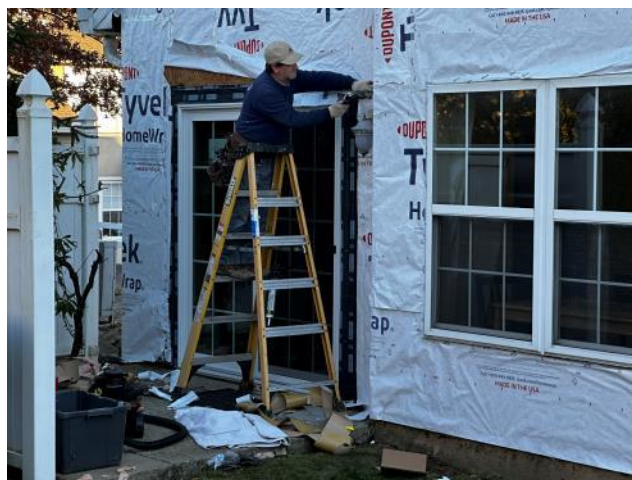
Photo #70: Overview of new flashing tape being installed at a sliding door.

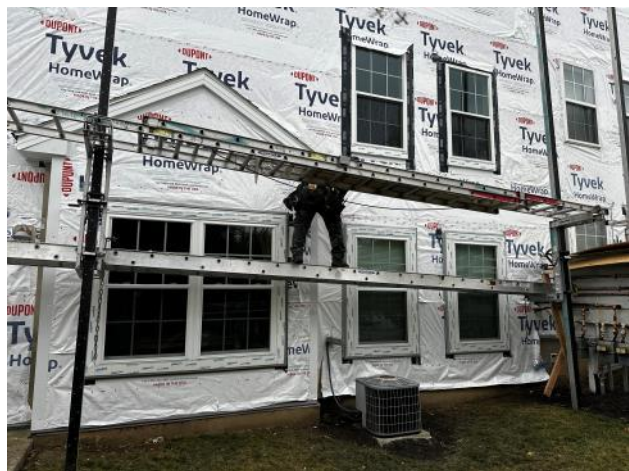
Photo #71: Overview of windows being properly flashed.

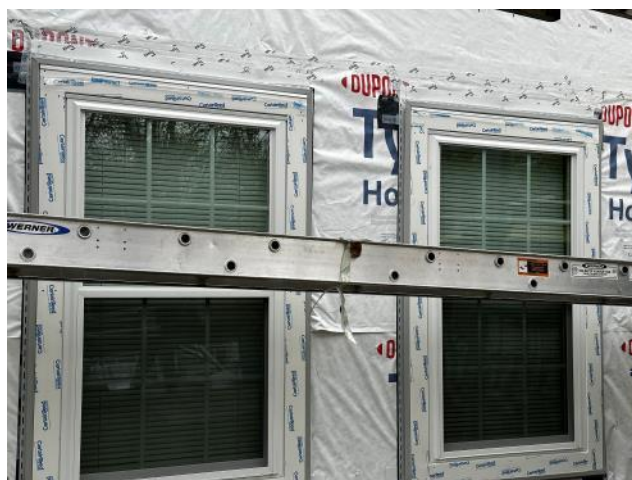
Photo #72: Overview of new vinyl j-channels being installed around the windows.

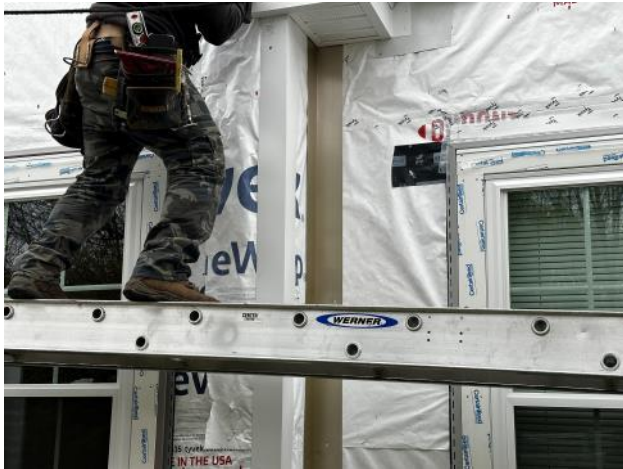
Photo #73: Overview of new metal flashing being installed at the corners.

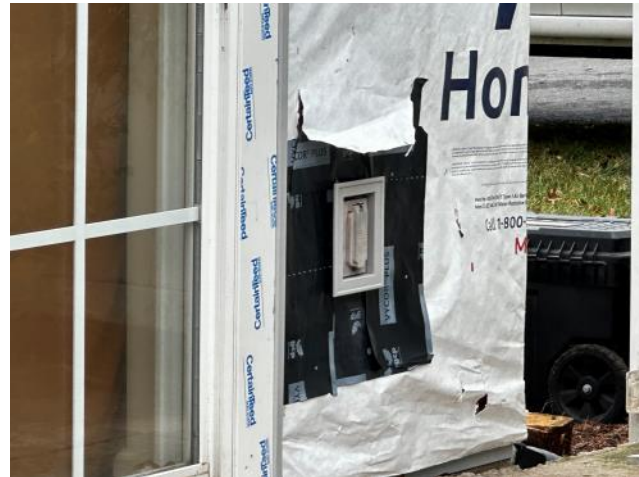
Photo #74: Overview of new flashing tape being installed at a wall penetration.

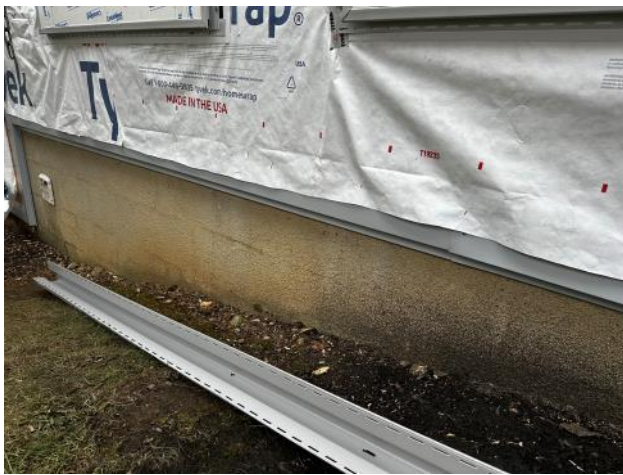
Photo #75: Overview of new metal flashing being installed before installing the starter strip.

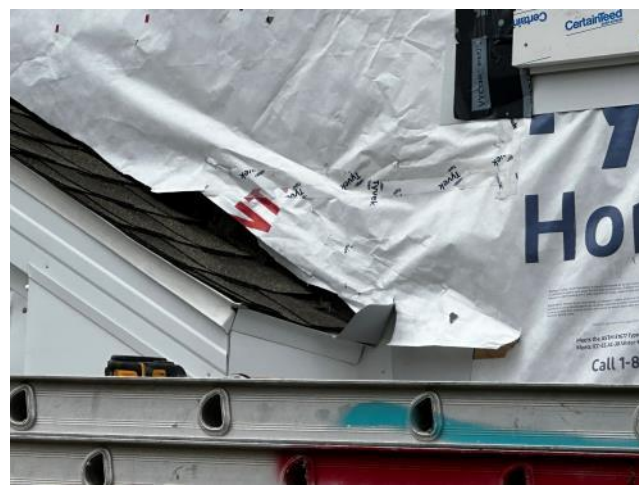
Photo #76: Overview of a new kick-out flashing being installed.

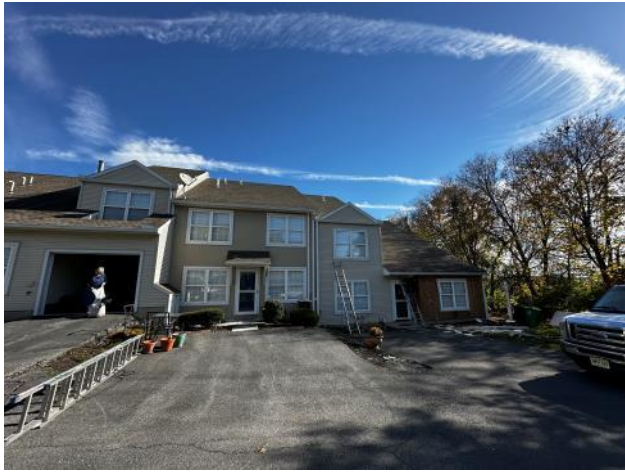
Photo #77: **Overview of Lemus Siding Crew (Blue) working at Building 8 (80-90 Courtyard Drive).**

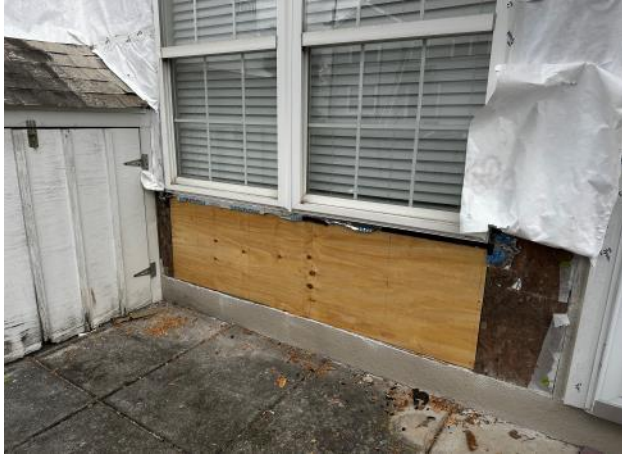
Photo #85: Overview of new sheathing installed.

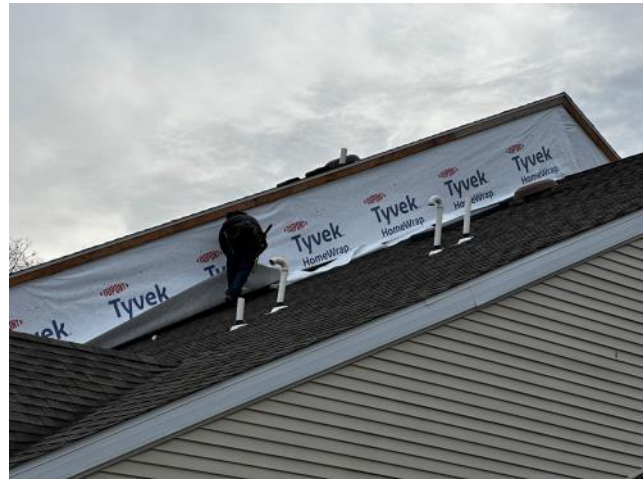
Photo #86: Overview of new Water Resistant Barrier (Tyvek) being installed at a sidewall above the roofline.

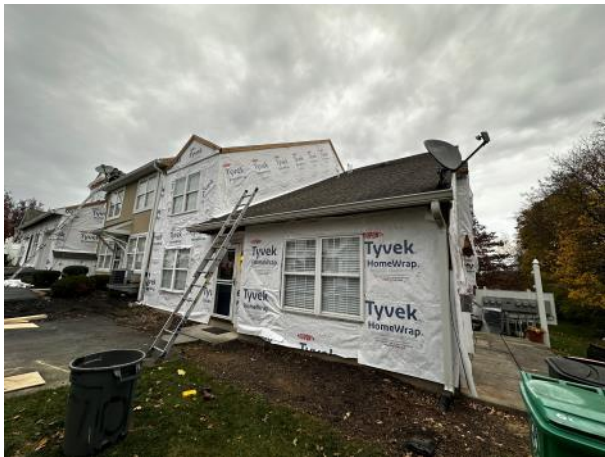
Photo #87: Overview of new Water Resistant Barrier (Tyvek) installed at a front section of the Building.

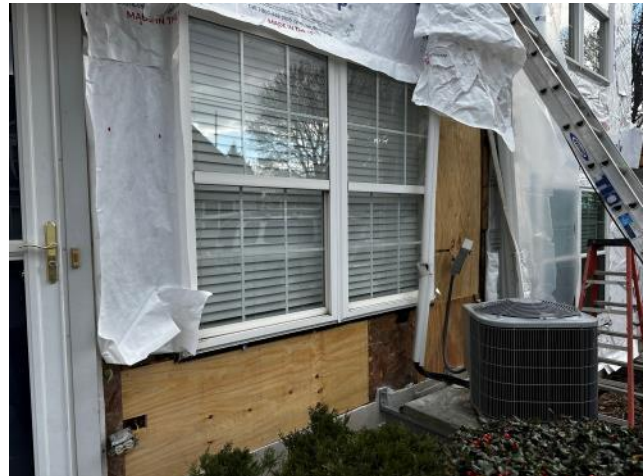
Photo #88: Overview of new sheathing installed.

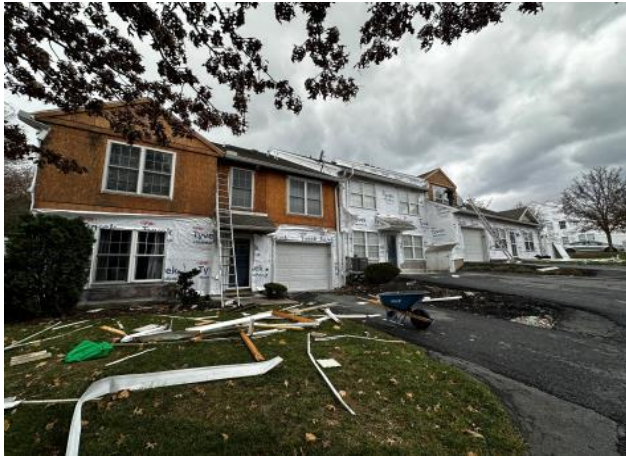
Photo #89: Overview of new Water Resistant Barrier (Tyvek) being installed at another front section of the Building.

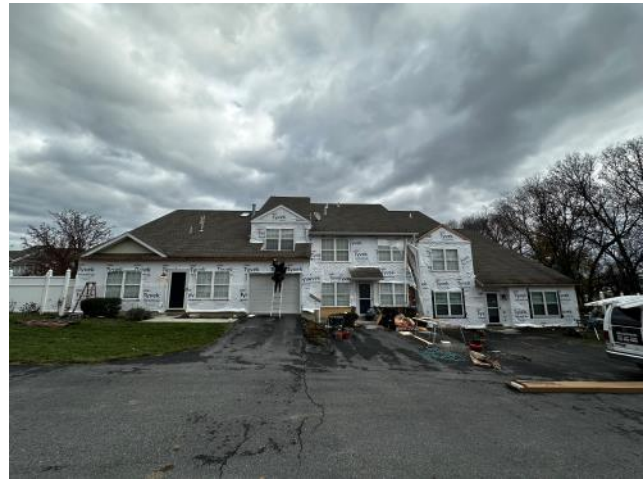
Photo #90: Overview of new Water Resistant Barrier (Tyvek) installed.

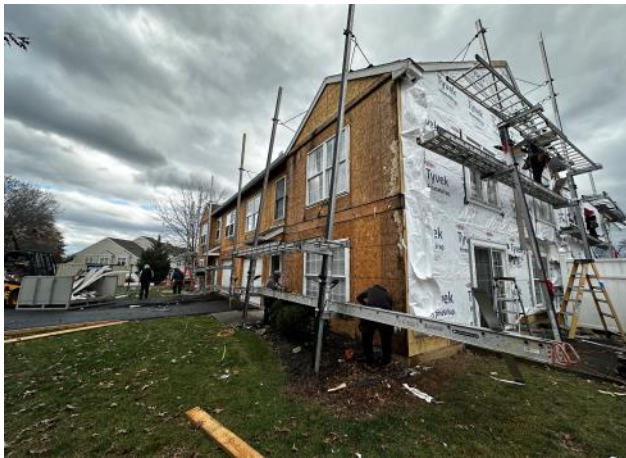
Photo #91: **Overview of Lemus Siding Crew (Yellow) working at Building 13 (73-79 Courtyard Drive).**

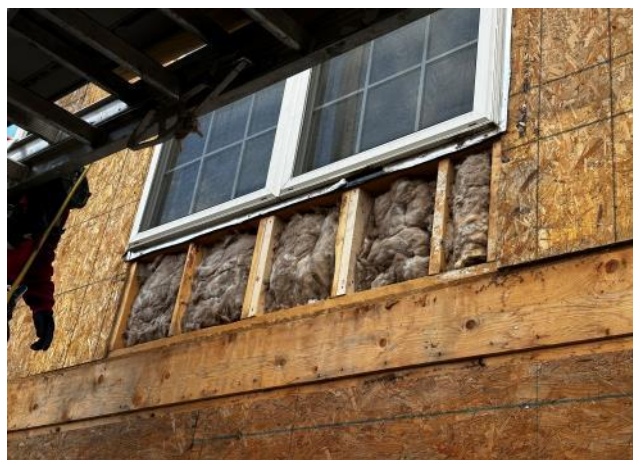
Photo #95: Overview of new studs being installed to reinforce the existing studs and new insulation installed as well.

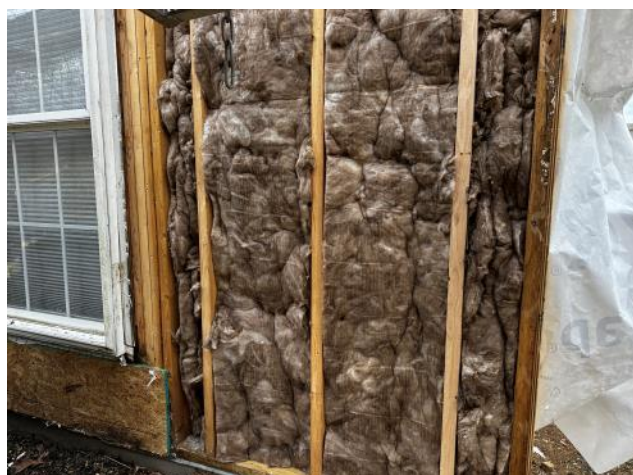
Photo #96: Overview of new insulation installed.

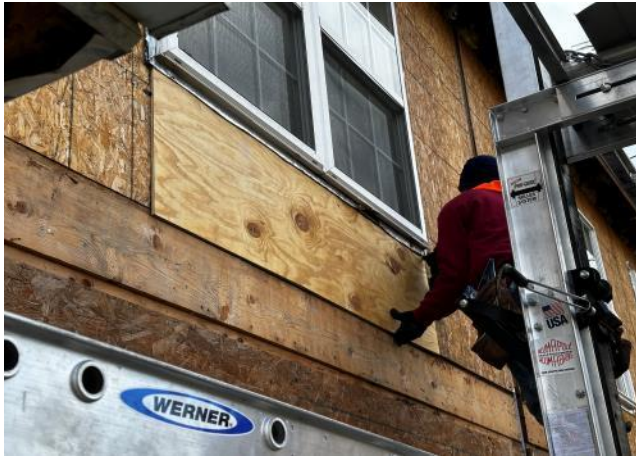
Photo #97: Overview of new sheathing being installed.

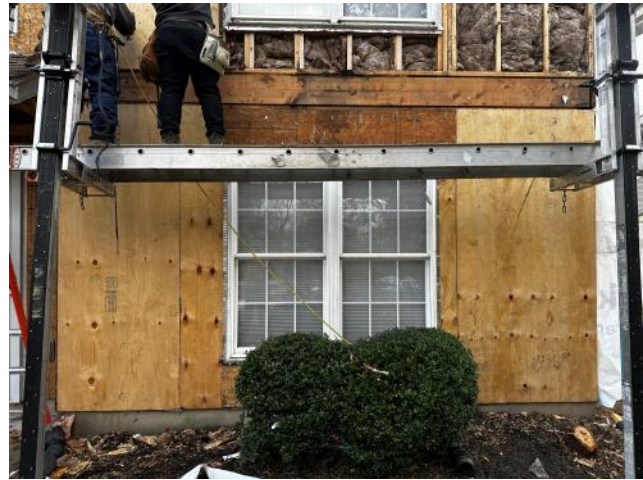
Photo #98: Overview of new sheathing being installed.

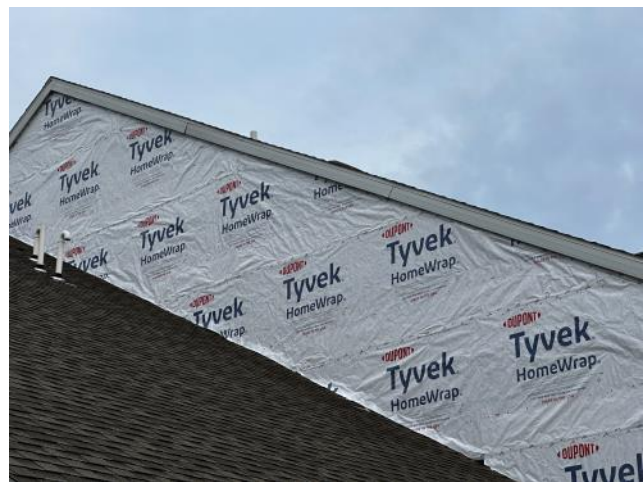
Photo #100: Overview of new Water Resistant Barrier (Tyvek) installed at a sidewall above the roofline.

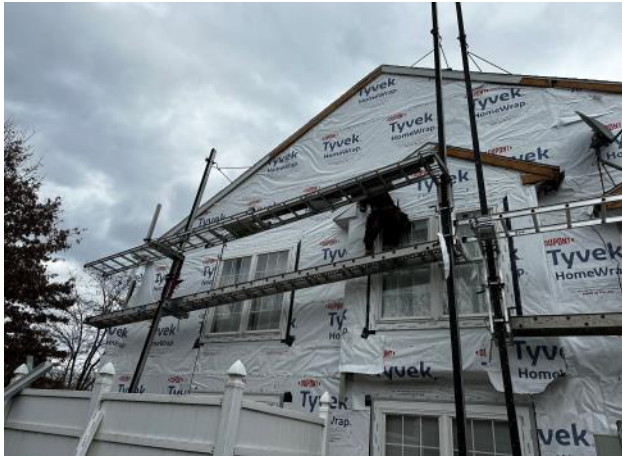
Photo #101: Overview of windows being properly flashed at a main side of the Building.

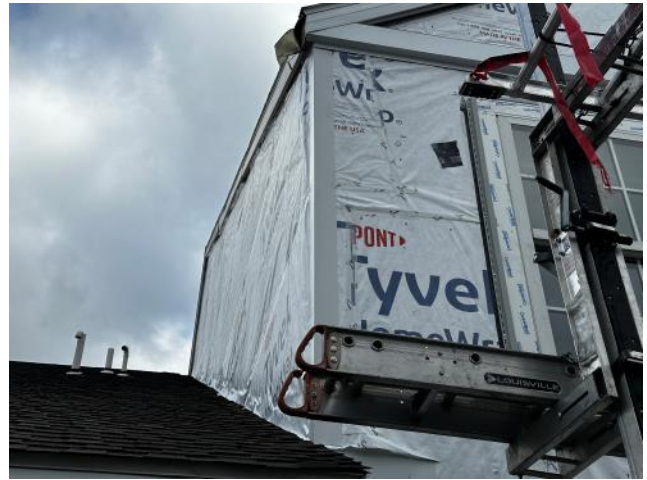
Photo #102: Overview of new metal flashing being installed at a corner.

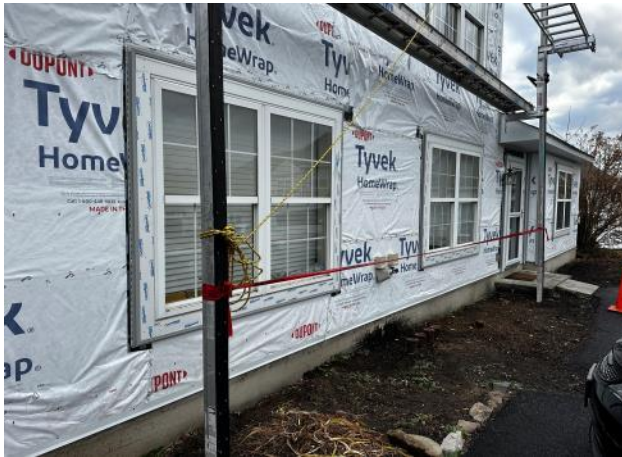
Photo #103: Overview of new azek trim installed at the windows and new j-channel being installed.

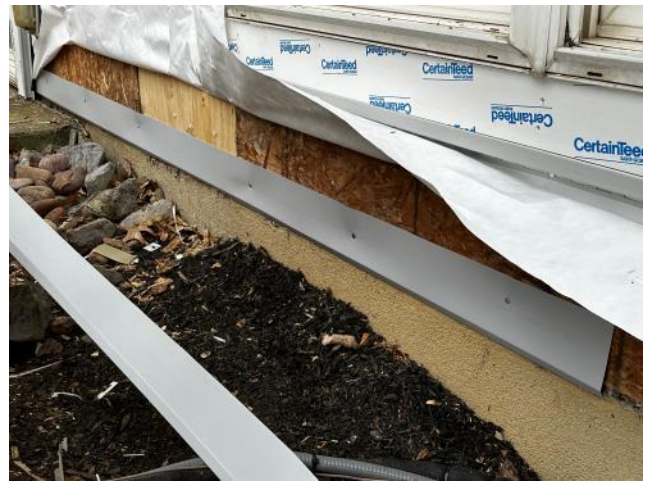
Photo #104: Overview of new metal flashing being installed before installing the starter strip.
