**Project:** Courtyards of Carlisle CA – Siding Project

**Project #:** 14372-04

## Field Report 2

Purpose of Visit: To oversee the progress of siding replacement

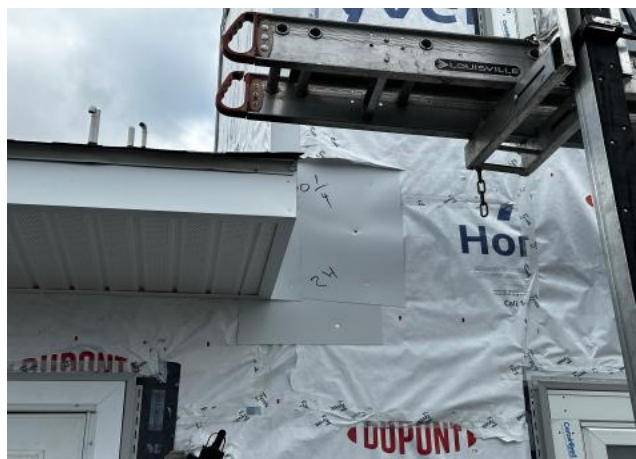
Photo #105: Overview of new metal flashing being installed where a roof meets a wall for extra protection.

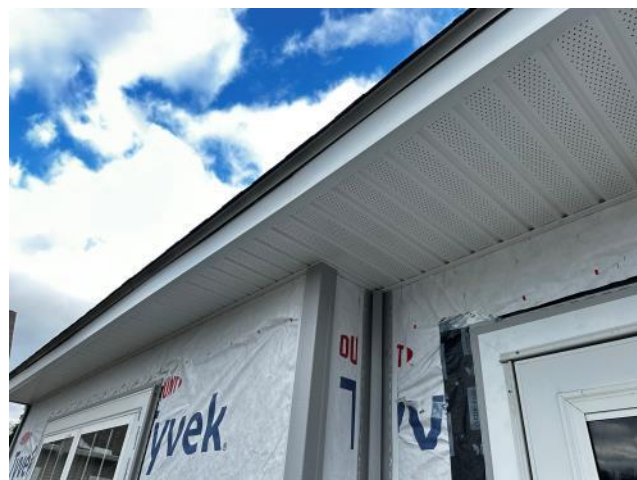
Photo #106: Overview of new aluminum wrap being installed at a fascia board.

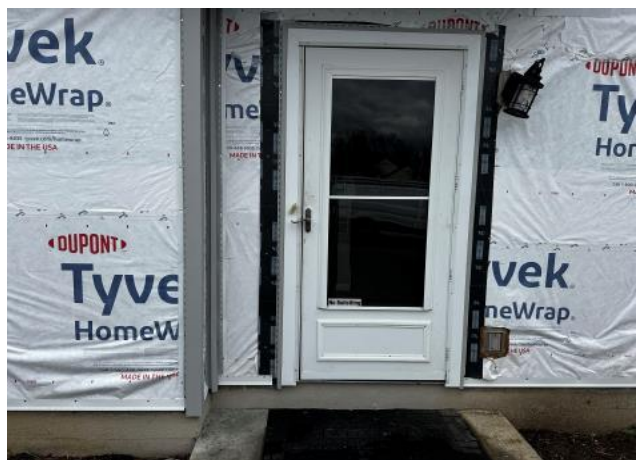
Photo #107: Overview of new flashing tape installed at a front door.

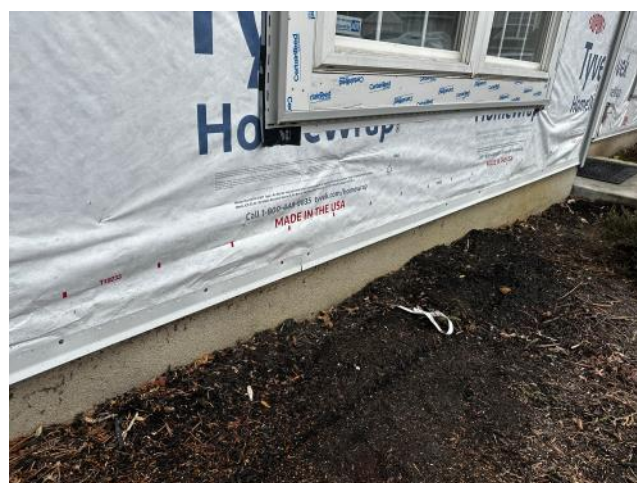
Photo #108: Overview of a new starter strip installed.
