Project: Courtyards of Carlisle CA – Siding Project

Project #: 14372-04

Field Report 3

Purpose of Visit: To oversee the progress of siding replacement

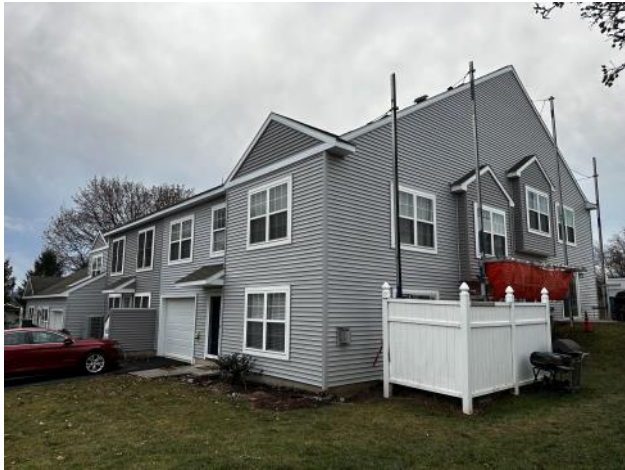
Photo #1: **Overview of Lemus Siding Crew (Blue) working at Building 9 (1239-1243/92-96 Courtyard Drive).**

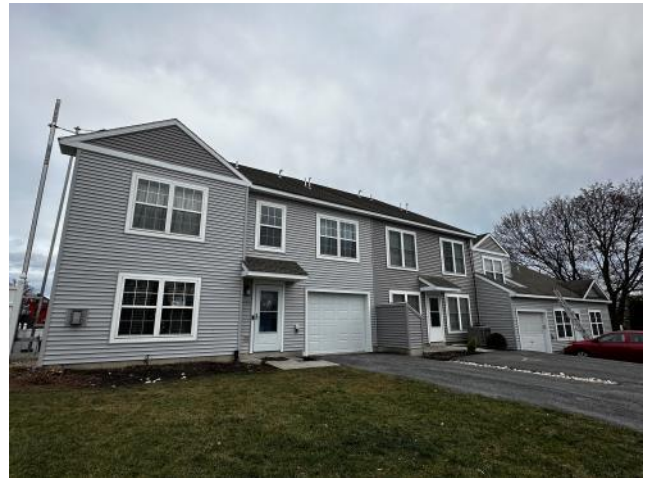
Photo #2: Overview of new vinyl siding and its accessories installation completed at Building 9.

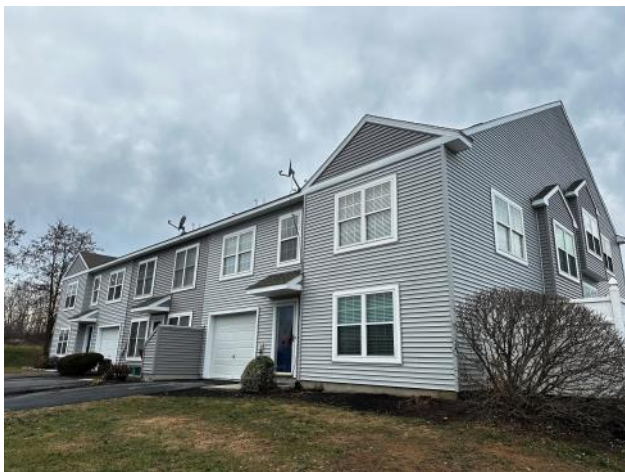
Photo #3: **Overview of Lemus Siding Crew (Blue) working at Building 10 (105-115 Courtyard Drive).**

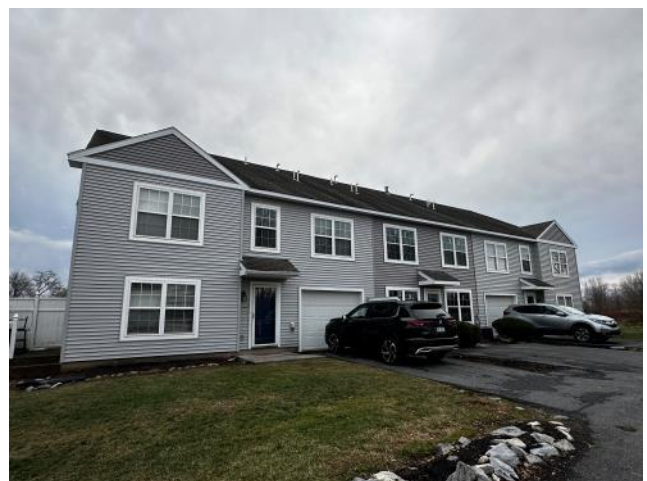
Photo #4: Overview of new vinyl siding and its accessories installation completed at Building 10.

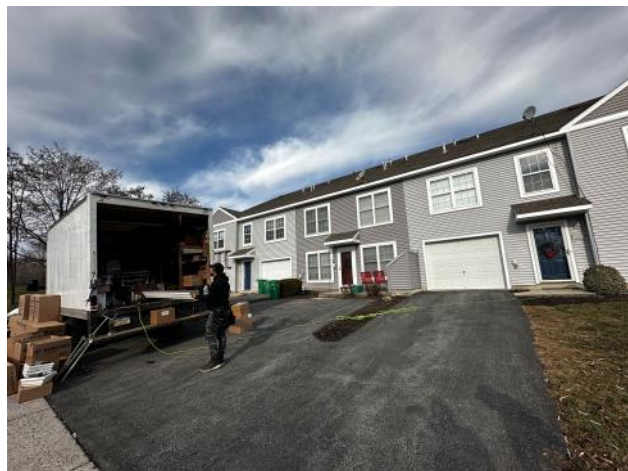
Photo #5: Overview of the gutter crew on-site working at Buildings 9 & 10.

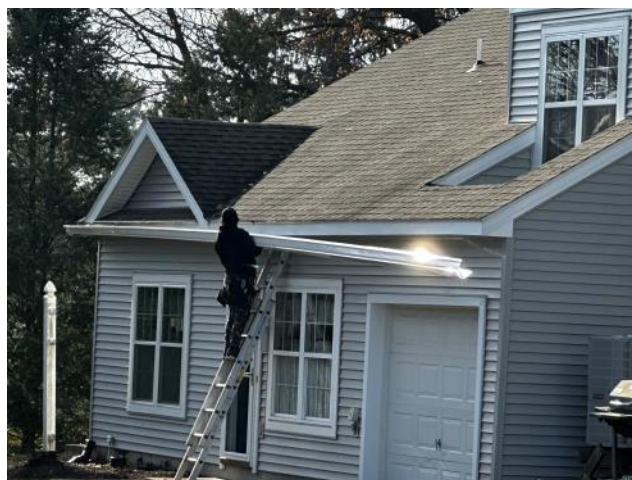
Photo #6: Overview of a new gutter being installed at a front section.

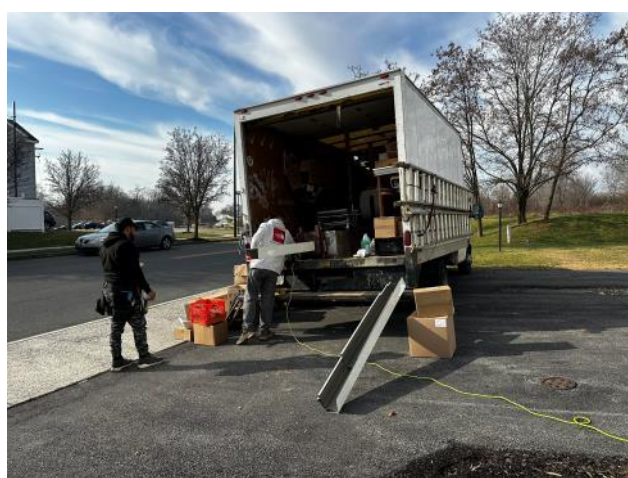
Photo #7: Overview of the gutters being fabricated seamless on-site.

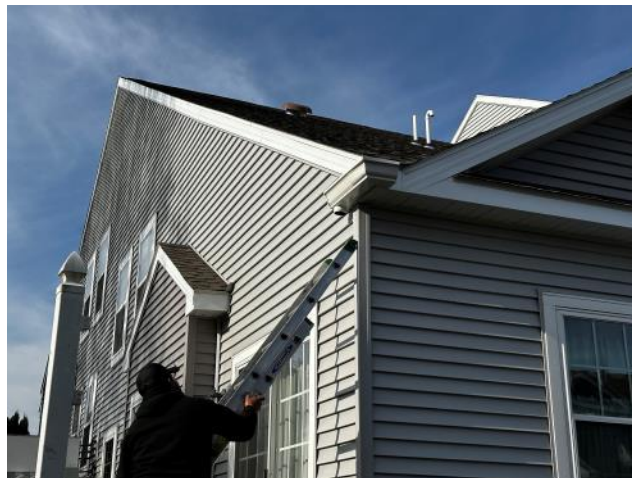
Photo #8: Overview of a new gutter being installed at a side section.

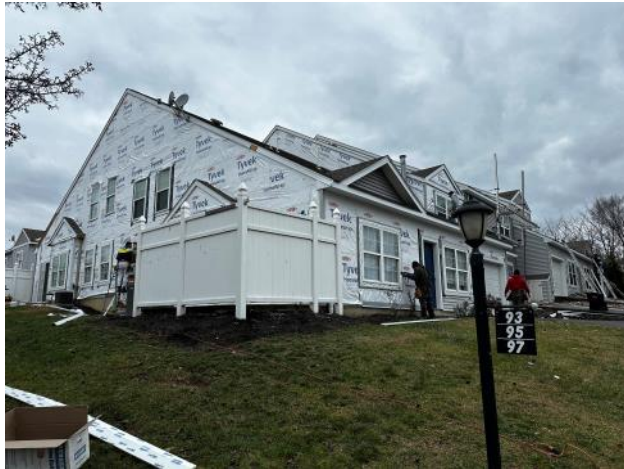
Photo #9: **Overview of Lemus Siding Crew (Yellow) working at Building 11 (99-103/93-97 Courtyard Drive).**

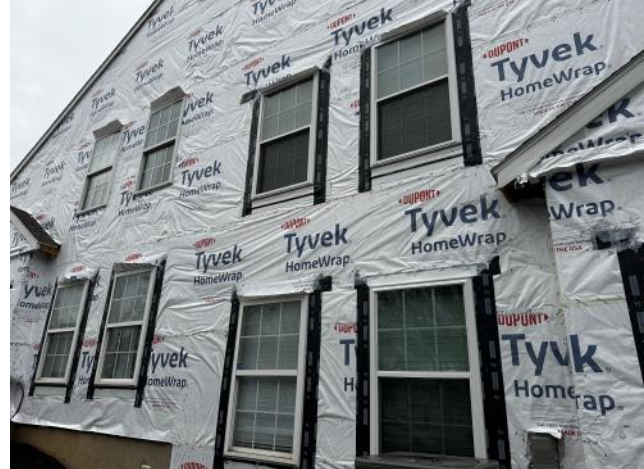
Photo #10: Overview of new flashing tape installed at the windows.

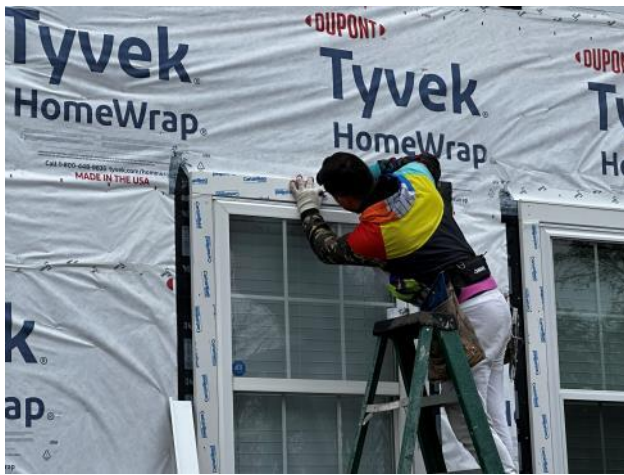
Photo #11: Overview of new azek trim being installed at a window.

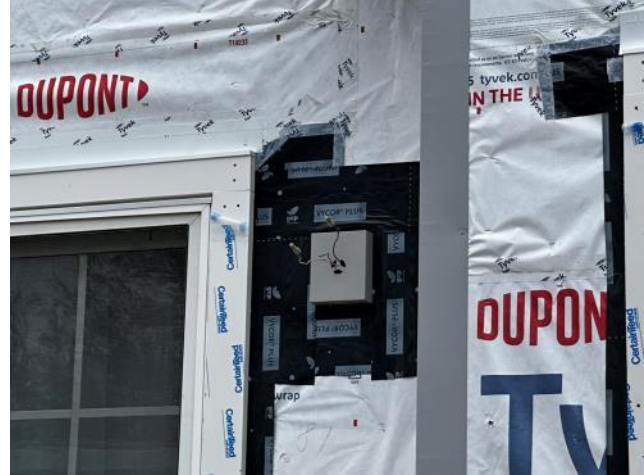
Photo #12: All wall penetrations are being properly flashed with flashing tape.

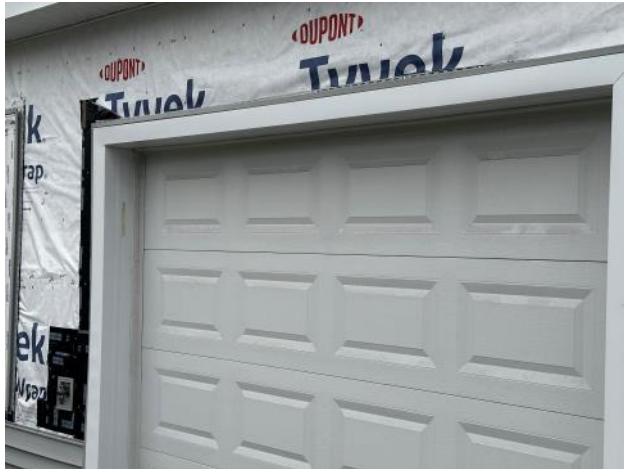
Photo #13: Overview of new aluminum wrap and weather strip installed at a garage door.

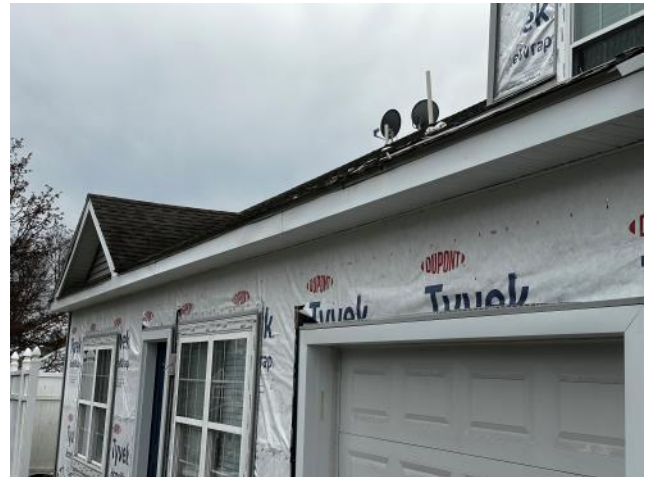
Photo #14: Overview of new aluminum wrap being installed at a fascia board.

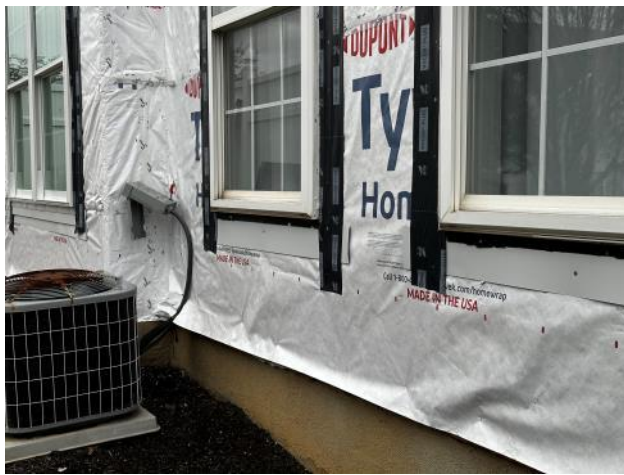
Photo #15: Overview of new metal flashing installed at the bottom of the windows.

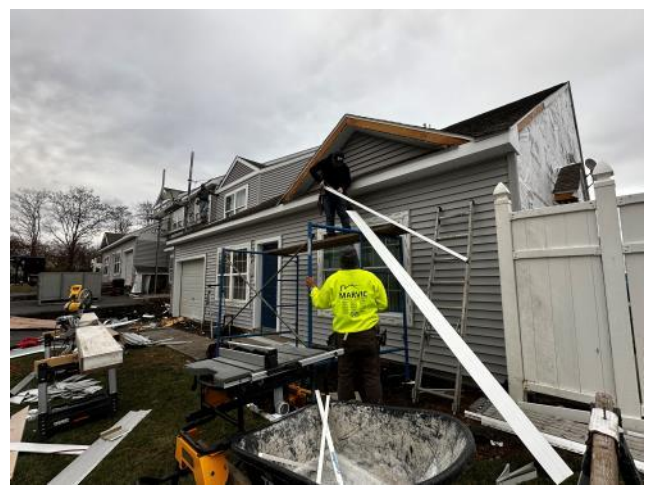
Photo #16: Overview of new vinyl siding being installed at a front section.

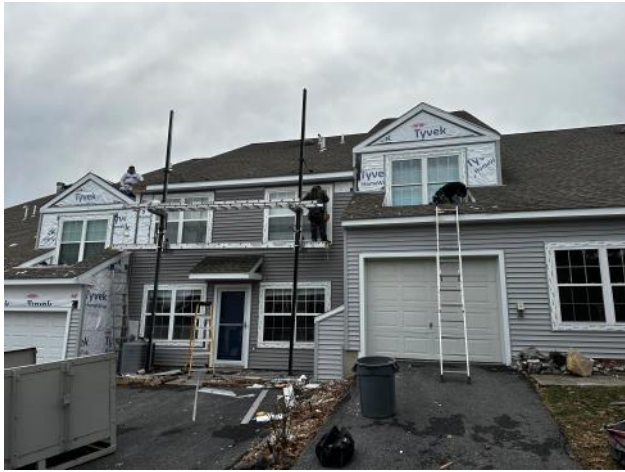
Photo #17: Overview of new vinyl siding being installed at another front section.

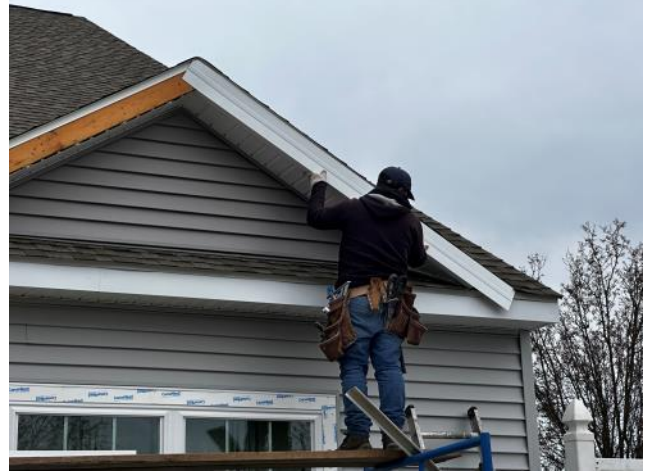
Photo #18: Overview of new aluminum wrap being installed at a rake board.

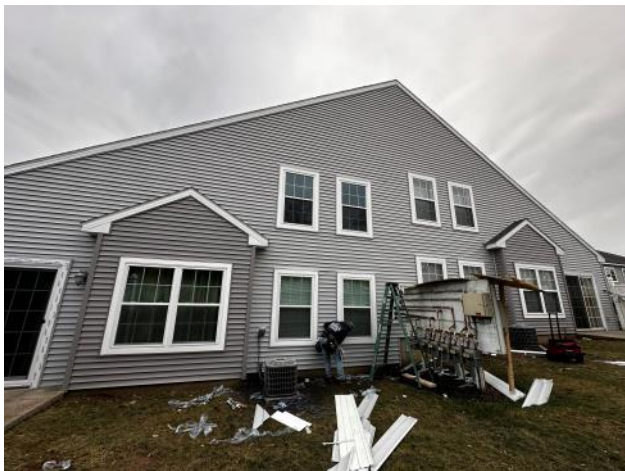
Photo #19: Overview of new vinyl siding installed at a main side of the Building.

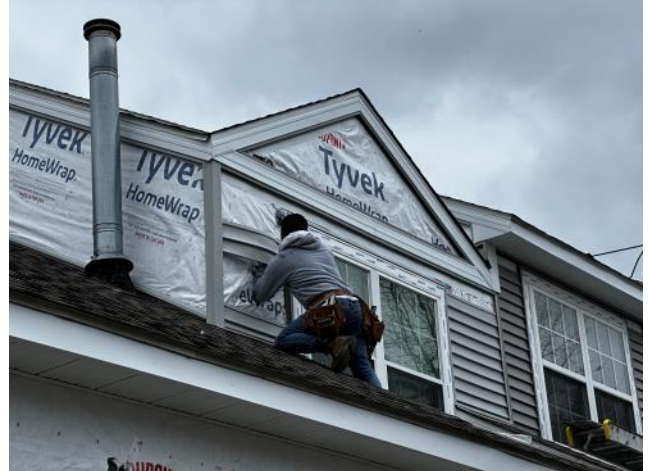
Photo #20: Overview of new vinyl siding being installed.

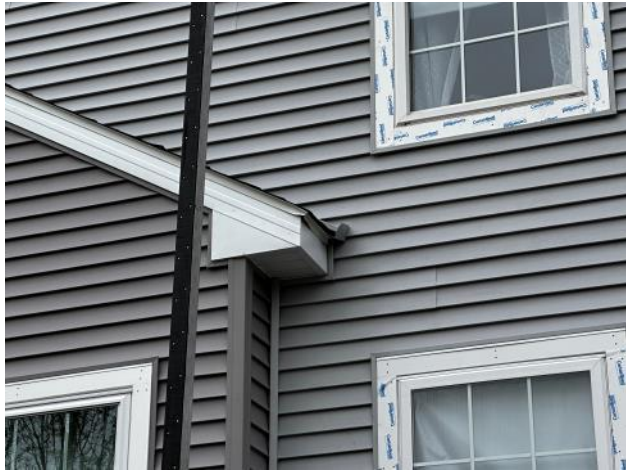
Photo #21: Overview of a new kick-out flashing installed.

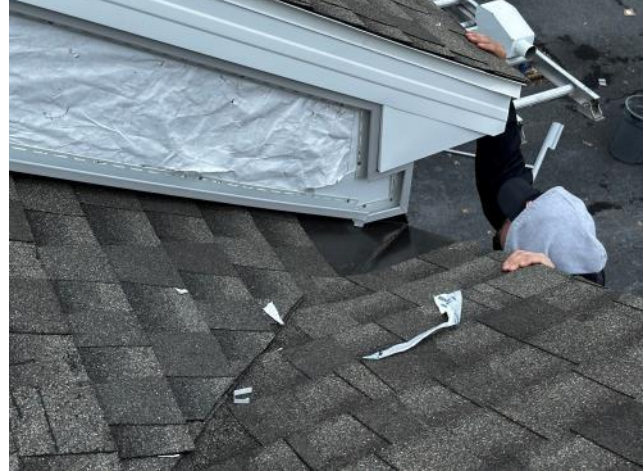
Photo #22: Overview of a front section where a front roof gable meets a separation wall.

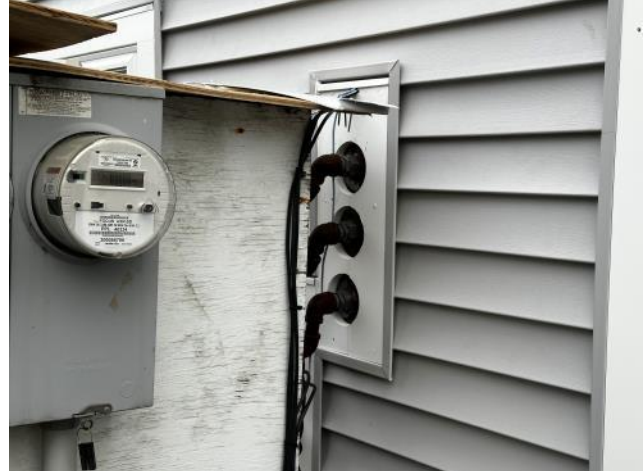
Photo #24: Overview of new azek block installed where the gas lines penetrate the Building.

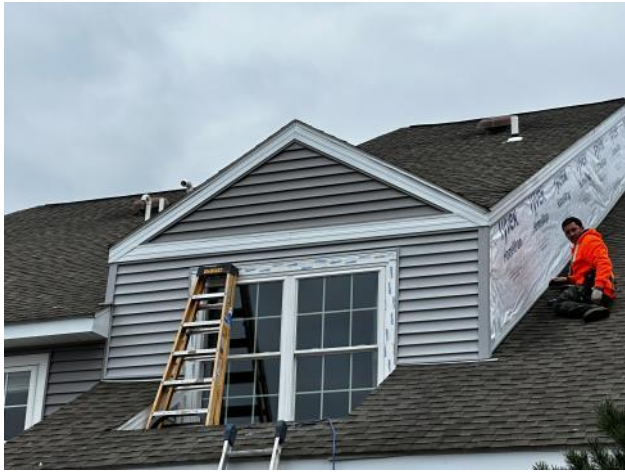
Photo #25: Overview of new vinyl siding being installed.

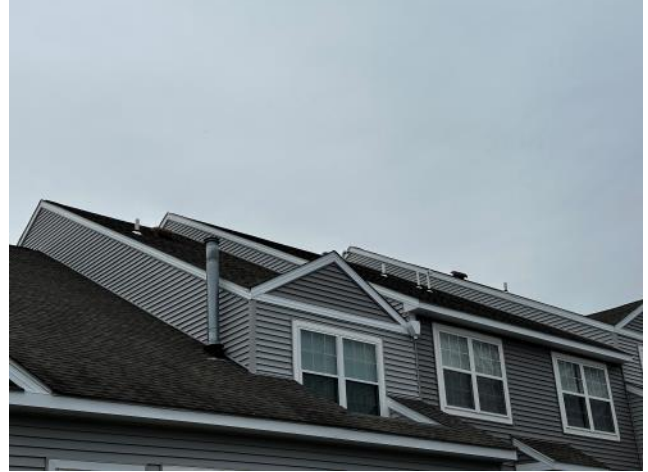
Photo #26: Overview of new vinyl siding installed at the upper sections.

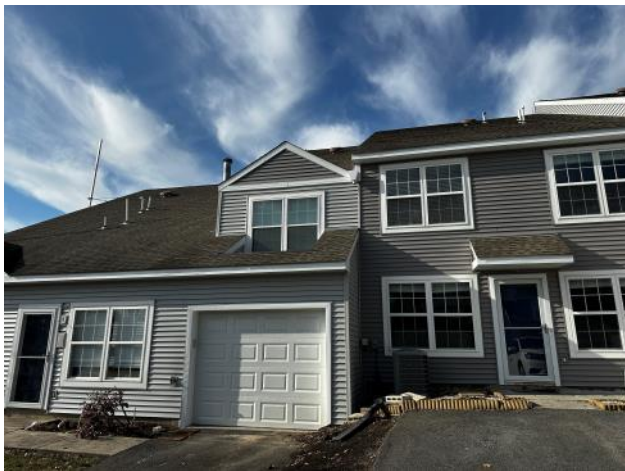
Photo #27: Overview of new vinyl siding installed at a front section of the Building.

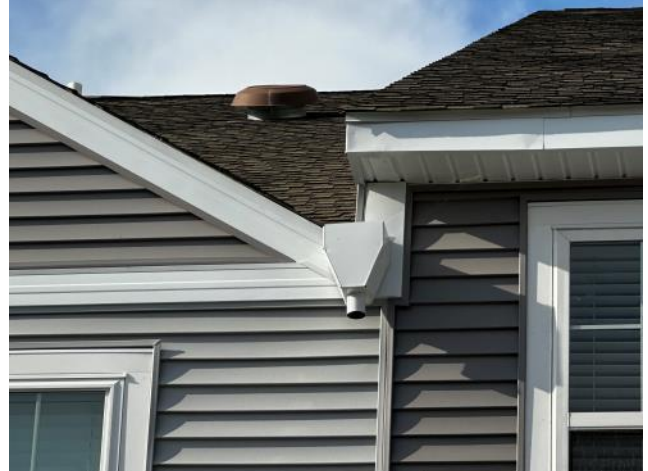
Photo #28: Overview of a new collection box that Lemus proposed to be installed at the front sections where a roof gable meets a separation wall.

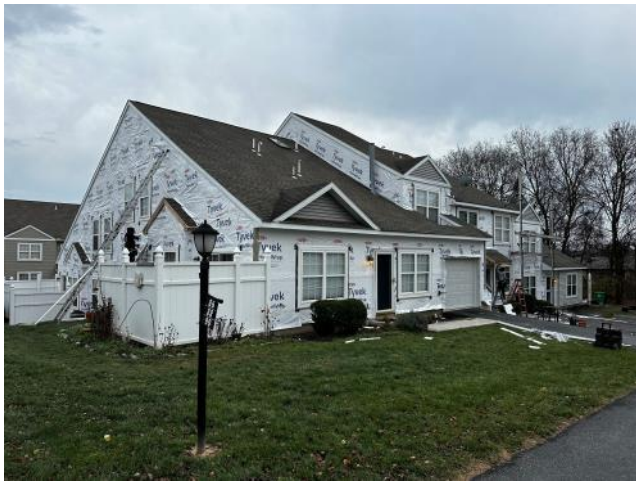
Photo #29: Overview of Lemus Siding Crew (Blue) working at Building 8 (80-90 Courtyard Drive).

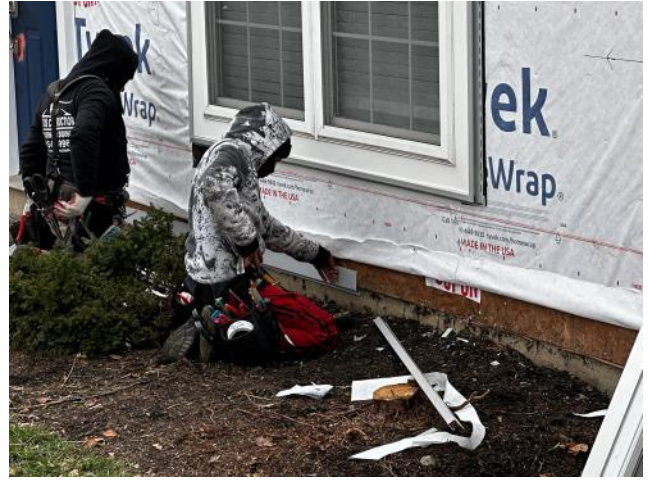
Photo #30: Overview of new metal flashing being installed before installing the starter strip.

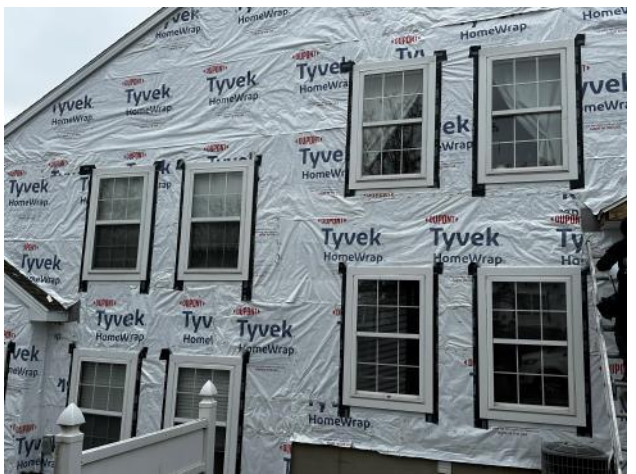
Photo #31: Overview of new flashing tape installed at a main side windows.

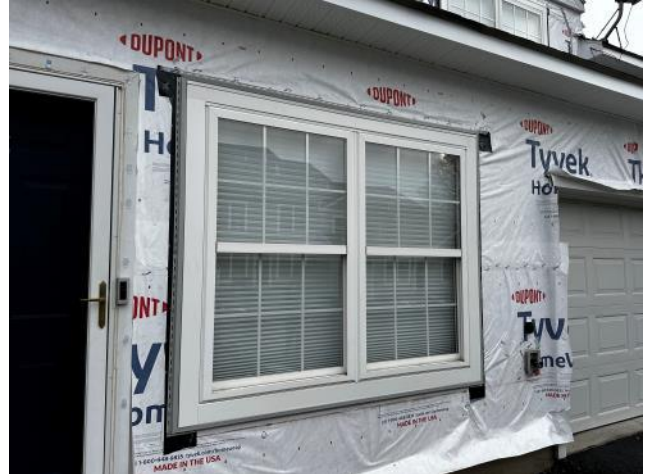
Photo #32: Overview of new azek trim installed at a window and new j-channel being installed.

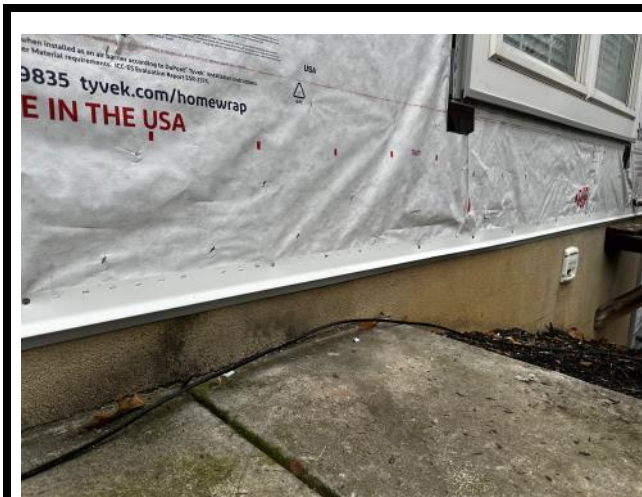
Photo #33: Overview of a new starter strip installed.

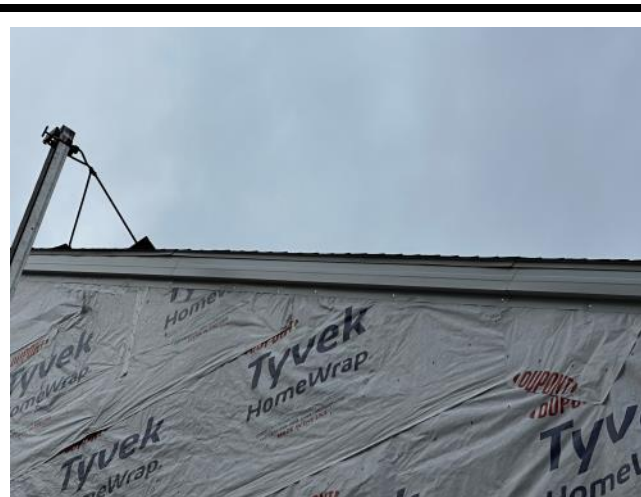
Photo #34: Overview of new aluminum wrap being installed at a rake board.

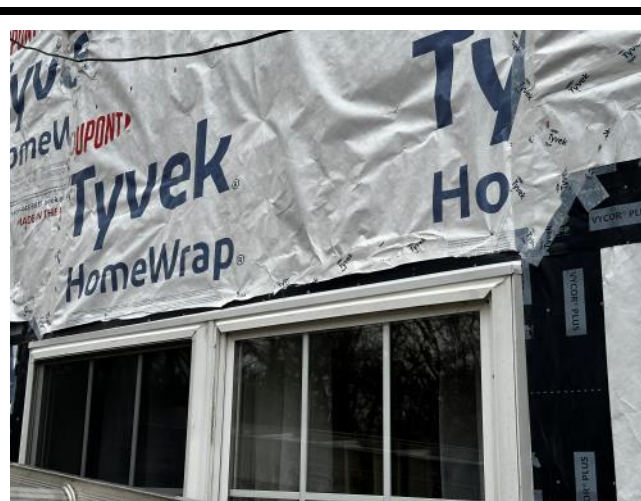
Photo #36: Overview of new metal drip cap and flashing tape installed at a window header.

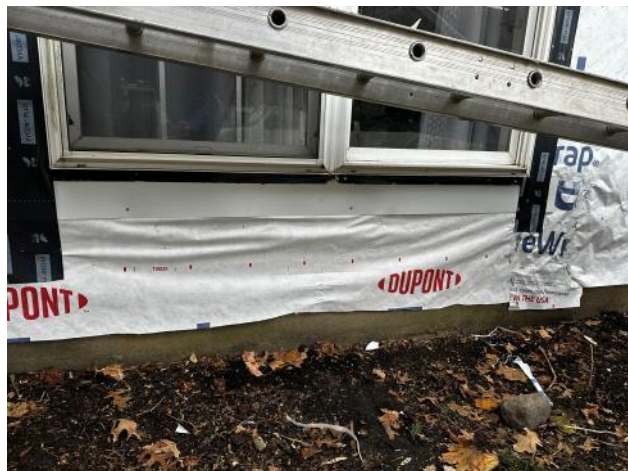
Photo #37: Overview of new metal flashing installed at the bottom of a window.

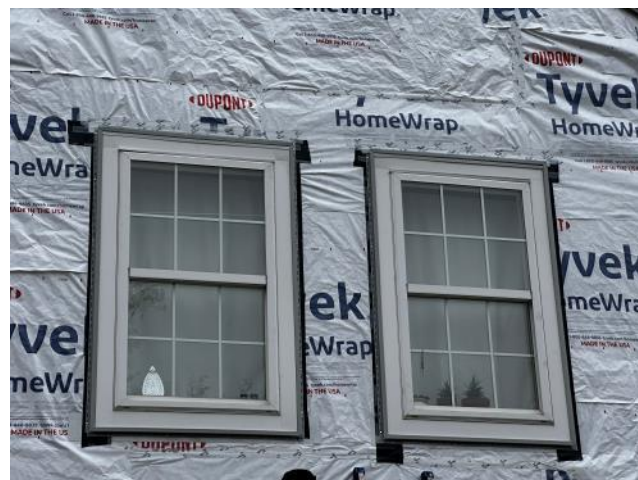
Photo #38: Overview of new azek trim installed at the windows.

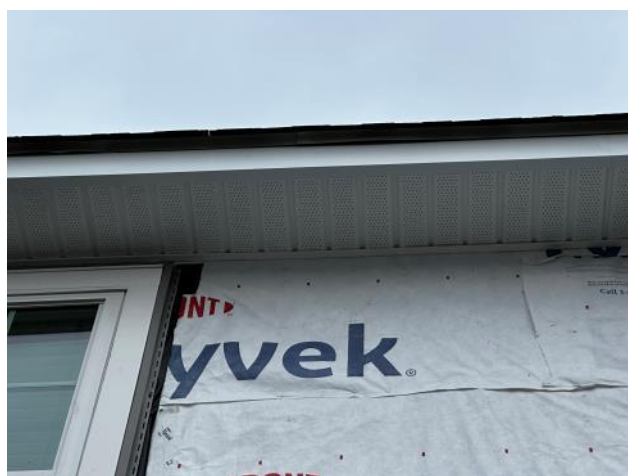
Photo #39: Overview of intake soffit installed.

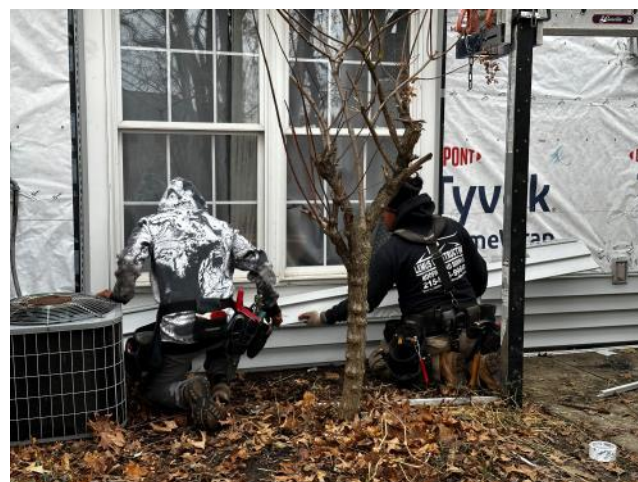
Photo #40: Overview of new vinyl siding being installed.

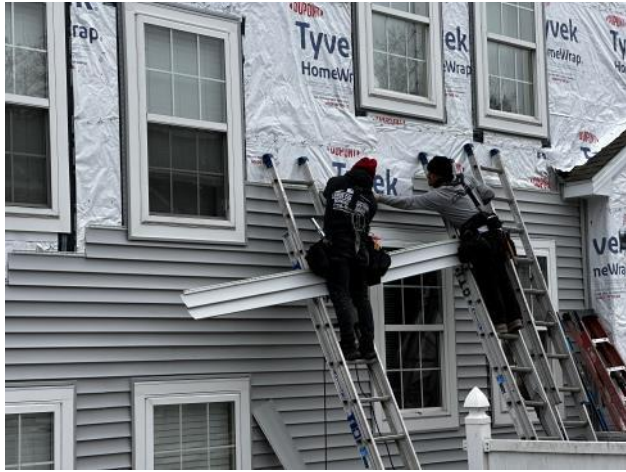
Photo #41: Overview of new vinyl siding being installed at a main side of the Building.

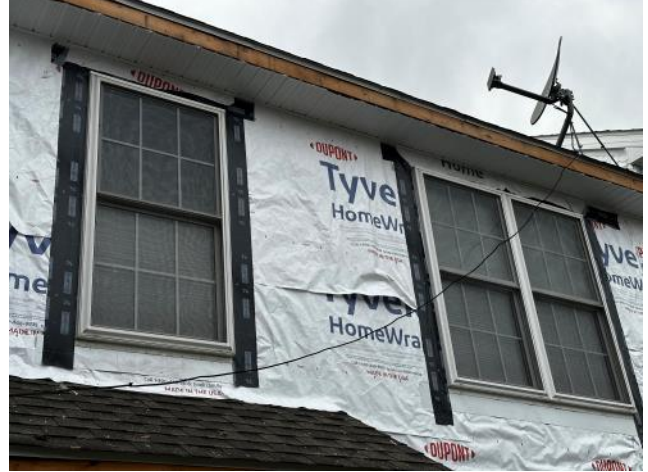
Photo #42: Overview of new flashing tape installed at other windows.

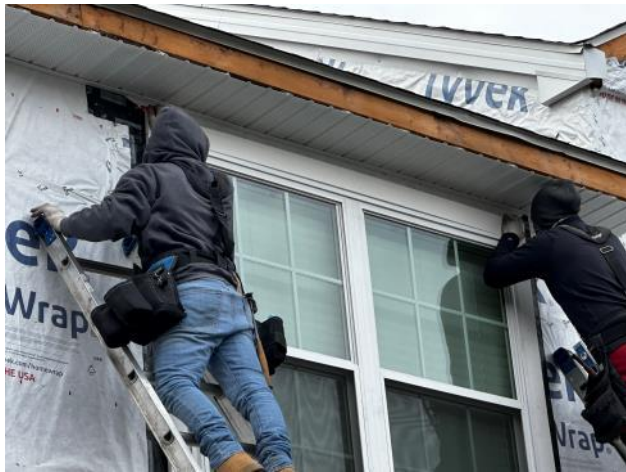
Photo #43: Overview of new azek trim being installed.

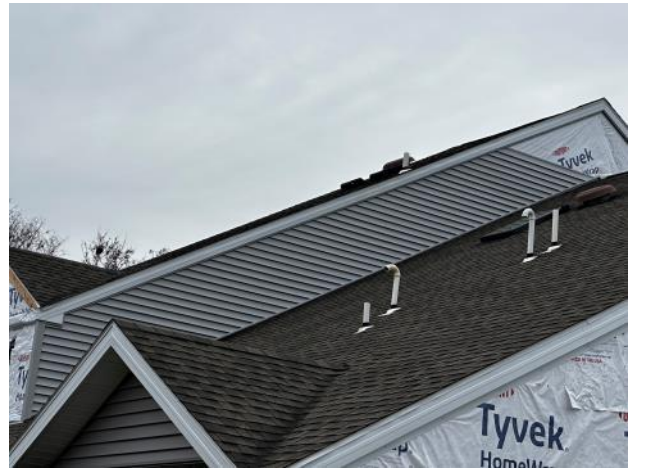
Photo #44: Overview of new vinyl siding being installed at an upper roofing sidewall.

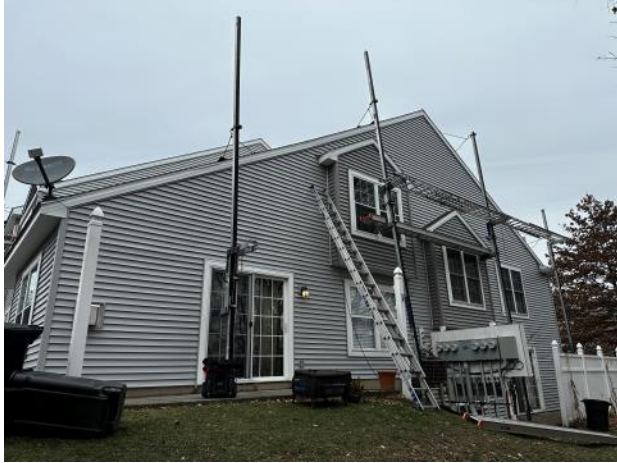
Photo #45: Overview of new vinyl siding installed at a main side of the Building.

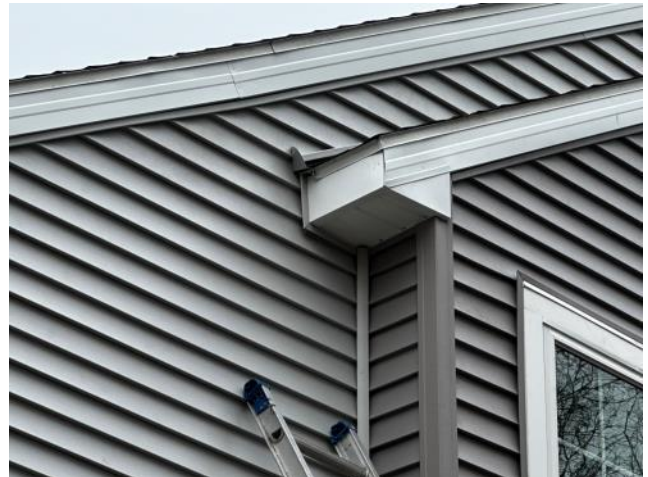
Photo #46: Overview of a new kick-out flashing installed.

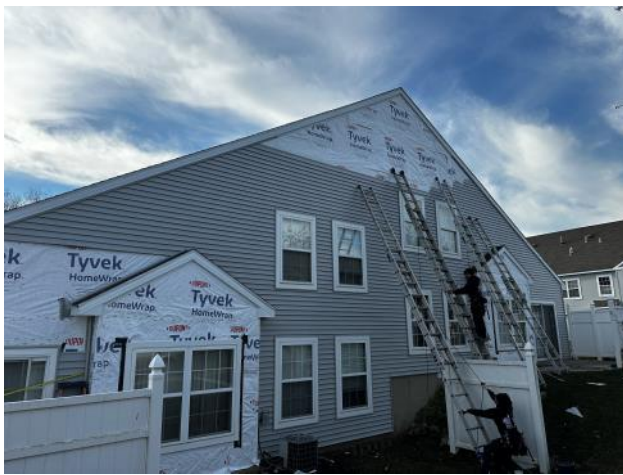
Photo #47: Overview of new vinyl siding being installed at the other main side of the Building.

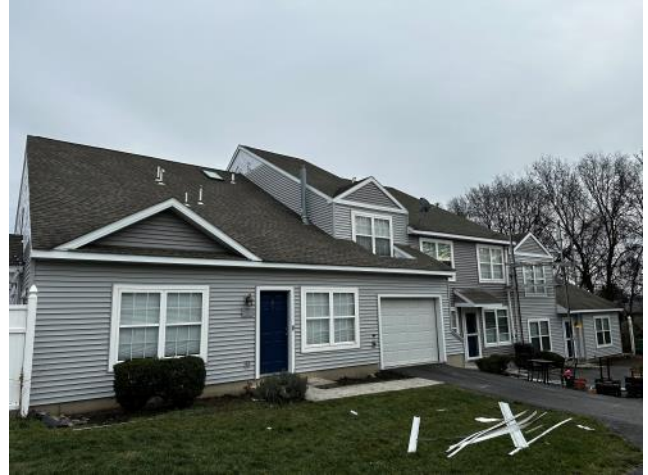
Photo #48: Overview of new vinyl siding being installed at the front of the Building.

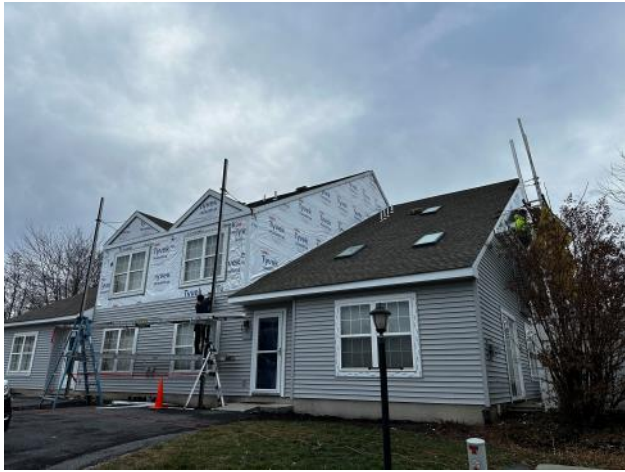
Photo #49: **Overview of Lemus Siding Crew (Yellow) working at Building 13 (73-79 Courtyard Drive).**

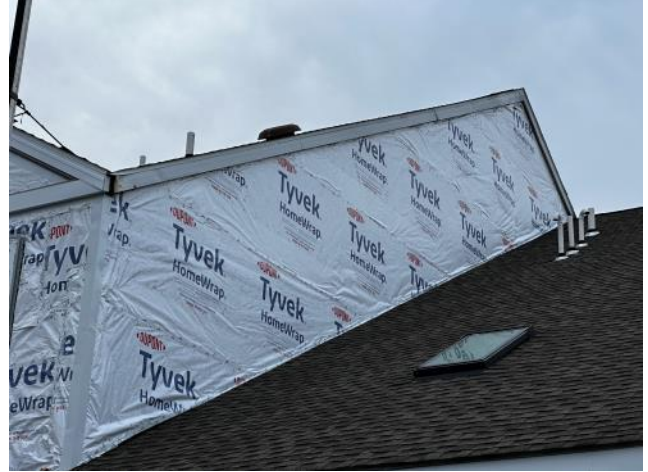
Photo #50: Overview of new Water Resistant Barrier (Tyvek) installed at a roofing sidewall.

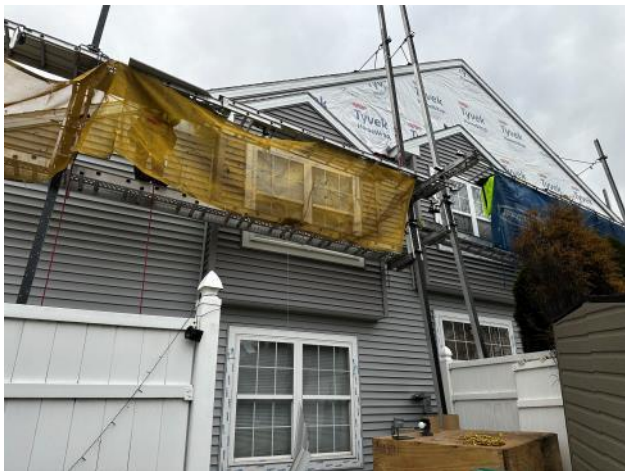
Photo #51: Overview of new vinyl siding being installed at a main side of the Building.

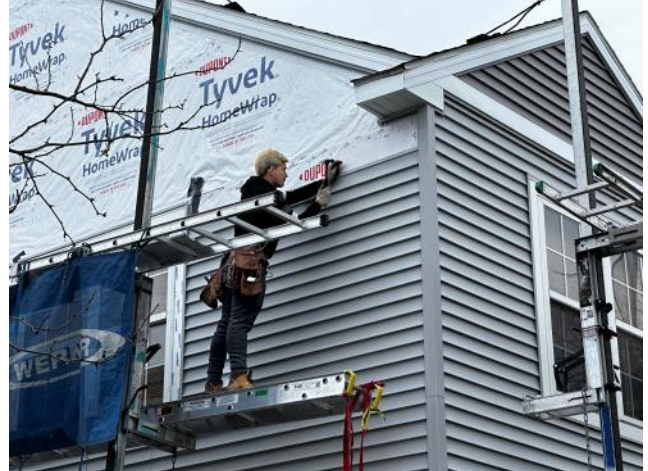
Photo #52: Overview of new vinyl siding being installed.

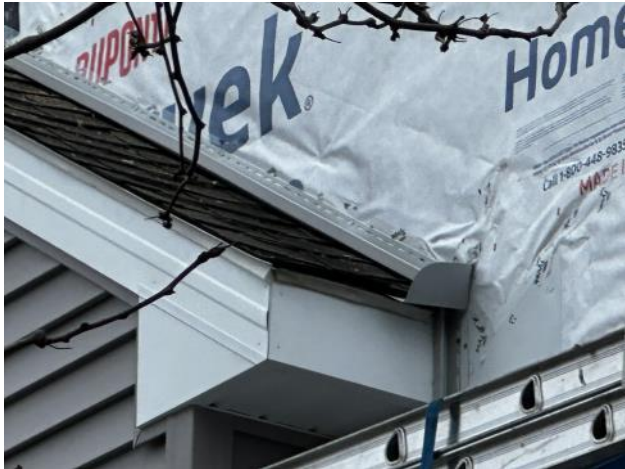
Photo #53: Overview of a new kick-out flashing being installed.

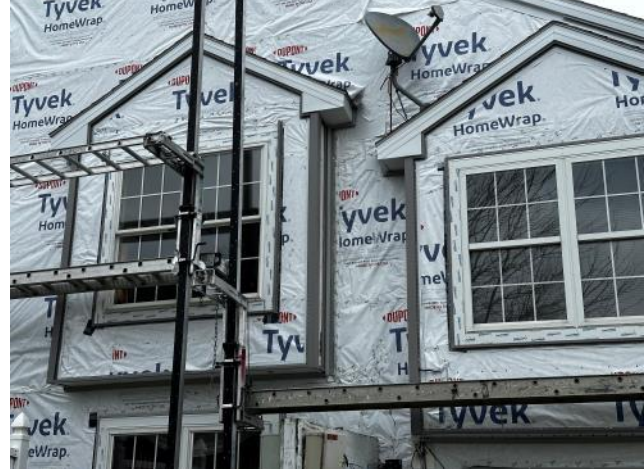
Photo #54: Overview of new siding corners being installed.

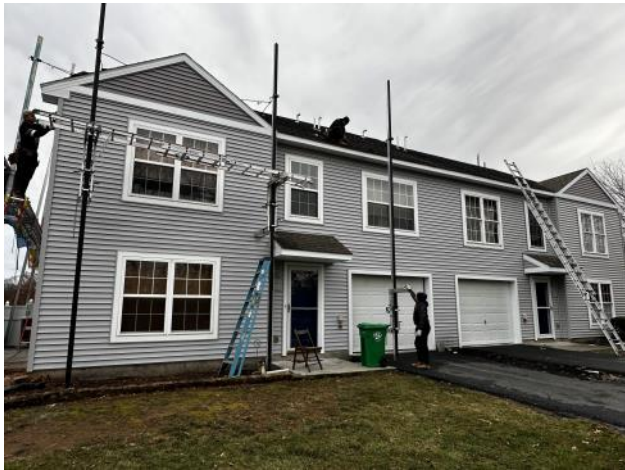
Photo #55: Overview of new vinyl siding installed at a front of the Building.

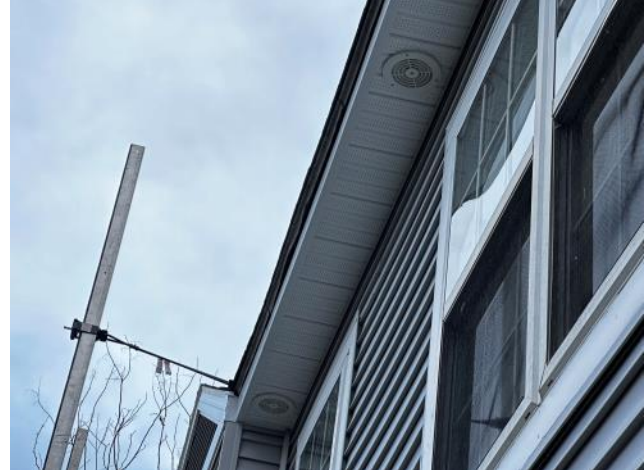
Photo #56: Overview of new bathroom vent caps installed at the soffit.

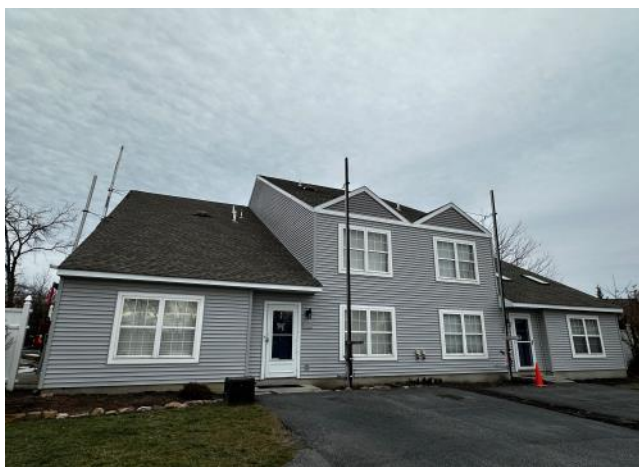
Photo #57: Overview of new vinyl siding installed at the other front of the Building.

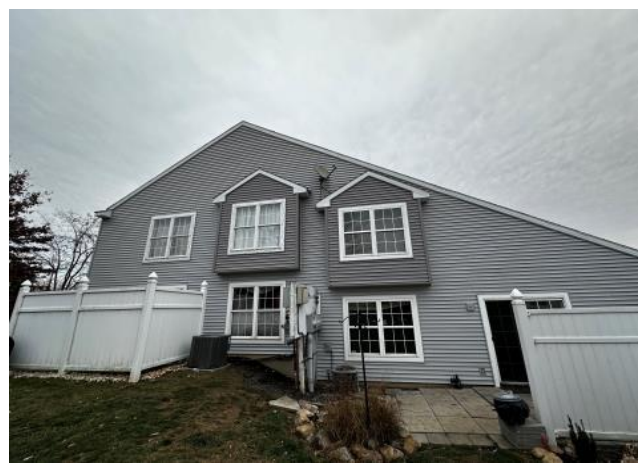
Photo #58: Overview of new vinyl siding installed at a main side of the Building.

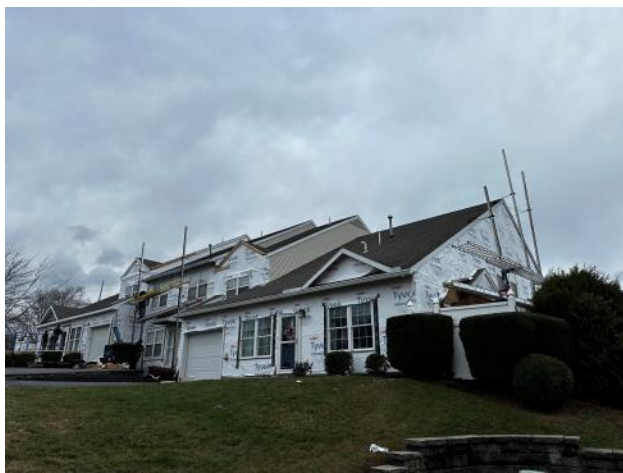
Photo #59: **Overview of Lemus Siding Crew (Green) working at Building 14 (61-71 Courtyard Drive).**

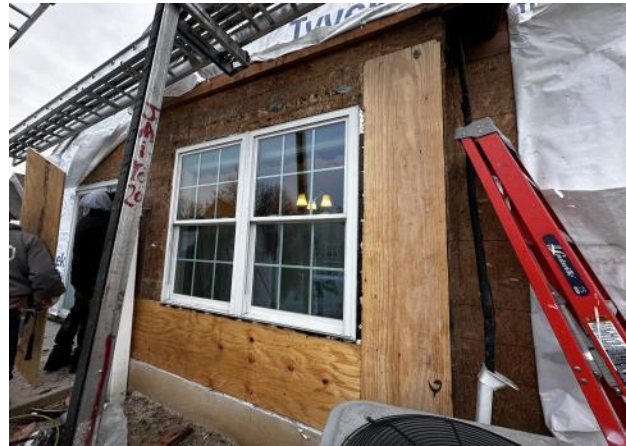
Photo #62: Overview of new sheathing installed.

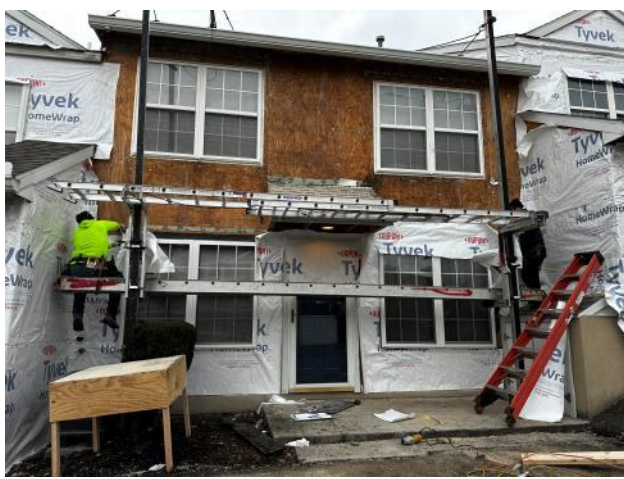
Photo #63: Overview of new Water Resistant Barrier (Tyvek) being installed.

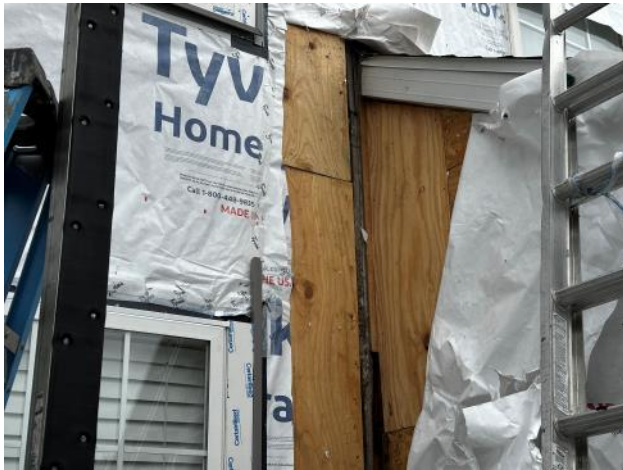
Photo #67: Overview of new sheathing installed between Units 67 and 69 due to the lack of flashing at the roof valley.

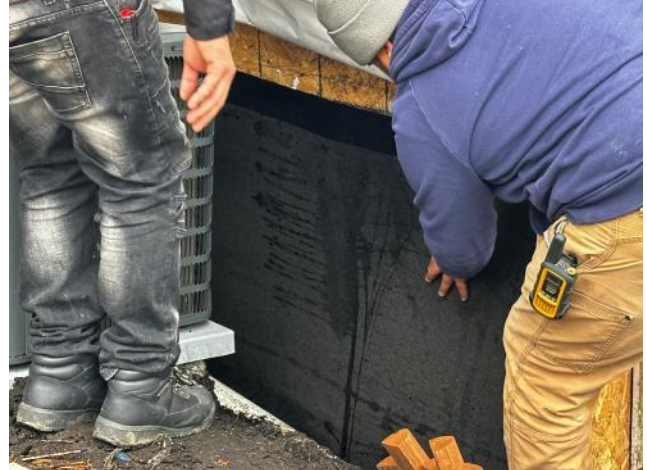
Photo #68: Overview of new waterproofing membrane being installed at section where the wall goes below grade.

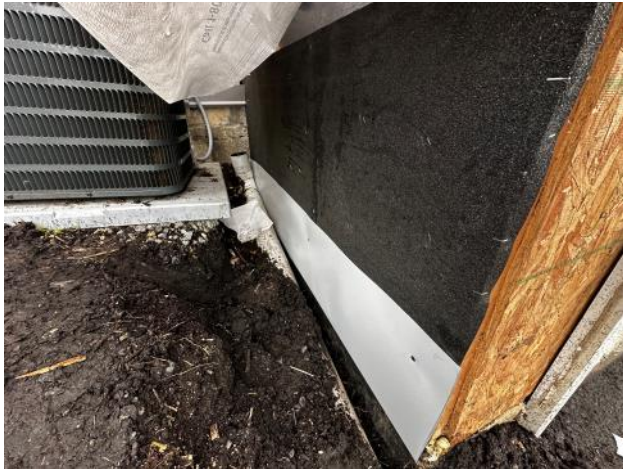
Photo #69: Overview of new metal flashing installed at the same location where the wall goes below grade for extra protection.

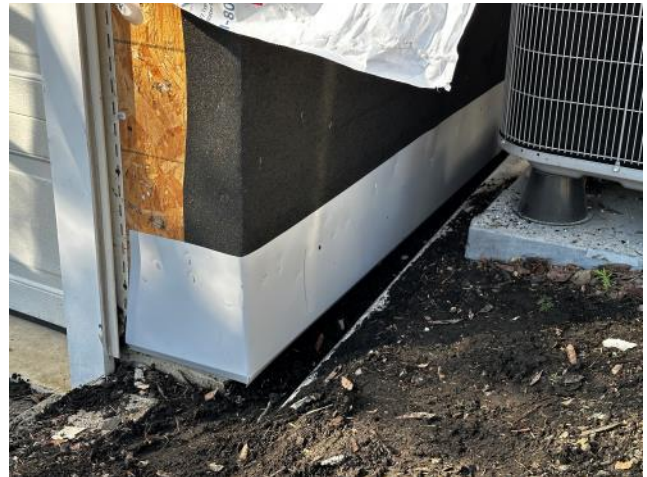
Photo #70: Overview of new metal flashing installed at other same location where the wall goes below grade for extra protection.

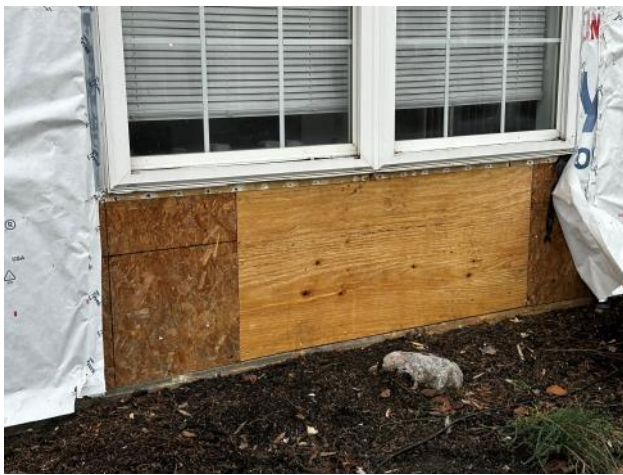
Photo #71: Overview of new sheathing installed below a window.

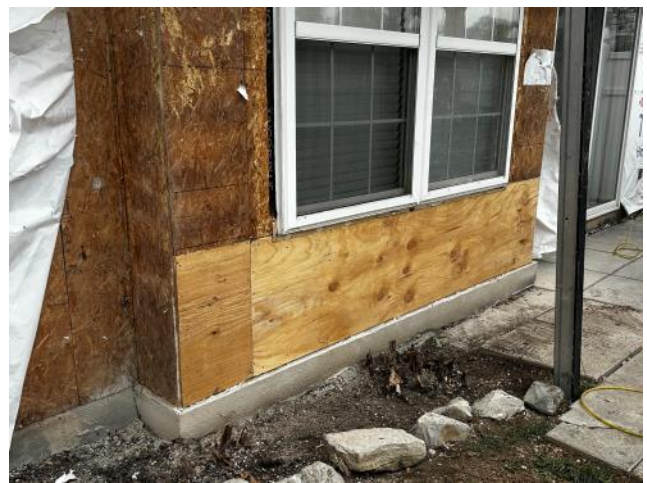
Photo #72: Overview of new sheathing installed below another window.

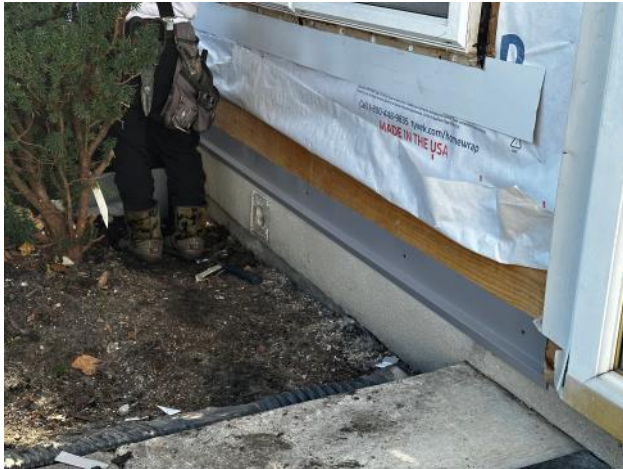
Photo #73: Overview of new metal flashing being installed before installing the starter strip.

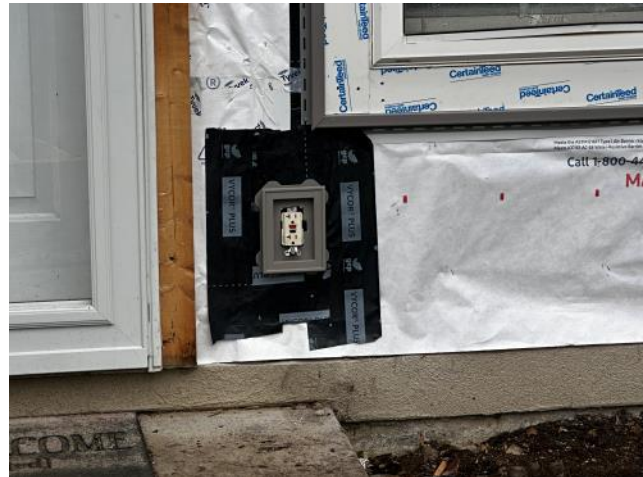
Photo #74: Overview new flashing tape installed at a wall penetration.

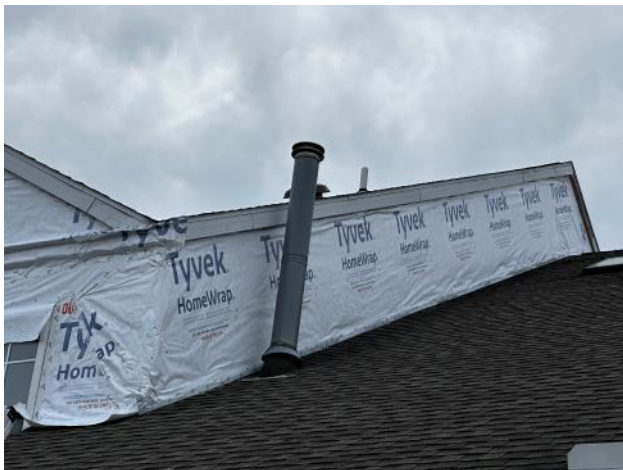
Photo #75: Overview of new Water Resistant Barrier (Tyvek) installed at a roofing sidewall.

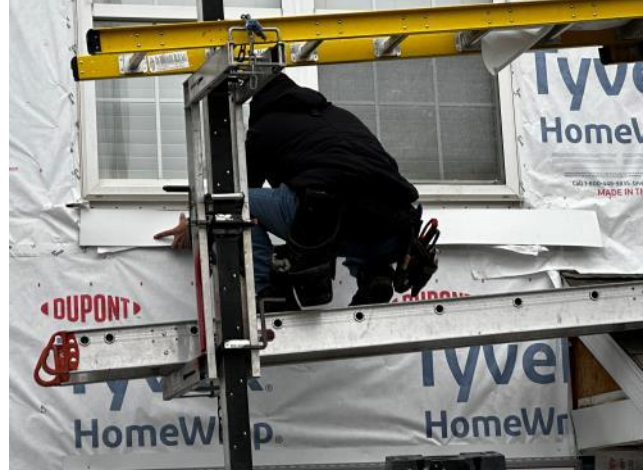
Photo #76: Overview of new metal flashing being installed at the bottom of a window.

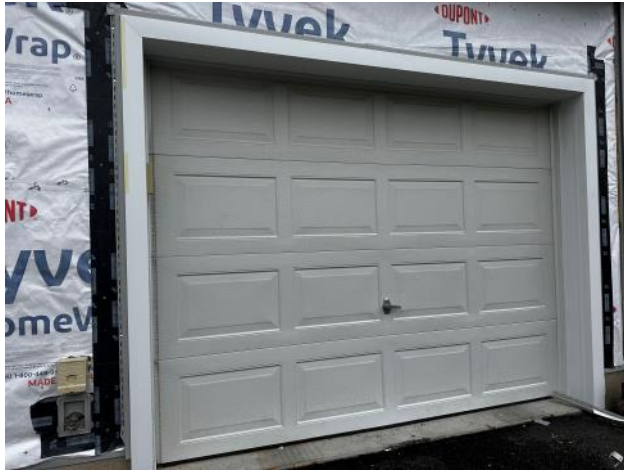
Photo #77: Overview of new aluminum wrap installed at a garage door.

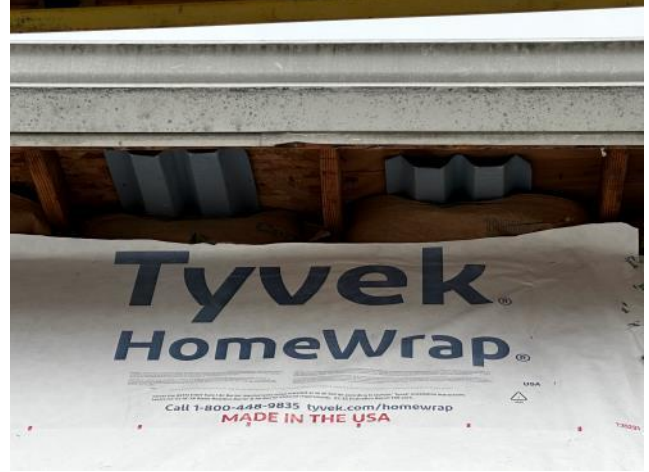
Photo #78: Overview of existing baffles that were observed.
