Project: Courtyards of Carlisle CA – Siding Project

Project #: 14372-04

Field Report 3

Purpose of Visit: To oversee the progress of siding replacement

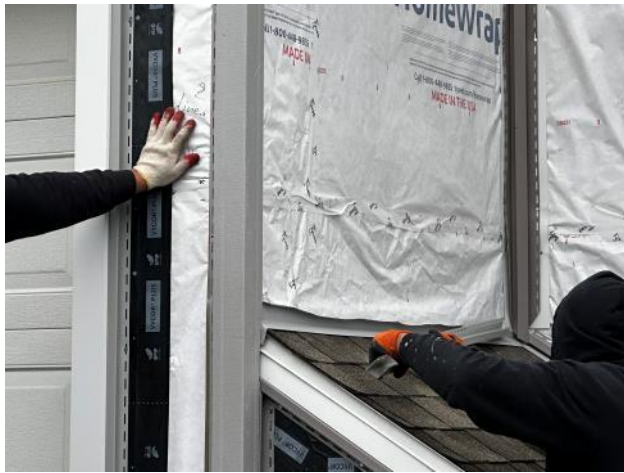
Photo #79: Overview of new siding corners being installed.

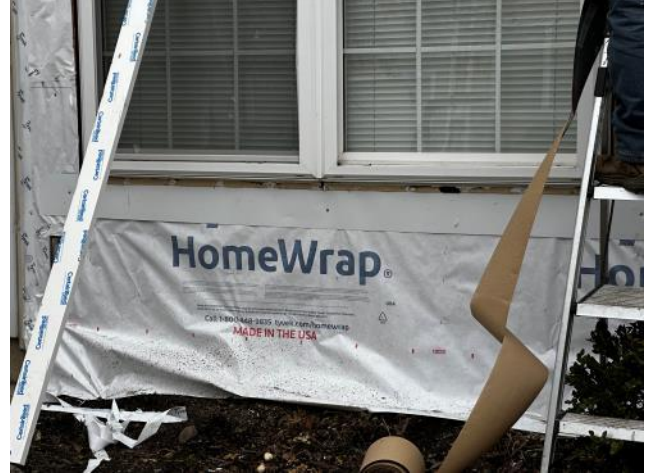
Photo #80: Overview of new metal flashing installed at the bottom of another window.

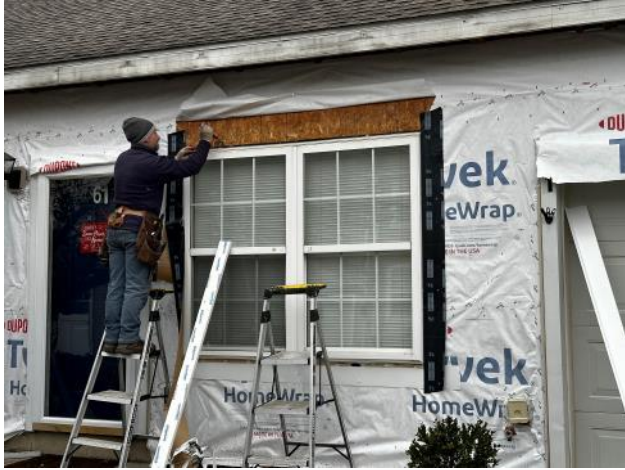
Photo #81: Overview of new flashing tape being installed at a window.

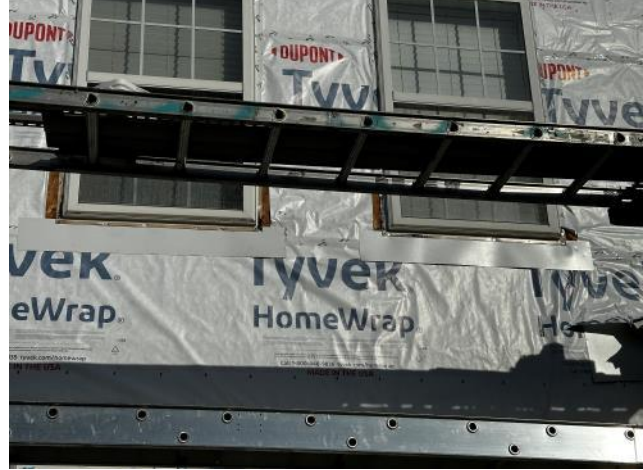
Photo #82: Overview of new metal flashing installed at the bottom of other windows.

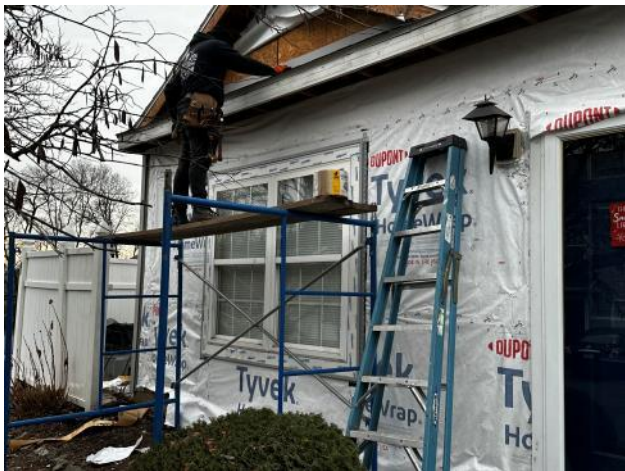
Photo #83: Overview of new Water Resistant Barrier (Tyvek) being installed.

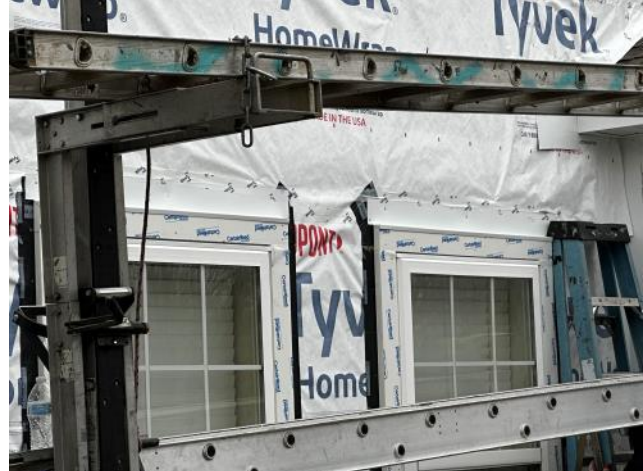
Photo #84: Overview of extra new metal drip caps installed over the azek trim.

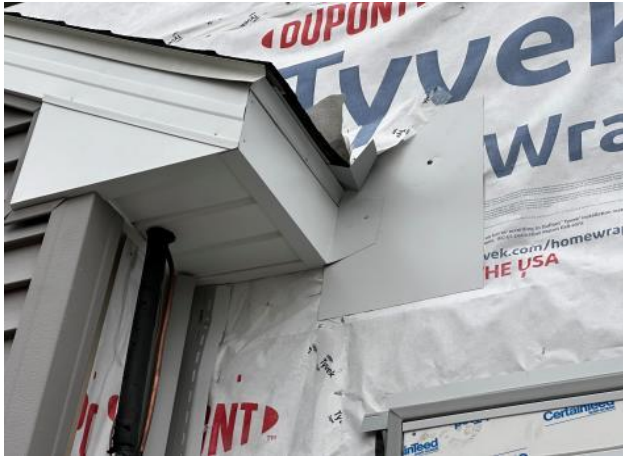
Photo #85: Overview of a new kick-out and metal flashing being installed.

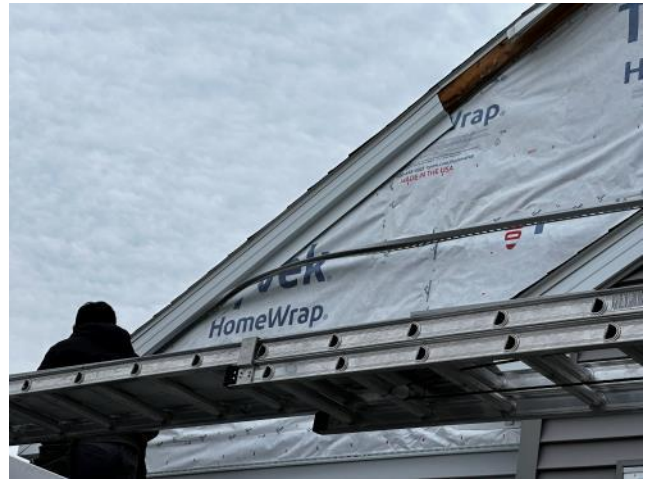
Photo #86: Overview of new aluminum wrap being installed at a rake board.

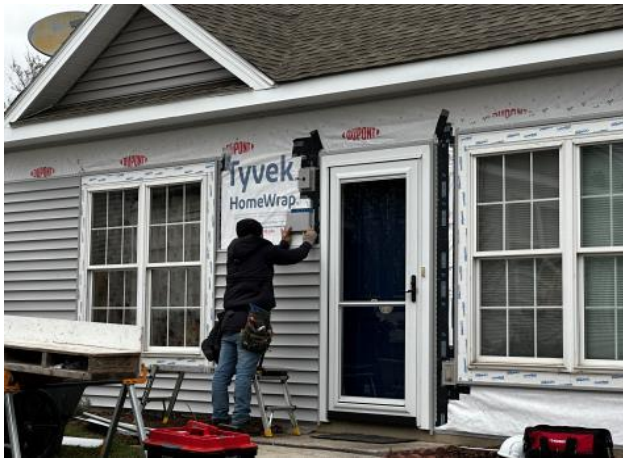
Photo #87: Overview of new vinyl siding being installed at a front section.

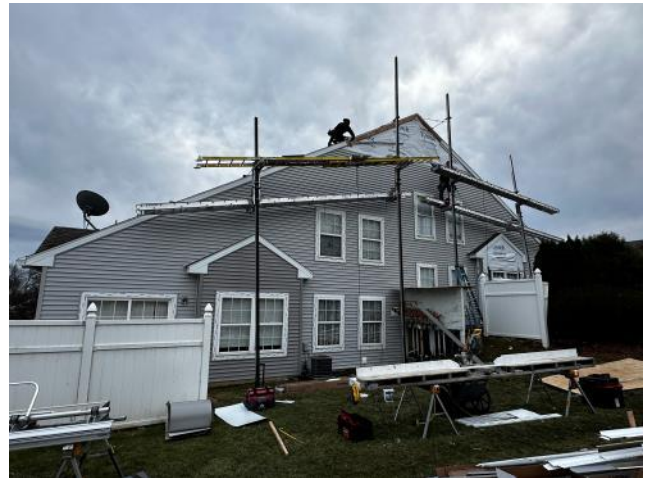
Photo #88: Overview of new vinyl siding being installed at a main side of the Building.

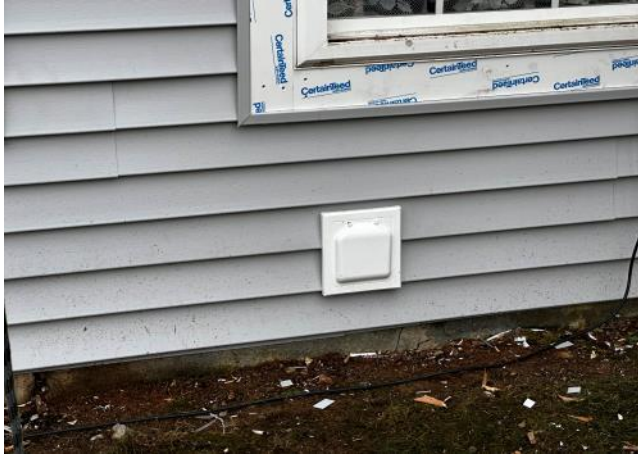
Photo #89: Overview of a new dryer vent cap installed.

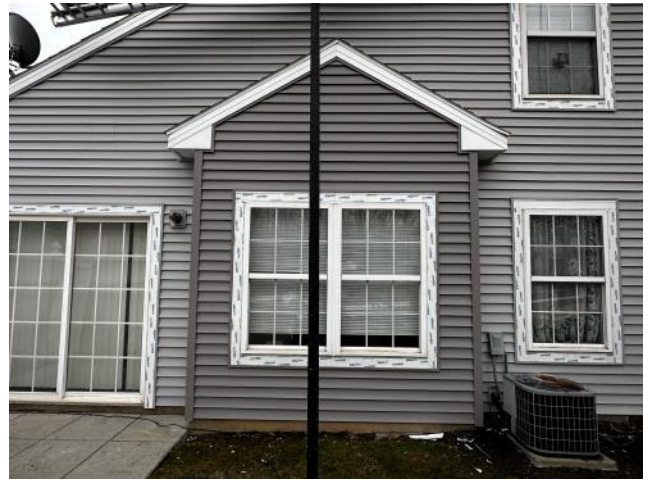
Photo #90: Overview of new vinyl siding (Granite Gray) installed at a box window.

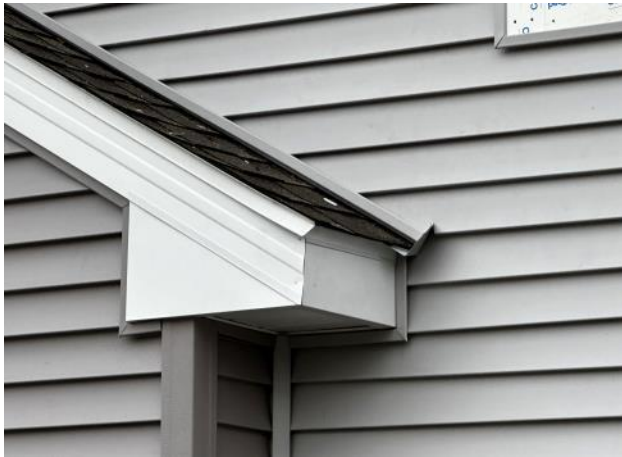
Photo #91: Overview of a new kick-out flashing installed.

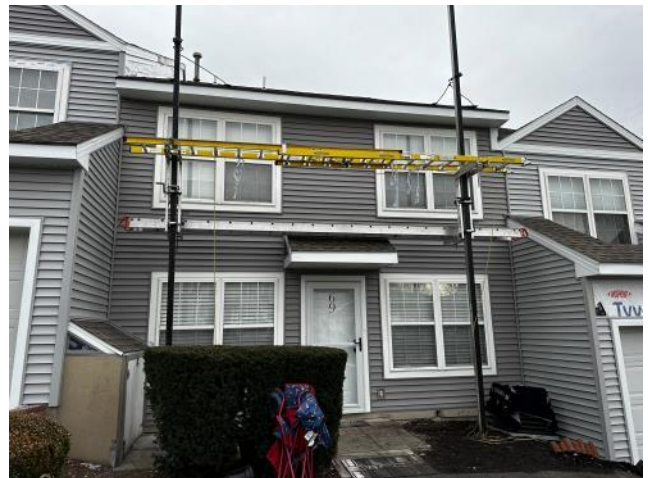
Photo #92: Overview of new vinyl siding (Granite Gray) installed at a unit where stucco was previously installed.

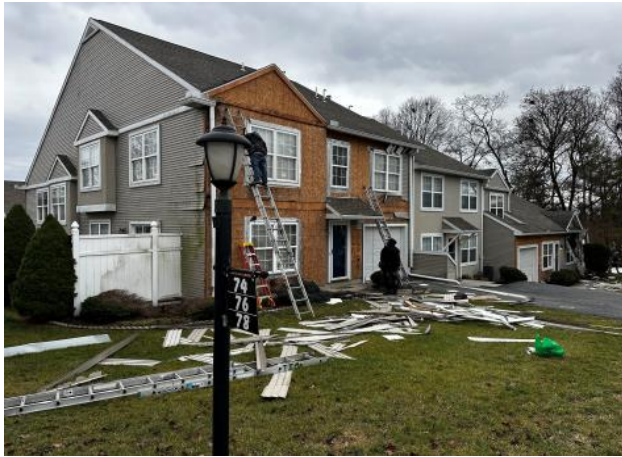
Photo #93: **Overview of Lemus Siding Crew (Blue) working at Building 7 (68-78 Courtyard Drive).**

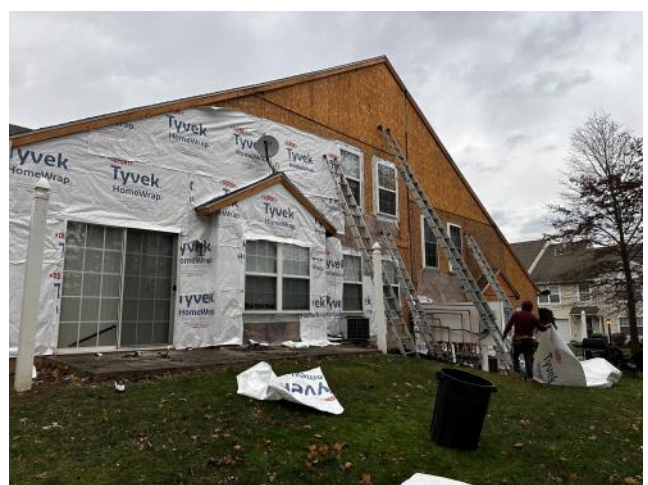
Photo #96: Overview of new Water Resistant Barrier (Tyvek) being installed.

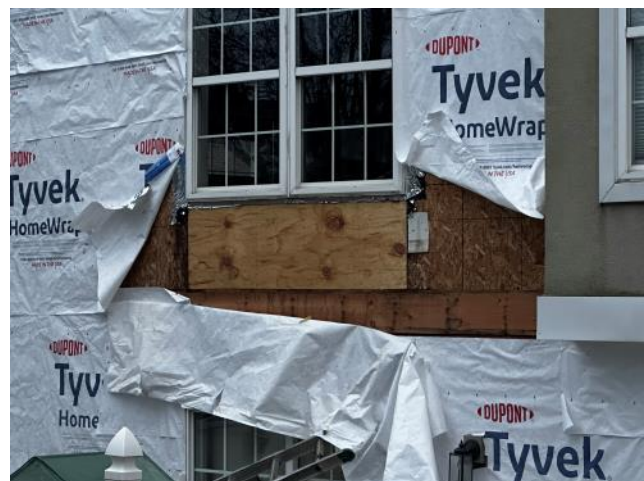
Photo #100: Overview of new sheathing installed.

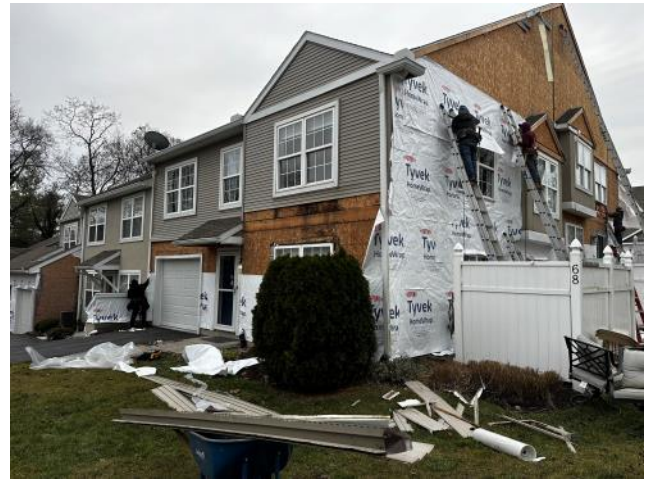
Photo #102: Overview of existing siding being removed and new Water Resistant Barrier (Tyvek) being installed.

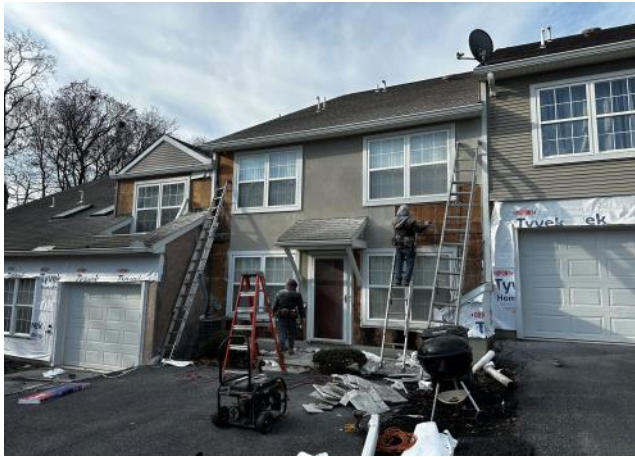
Photo #105: Overview of existing stucco being removed at Unit 70.

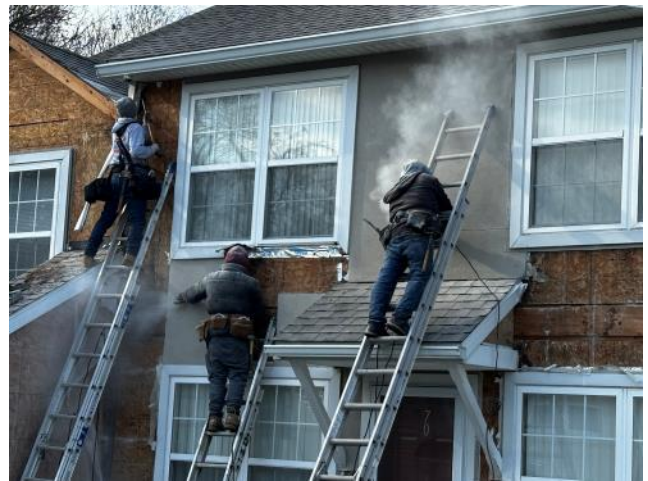
Photo #108: Overview of existing stucco being removed.

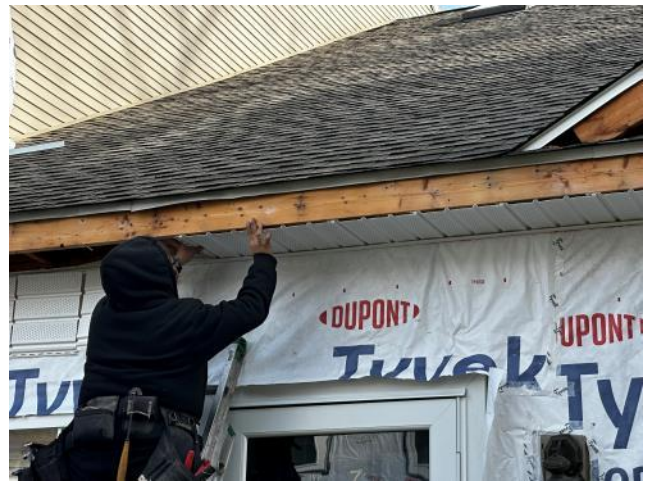
Photo #112: Overview of new intake soffit being installed.

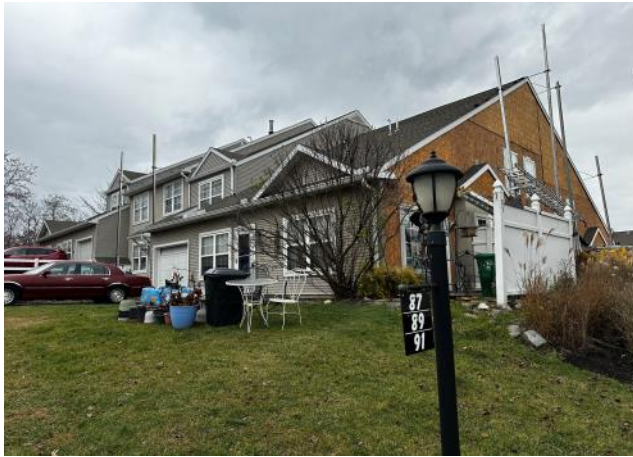
Photo #113: **Overview of Lemus Siding Crew (Green) working at Building 12 (81-91 Courtyard Drive).**

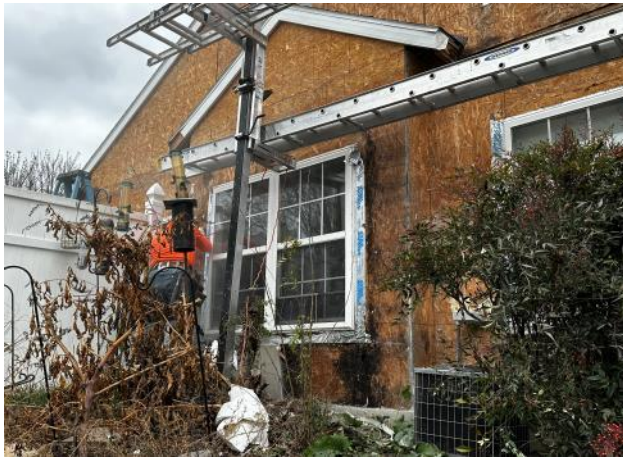
Photo #115: Overview of existing stucco being removed at the box window of Unit 87.

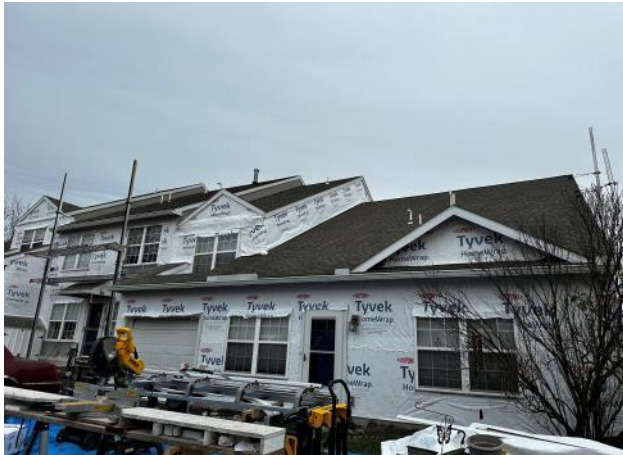
Photo #121: Overview of new Water Resistant Barrier (Tyvek) being installed.

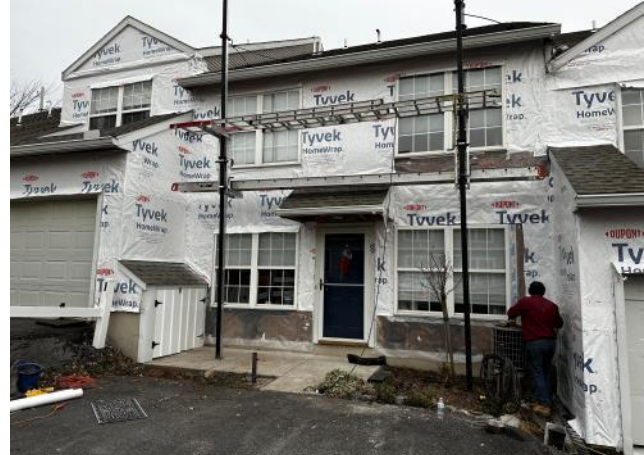
Photo #122: Overview of new Water Resistant Barrier (Tyvek) installed at Unit 89.

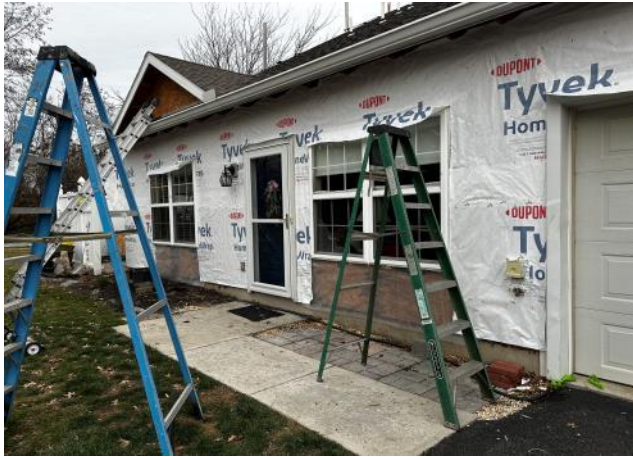
Photo #125: Overview of new Water Resistant Barrier (Tyvek) installed at Unit 91.

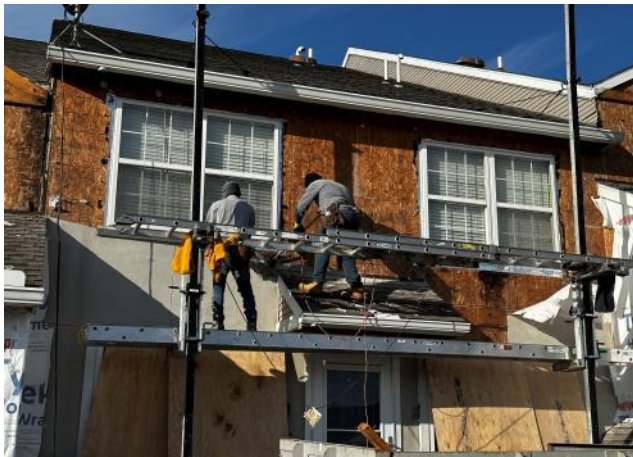
Photo #127: Overview of existing stucco being removed at Unit 83.

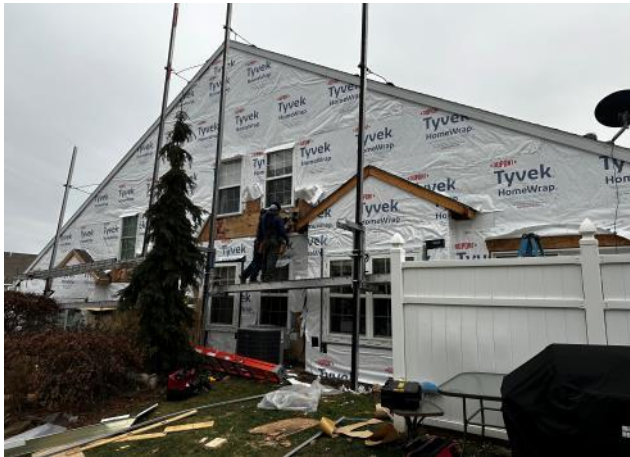
Photo #135: Overview of new Water Resistant Barrier (Tyvek) installed at Units 85 and 91.

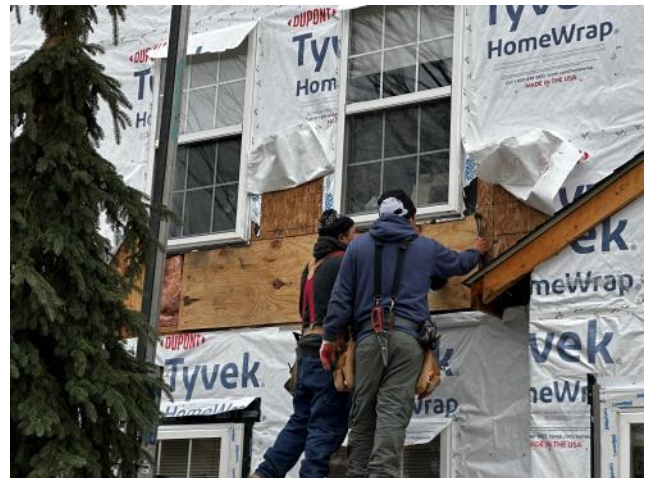
Photo #136: Overview of new sheathing being installed.

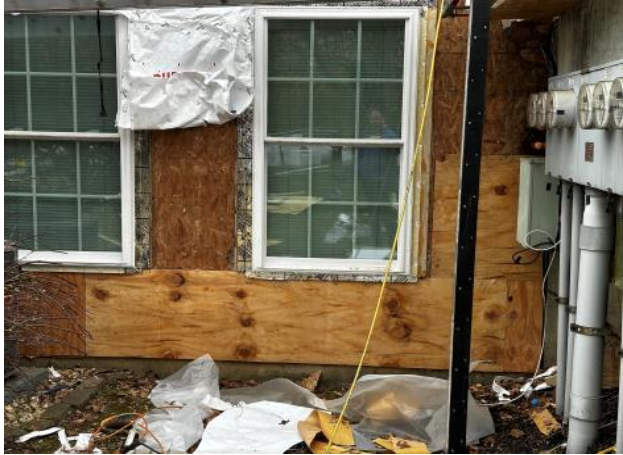
Photo #137: Overview of new sheathing installed.

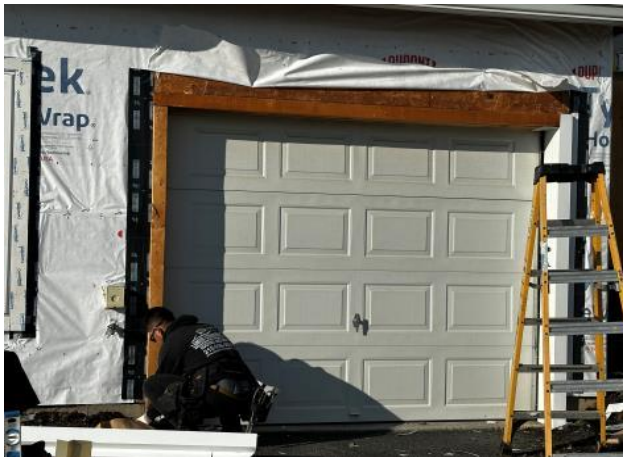
Photo #139: Overview of new flashing tape being installed at a garage door.

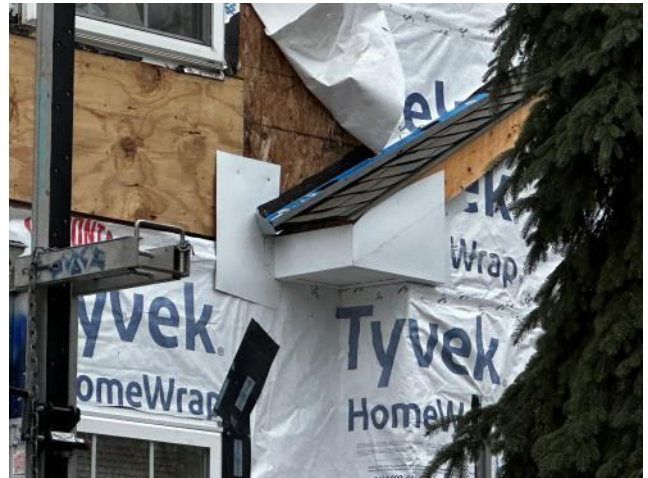
Photo #140: Overview of a new kick-out and metal flashing being installed.

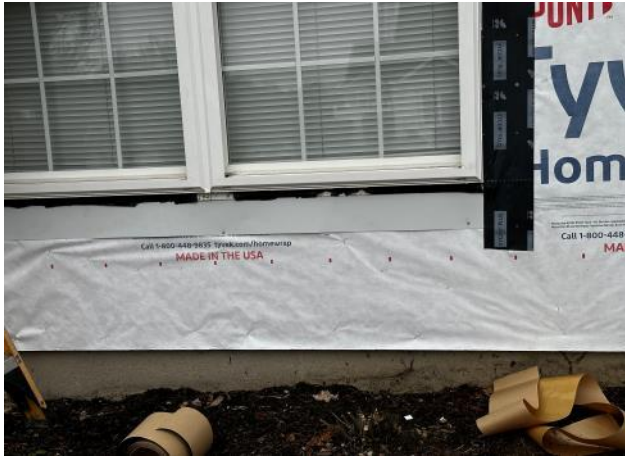
Photo #141: Overview of new metal flashing installed at the bottom of a window.

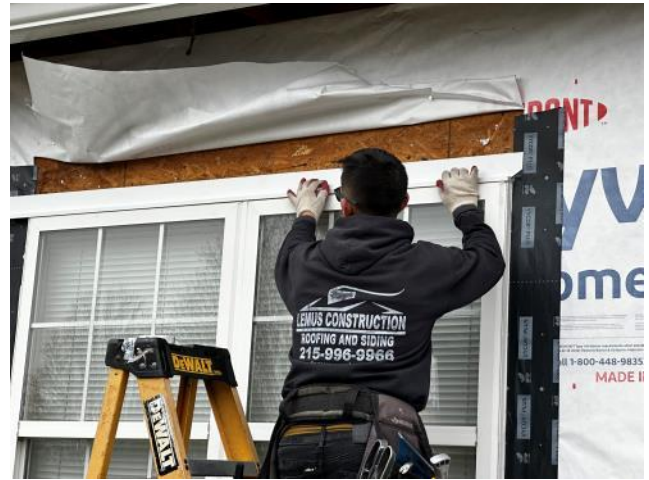
Photo #142: Overview of new metal drip cap being installed.

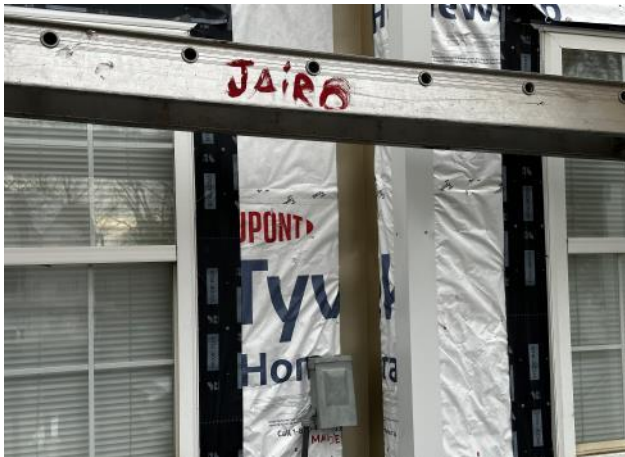
Photo #143: Overview of new metal flashing installed at an inside and an outside corners.

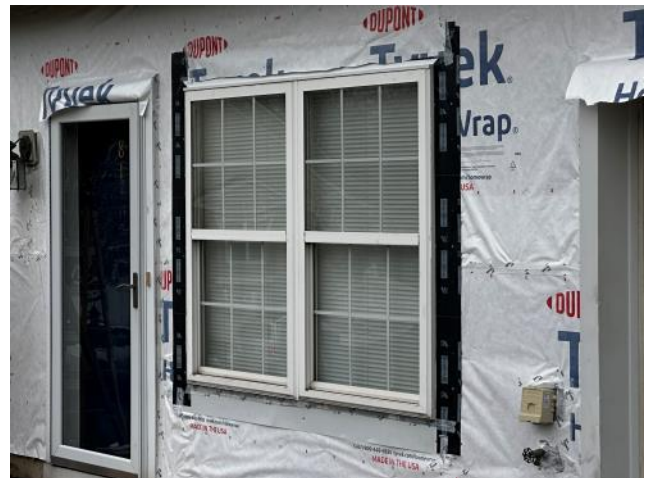
Photo #144: Overview of new metal drip cap and flashing tape being installed at a window.

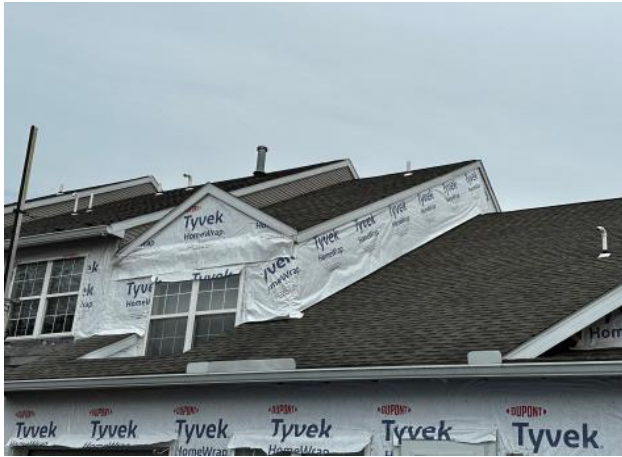
Photo #145: Overview of new Water Resistant Barrier (Tyvek) installed at a roofing sidewall.

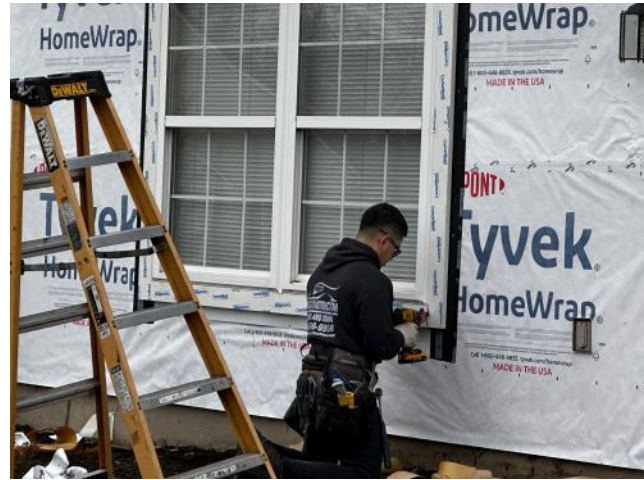
Photo #146: Overview of new azek trim being installed at a window.

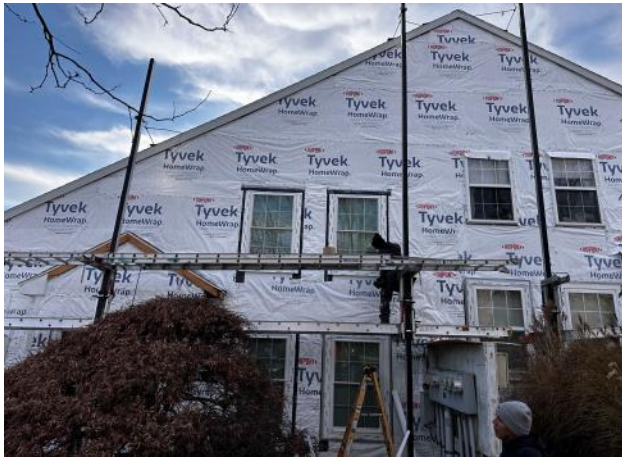
Photo #147: Overview of the windows being properly flashed.

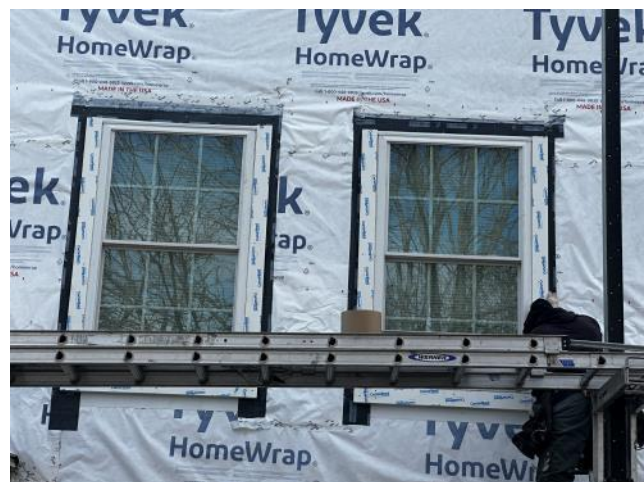
Photo #148: Overview of new flashing tape installed at the windows.

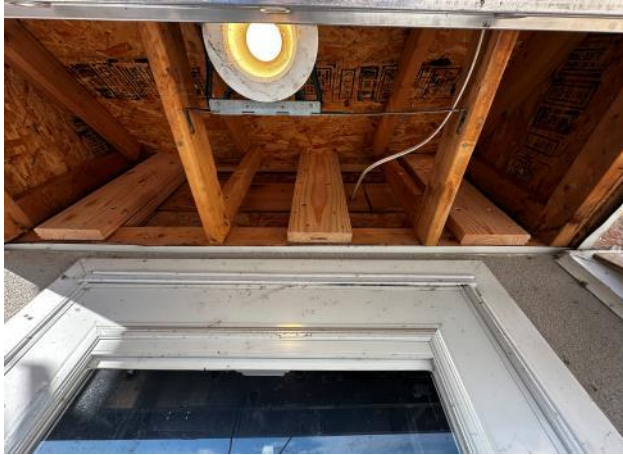
Photo #149: Overview of an entrance roof being reinforced with structural screws in order to eliminate the front brackets.

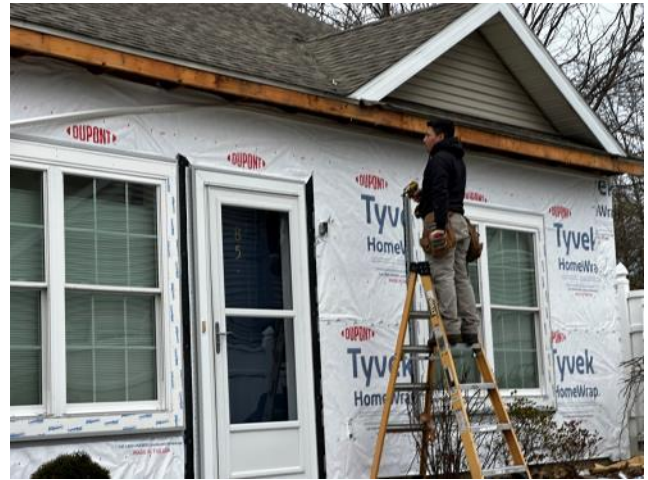
Photo #150: Overview of new intake soffit being installed.

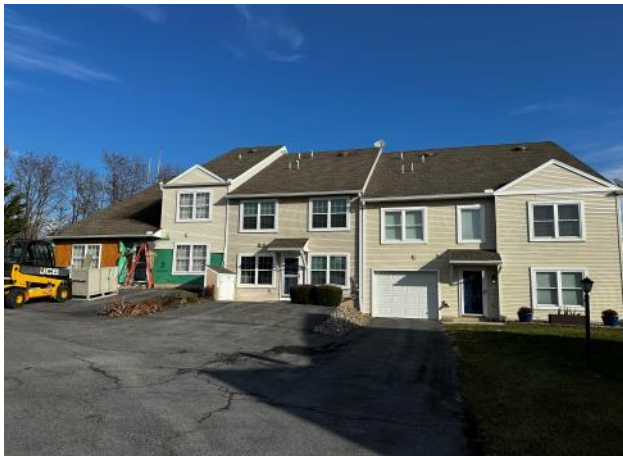
Photo #151: **Overview of Lemus Siding Crew (Green) working at Building 15 (24-28, 55-59 Courtyard Drive).**

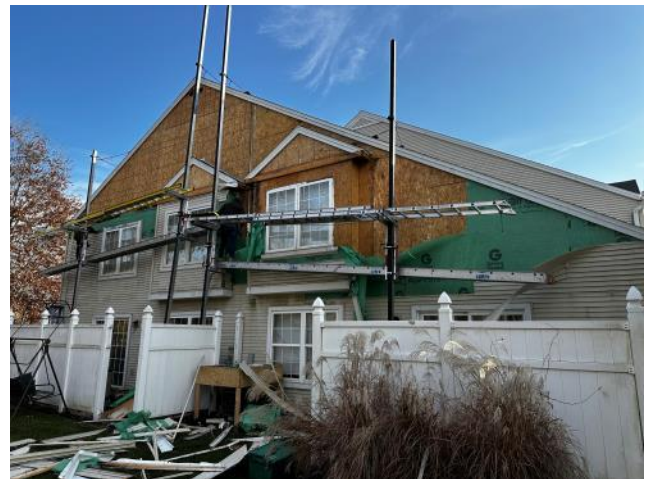
Photo #152: Overview of existing siding being removed.

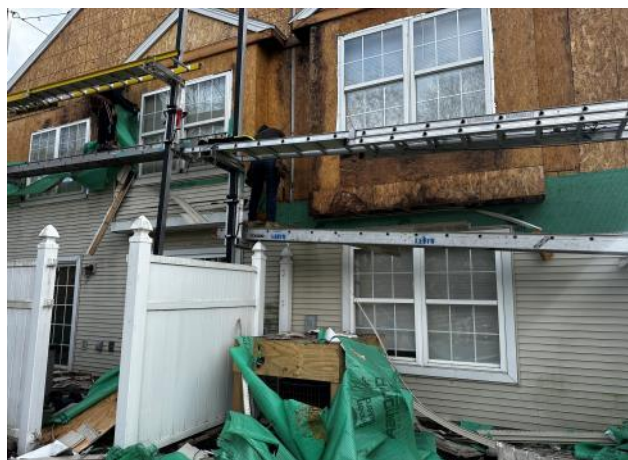
Photo #155: Overview of existing siding being removed.
