**Project:** Courtyards of Carlisle CA – Siding Project

**Project #:** 14372-04

**Date:** Jan 3, 4, 5, 2024

## Field Report 6

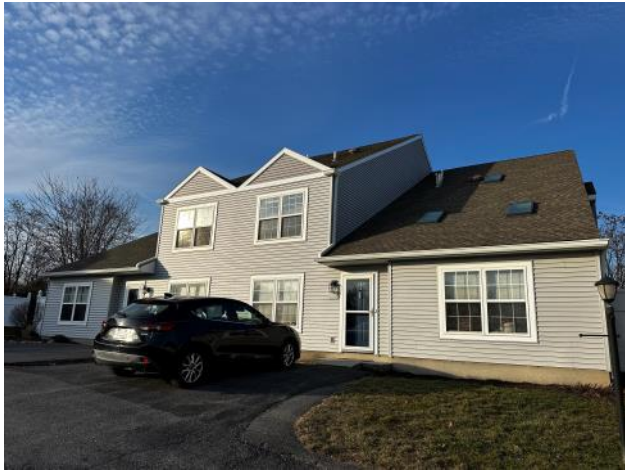
Photo #1: Overview of new gutters and downspouts installed at a front section of **Building 13**. A small section between units still needs to be completed.

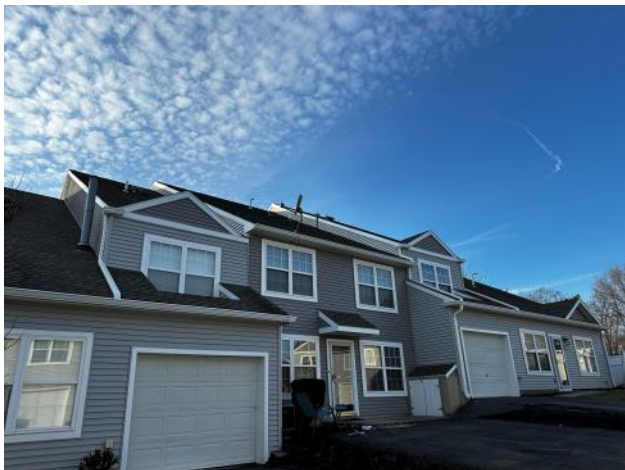
Photo #3: Overview of new gutters and downspouts installed at a front section of **Building 14**.

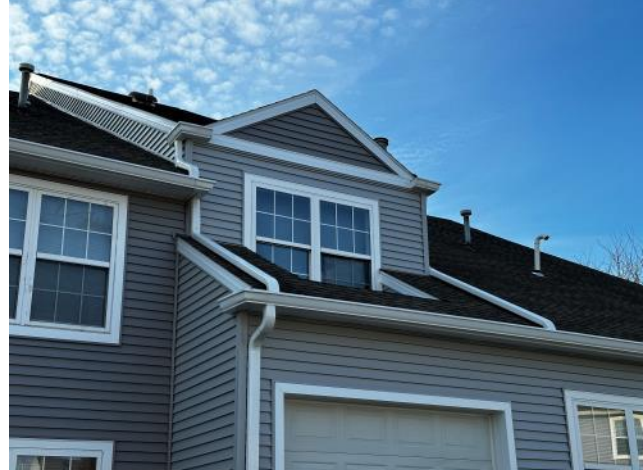
Photo #4: Overview of new downspout extensions installed.

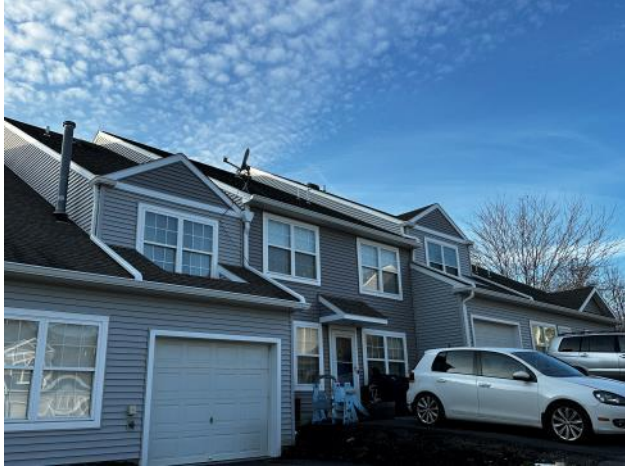
Photo #5: Overview of new gutters and downspouts installed at a front section of **Building 12**.

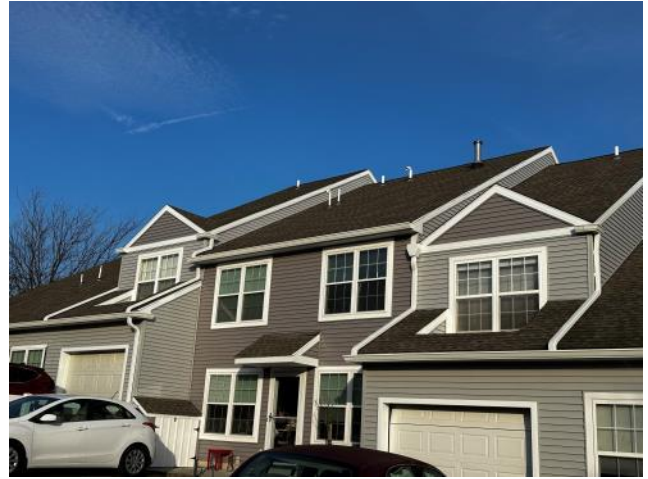
Photo #6: Overview of new gutters and downspouts installed at the other front section of the Building.

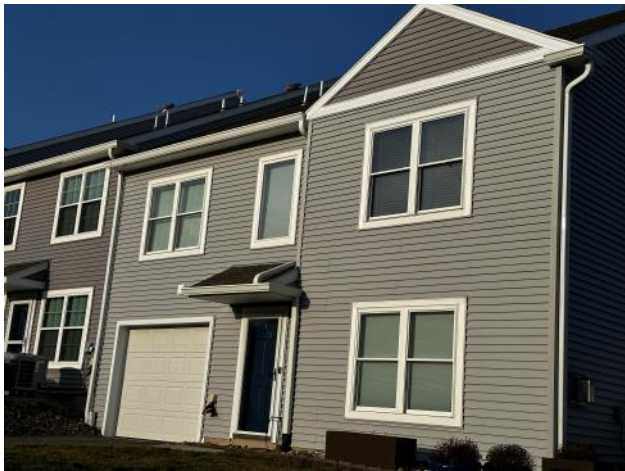
Photo #7: Overview of new gutters and downspouts installed at a front section of **Building 15**.

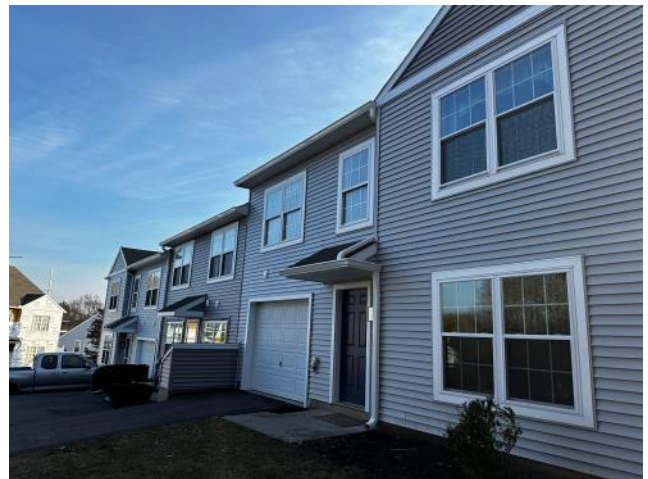
Photo #8: Overview of new gutters and downspouts installed at the other front section of the Building.

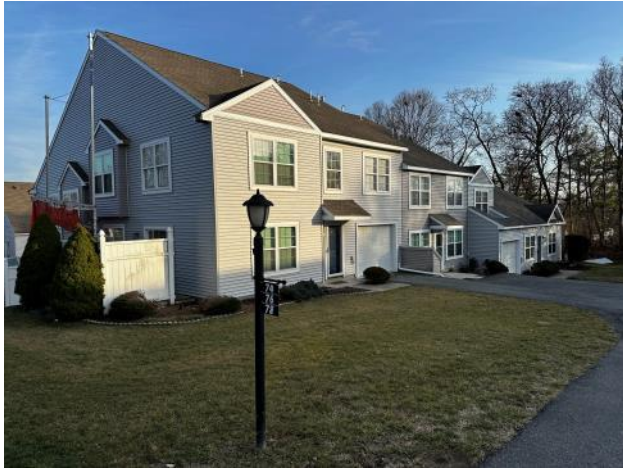
Photo #9: Overview of new vinyl siding installation completed at **Building 7 (68-78 Courtyard Drive)**.

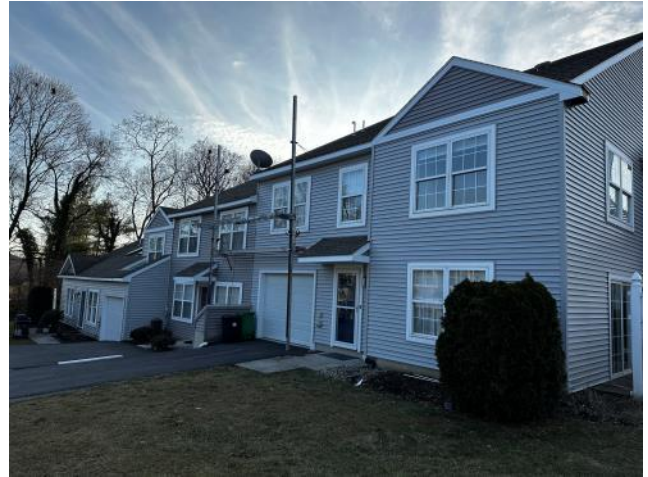
Photo #10: Overview of new vinyl siding installed at the other front side of Building 7.

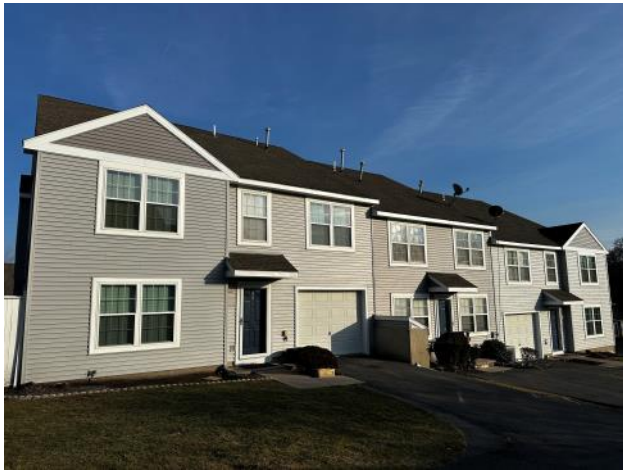
Photo #11: Overview of new vinyl siding installation completed at **Building 16 (43-53 Courtyard Drive)**.

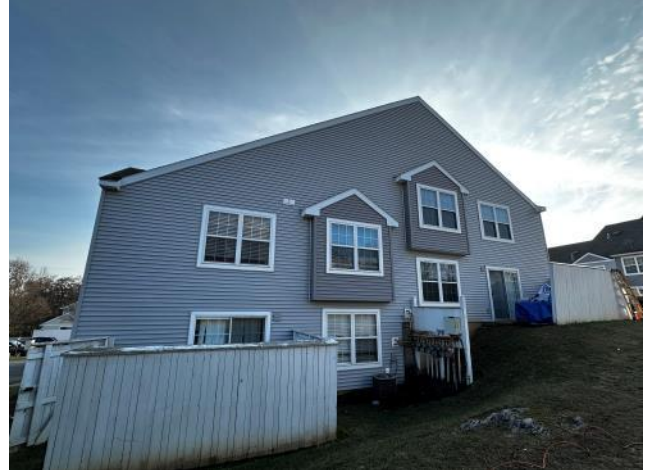
Photo #12: Overview of new vinyl siding installed at a main side of the Building, including at the box windows (Granite Gray).

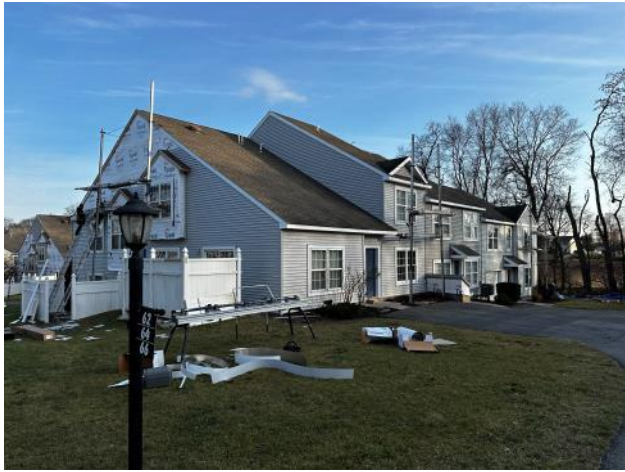
Photo #13: **Overview of Lemus Siding Crew (Blue) working at Building 6 (56-66 Courtyard Drive).**

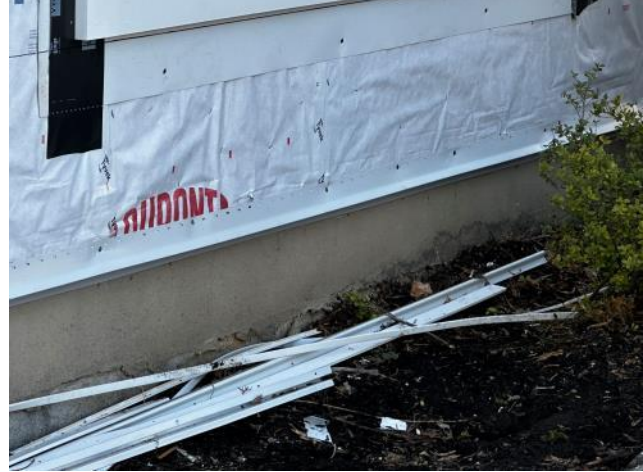
Photo #14: Overview of new starter strip installed.

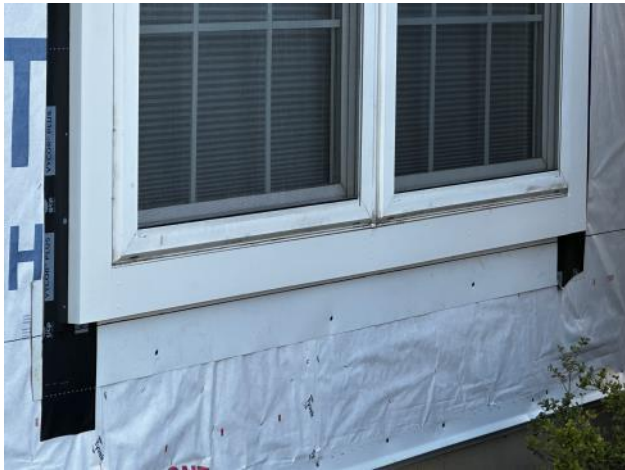
Photo #15: Overview of new metal flashing installed at the bottom of a window.

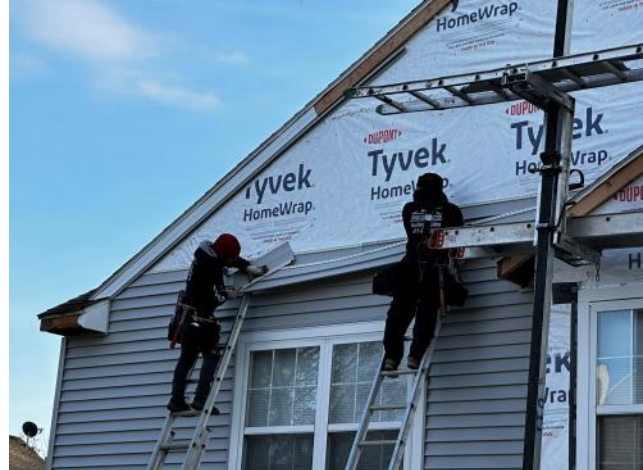
Photo #16: Overview of new vinyl siding being installed at a side section.

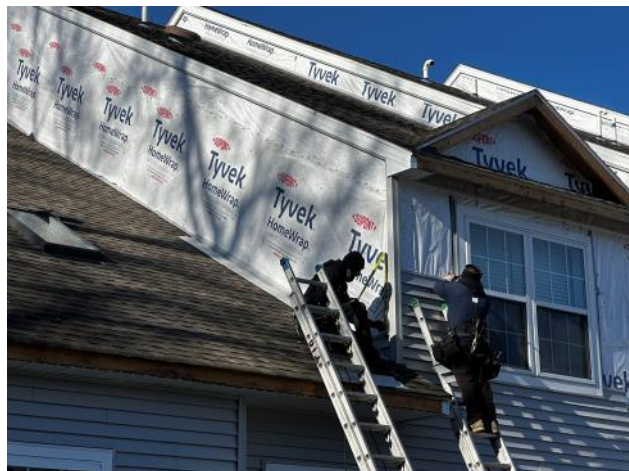
Photo #17: Overview of new vinyl siding being installed at a front section.

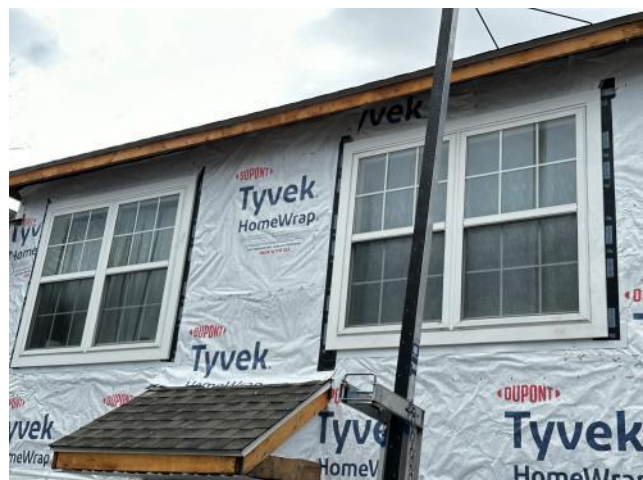
Photo #18: Overview of windows properly flashed and new pvc trim installed as well.

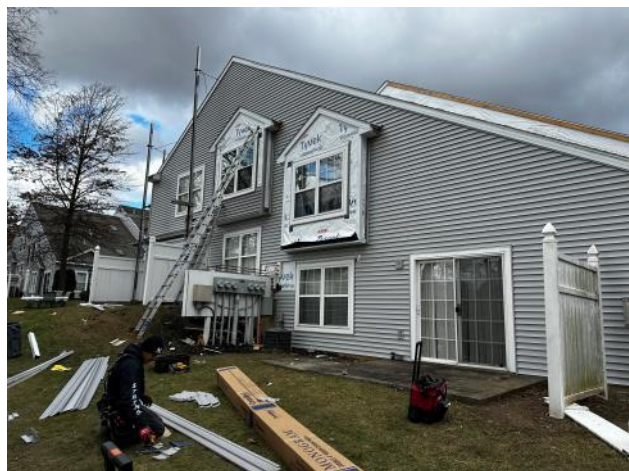
Photo #19: Overview of new vinyl siding being installed at the box windows of a main side of the Building.

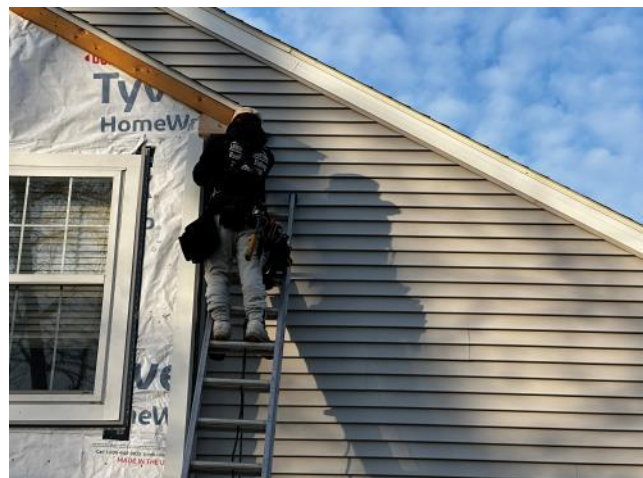
Photo #20: Overview of a new kick-out flashing being installed.

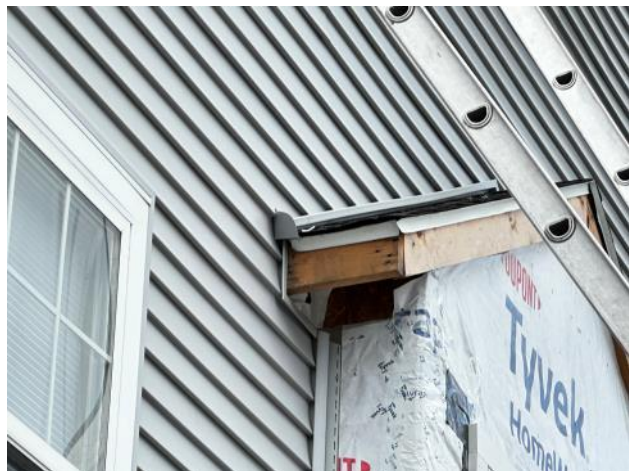
Photo #21: Overview of a new kick-out flashing installed.

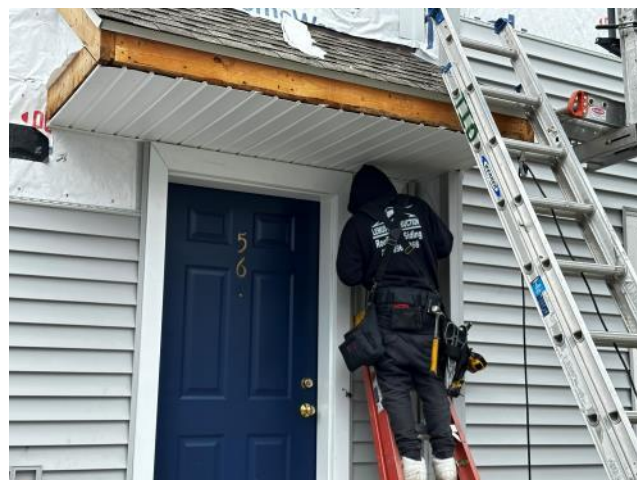
Photo #22: Overview of new intake soffit being installed at a entrance.

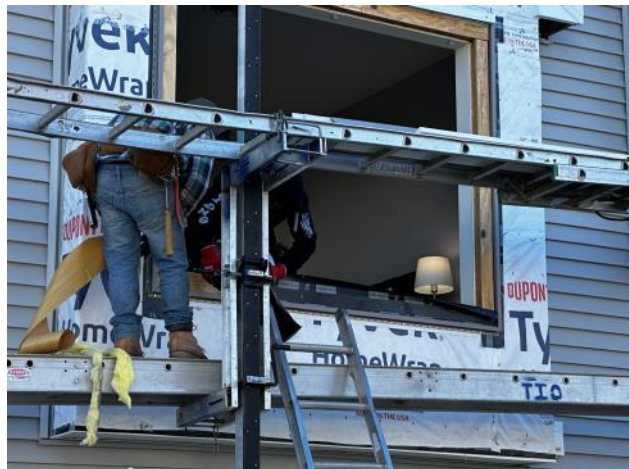
Photo #23: Overview of a new window being installed at Unit 56. New bottom flashing was being installed before installing the new window.

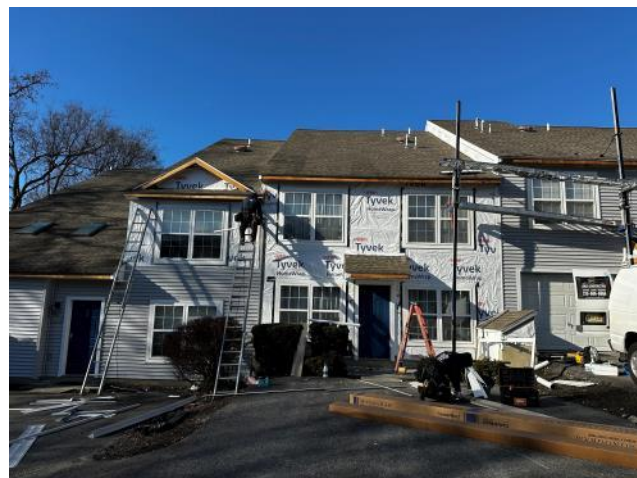
Photo #24: Overview of new vinyl siding being installed at a front section of the Building.

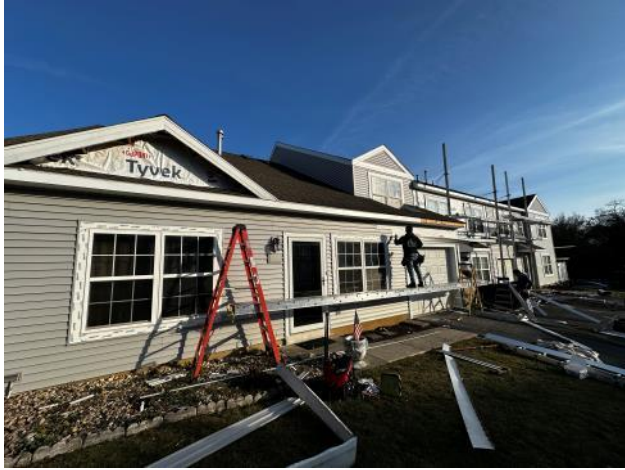
Photo #25: **Overview of Lemus Siding Crew (Yellow) working at Building 17 (2-6, 37-41 Courtyard Lane/Courtyard Drive).**

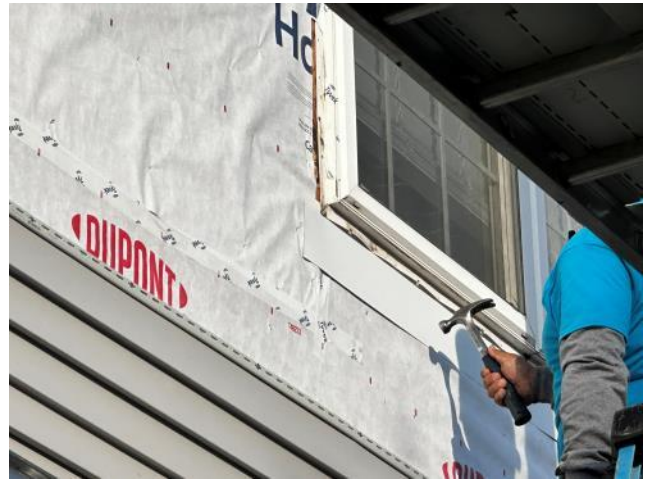
Photo #26: Overview of new metal flashing installed at the bottom of a window.

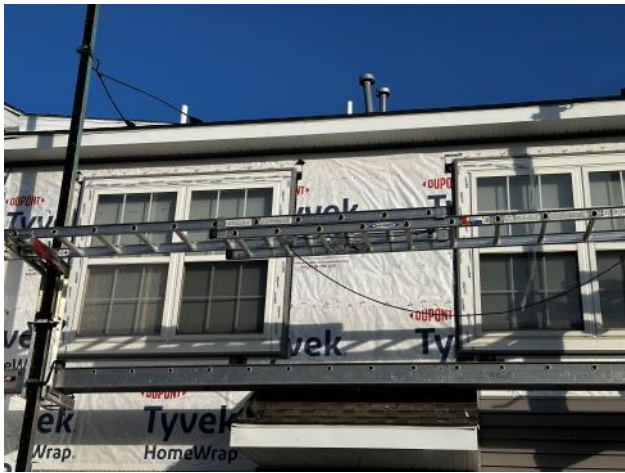
Photo #27: Overview of windows properly flashed and new pvc trim installed as well.

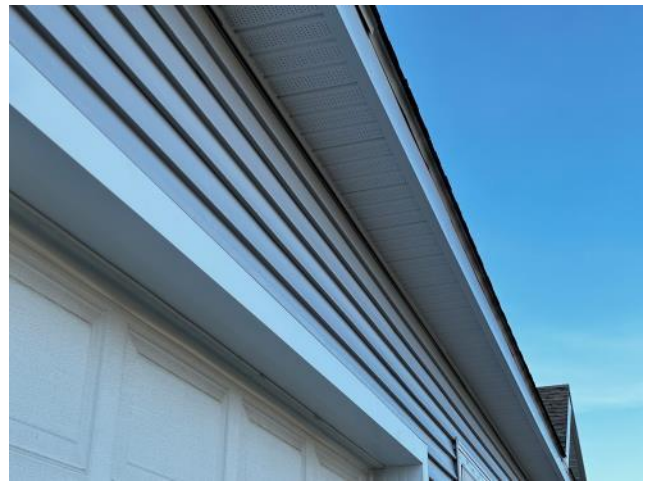
Photo #28: Overview of new intake soffit installed.

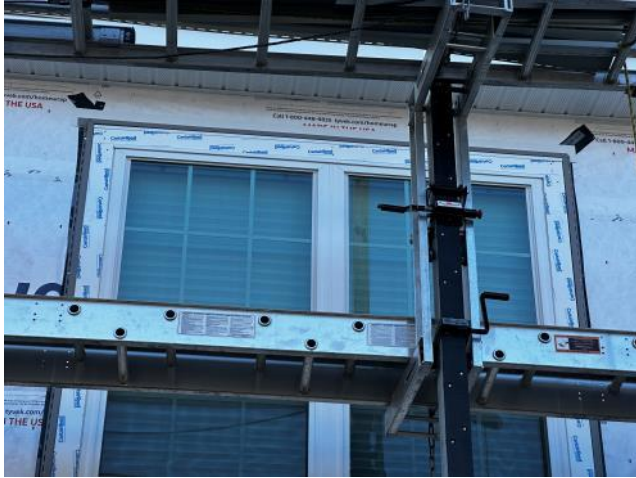
Photo #29: Overview of new j-channel installed around a window.

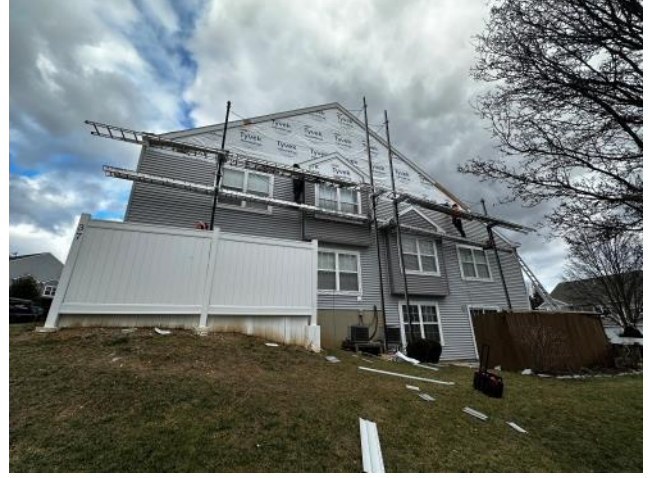
Photo #30: Overview of new vinyl siding being installed at a main side of the Building.

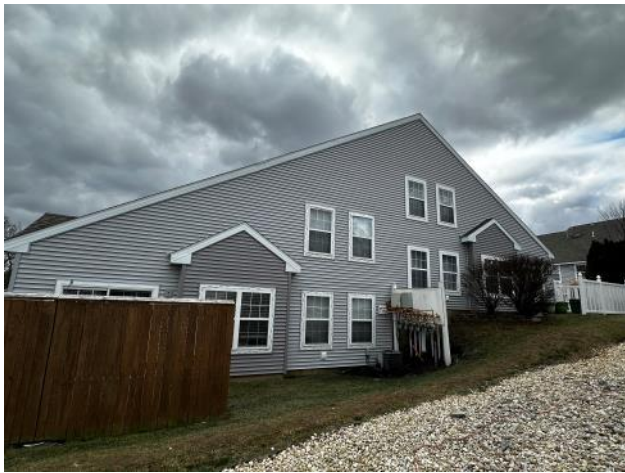
Photo #31: Overview of new vinyl siding completed at the other main side of the Building.

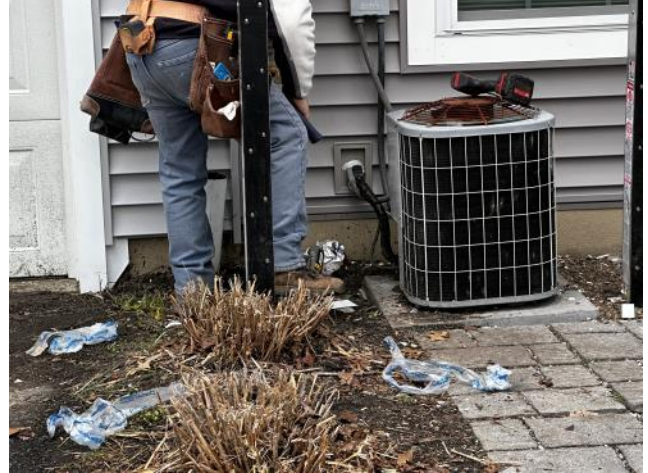
Photo #32: All penetrations are being properly sealed after new siding is installed.

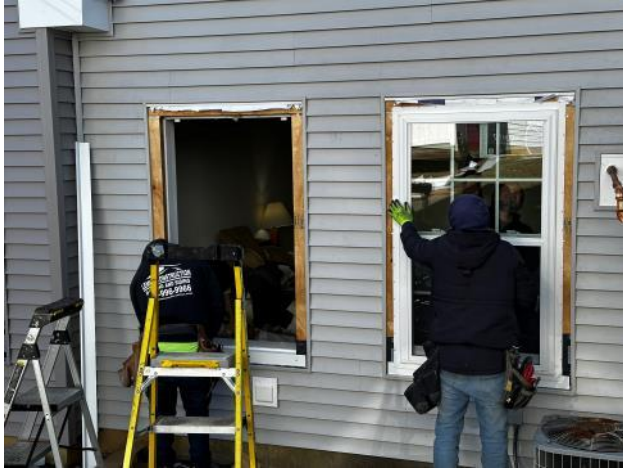
Photo #33: Overview of new windows being installed at Unit 6.

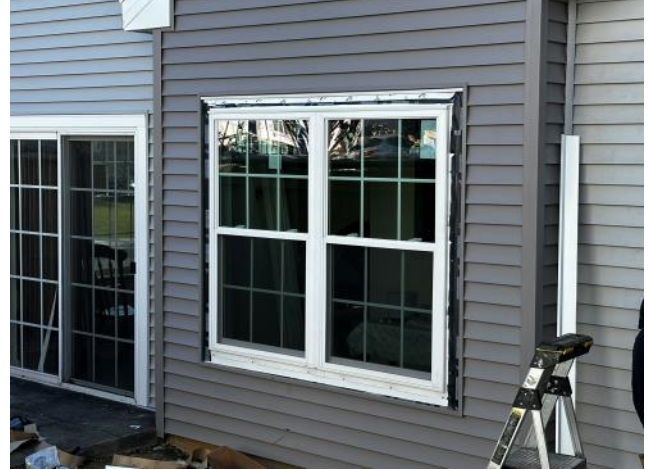
Photo #34: Overview of another new window installed at Unit 6

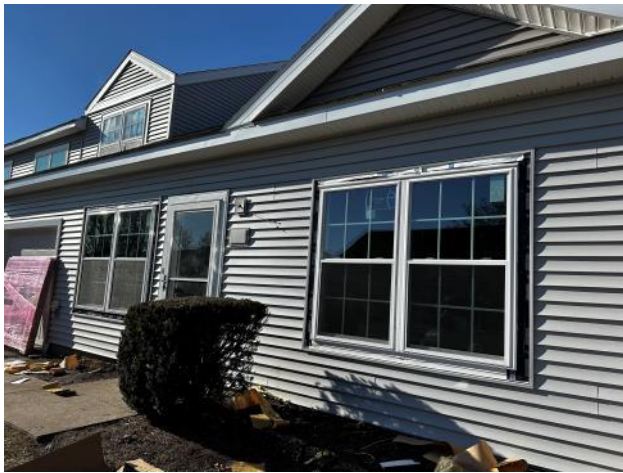
Photo #35: Overview of other new windows installed at the front of Unit 6.

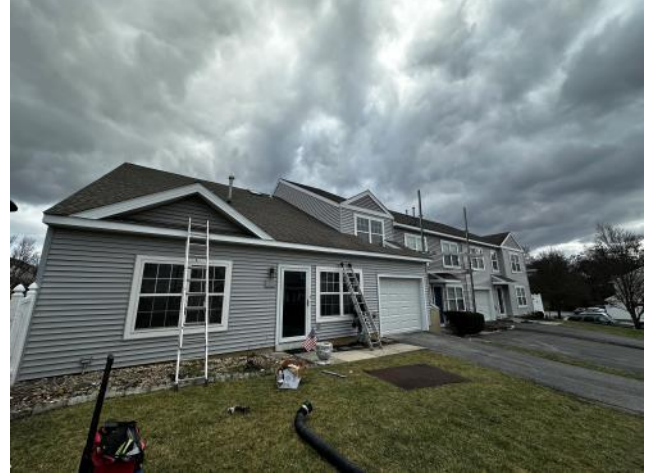
Photo #36: Overview of new vinyl siding being completed at Building 17.

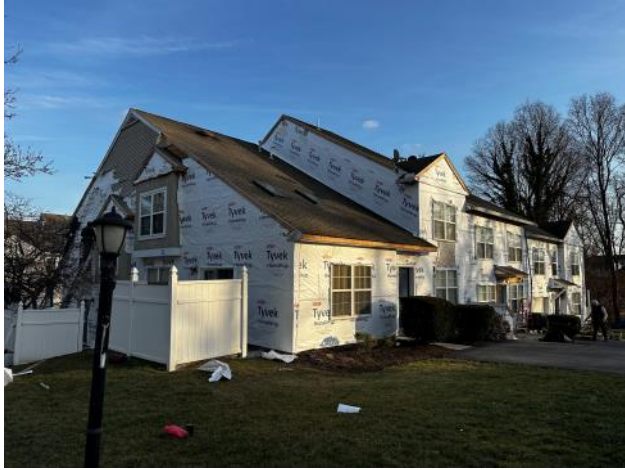
Photo #37: **Overview of Lemus Siding Crew (Blue) working at Building 5 (44-54 Courtyard Drive).**

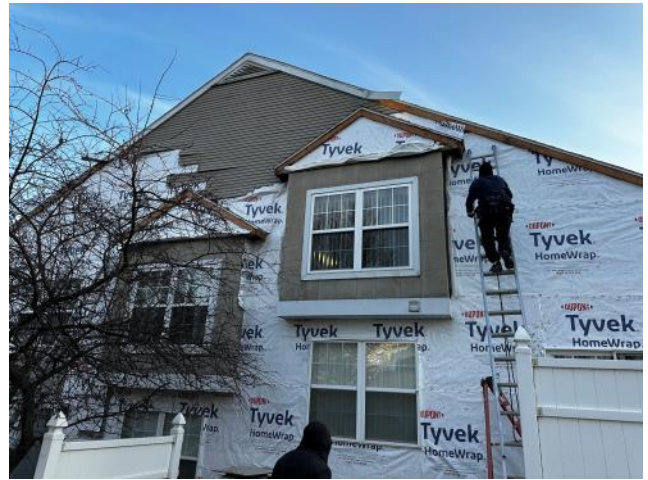
Photo #38: Overview of existing stucco being removed at the box windows.

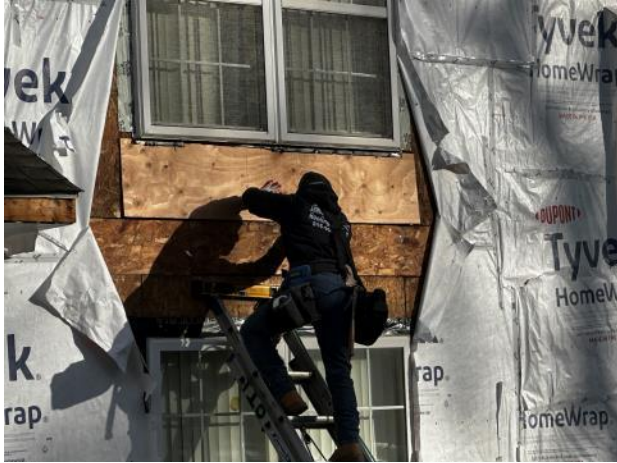
Photo #45: Overview of new sheathing being installed below a window.

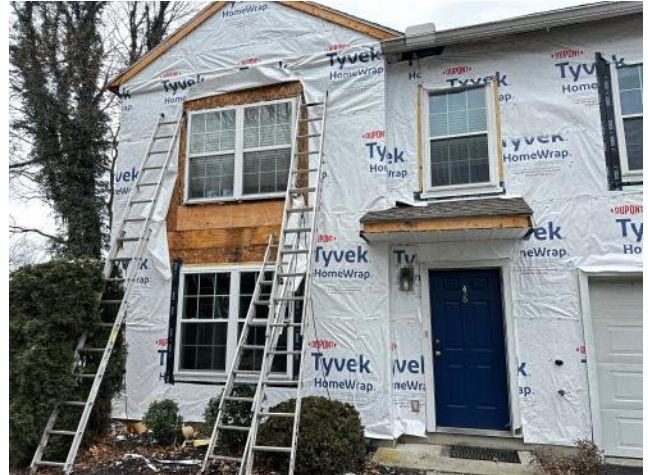
Photo #46: Overview of new sheathing installed at an upper window.

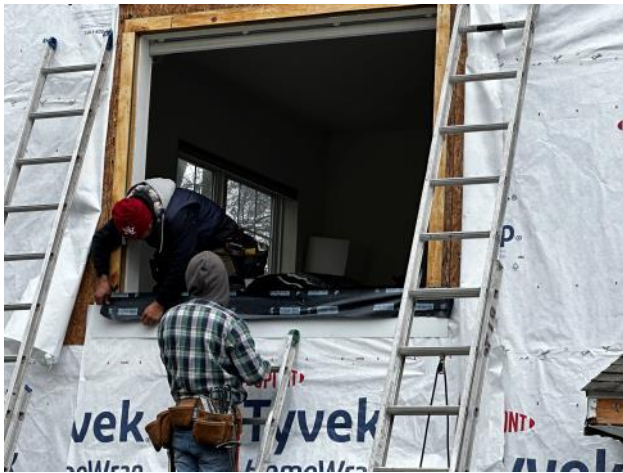
Photo #47: Overview of a new window being installed at Unit 48. New bottom flashing was being installed before installing the new window.

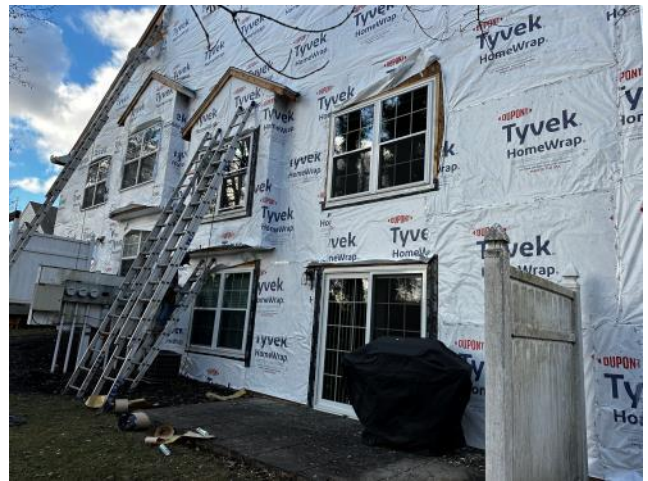
Photo #48: Overview of new windows installed at Unit 48

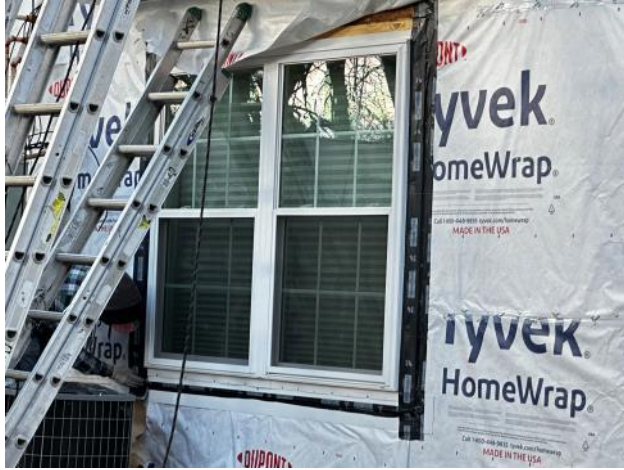
Photo #49: Overview of a new window being properly flashed.

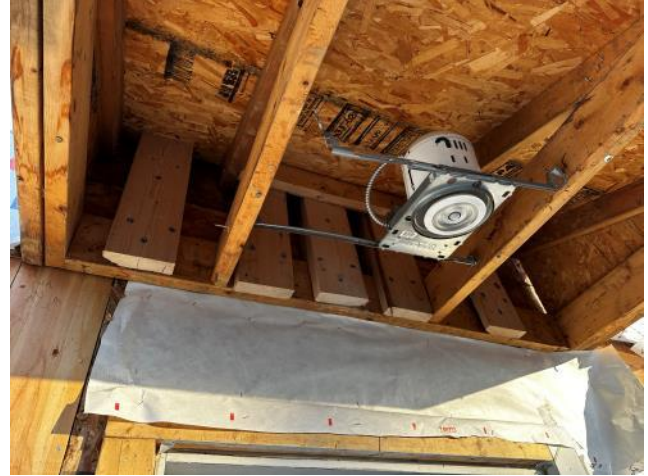
Photo #50: Overview of new structural screws and brackets to reinforced the small entrance roof.

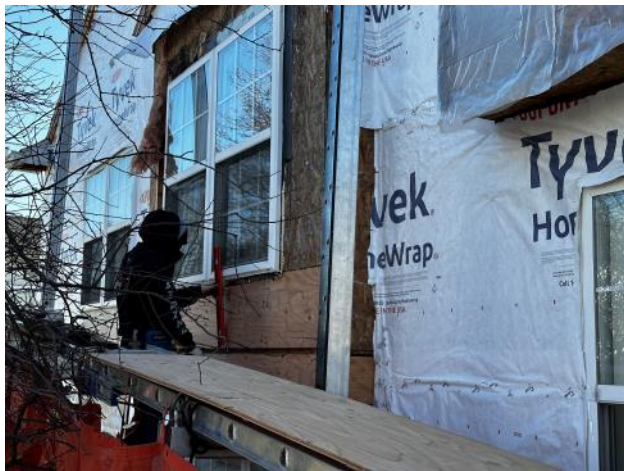
Photo #51: Overview of new sheathing being installed below a box window.

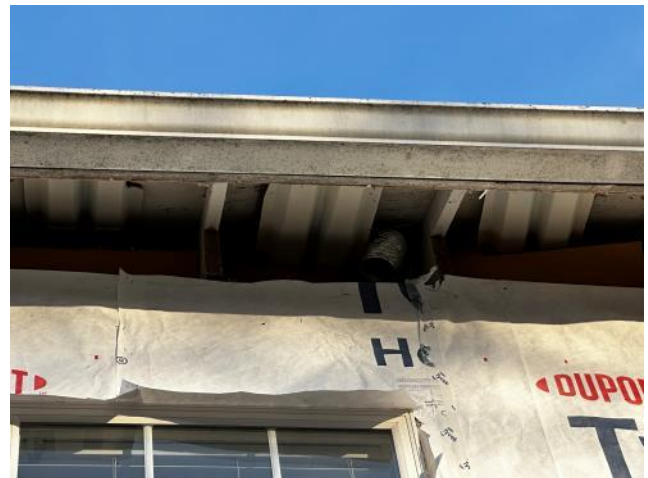
Photo #52: Overview of existing baffles that were observed in the Building.

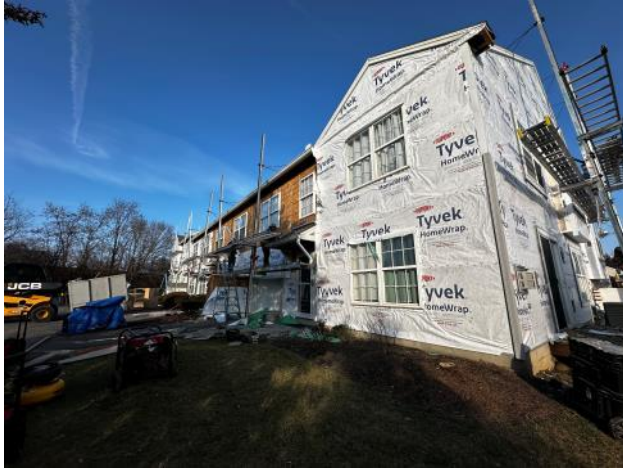
Photo #53: **Overview of Lemus Siding Crew (Green) working at Building 18 (8-22 Courtyard Lane).**

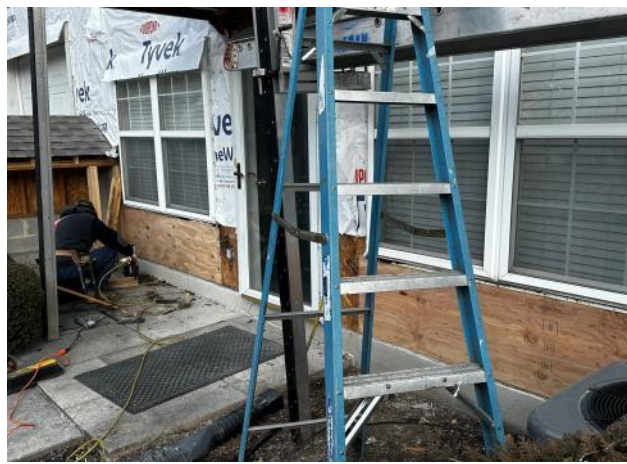
Photo #58: Overview of new sheathing being installed below lower windows.

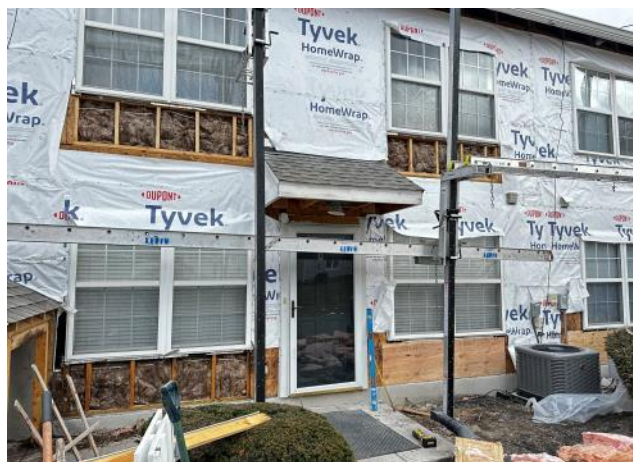
Photo #59: Overview of new insulation and new sheathing being installed.

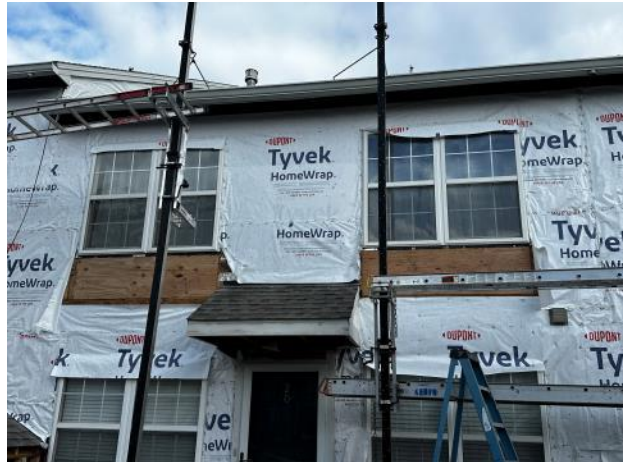
Photo #60: Overview of new sheathing being installed below upper windows.

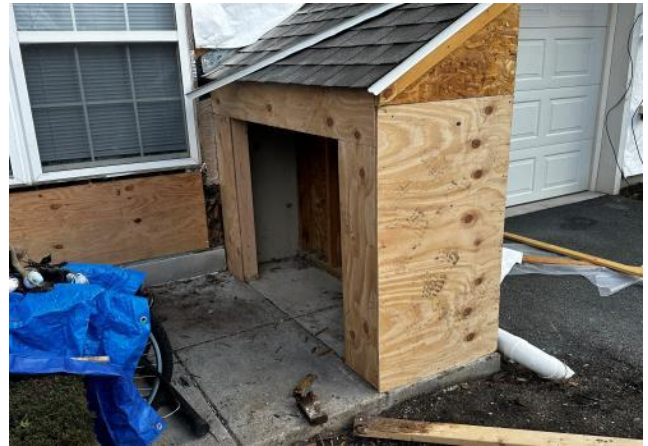
Photo #62: Overview of new sheathing and studs installed at a exterior shed.

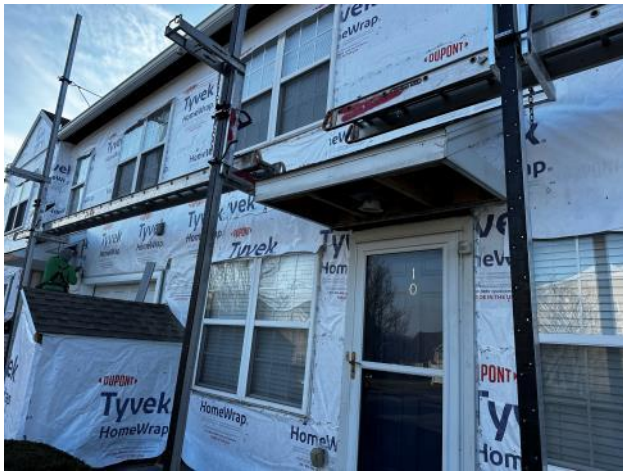
Photo #63: Overview of an entrance roof being reinforced with structural screws in order to eliminate the front brackets.

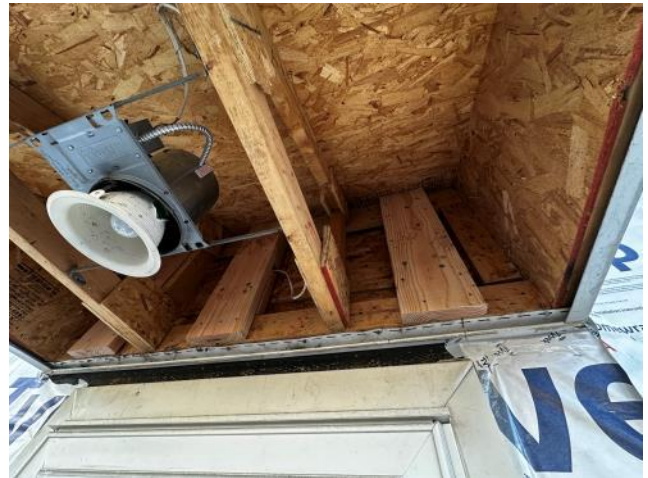
Photo #64: Overview of new structural screws and brackets to reinforced the small entrance roof.

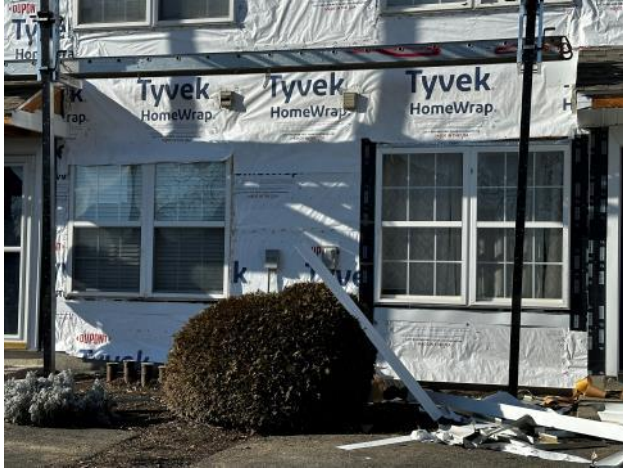
Photo #65: Overview of a window being properly flashed.

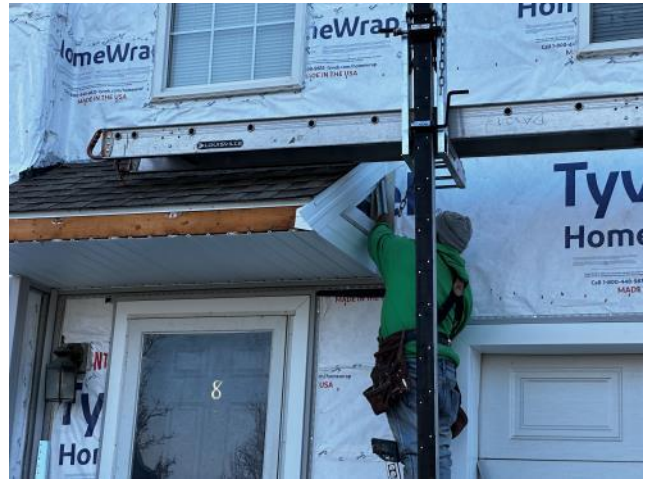
Photo #66: Overview of new metal wrap being installed at a rake section.

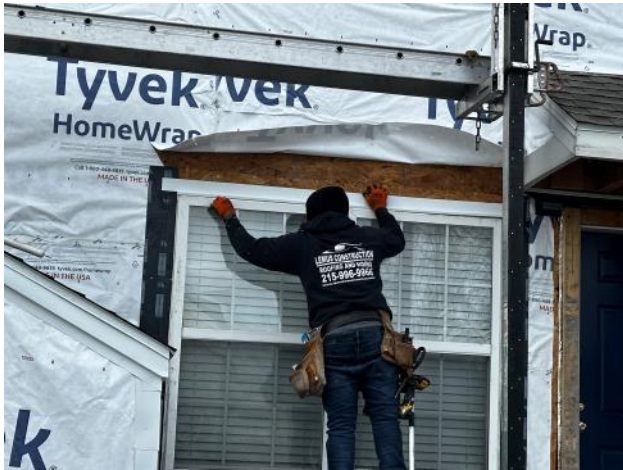
Photo #67: Overview of a new metal drip cap being installed at a window.

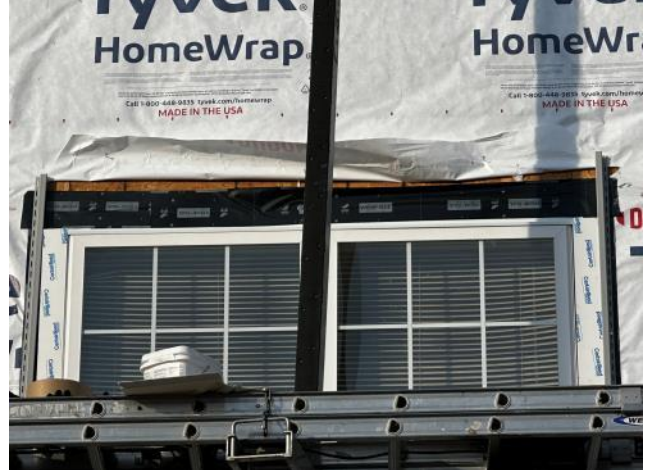
Photo #68: Overview of new flashing tape being installed at the header of a window.

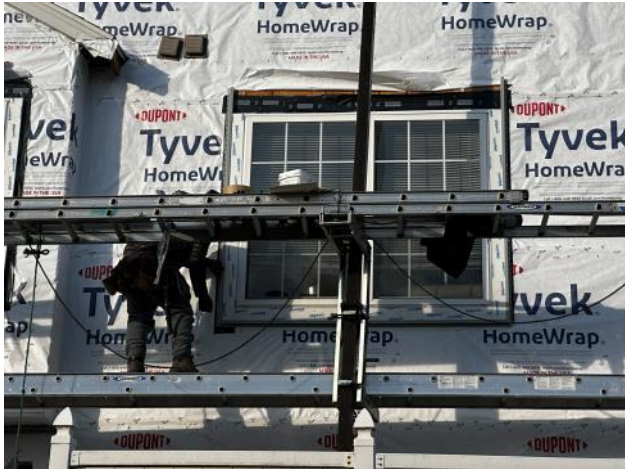
Photo #69: Overview of new j-channel being installed around a window.

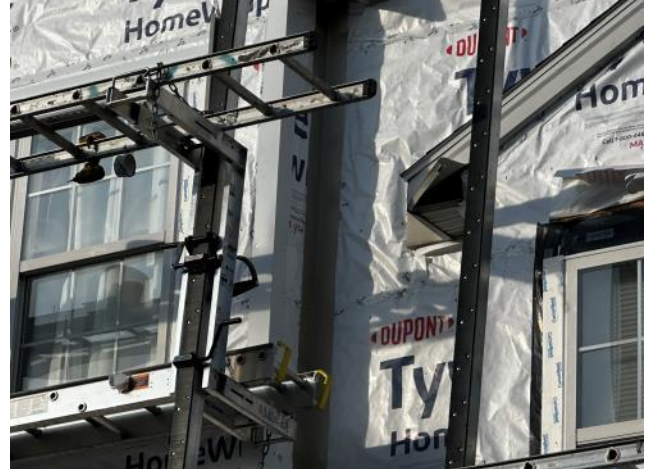
Photo #70: Overview of new outer and inner metal flashing corners installed.

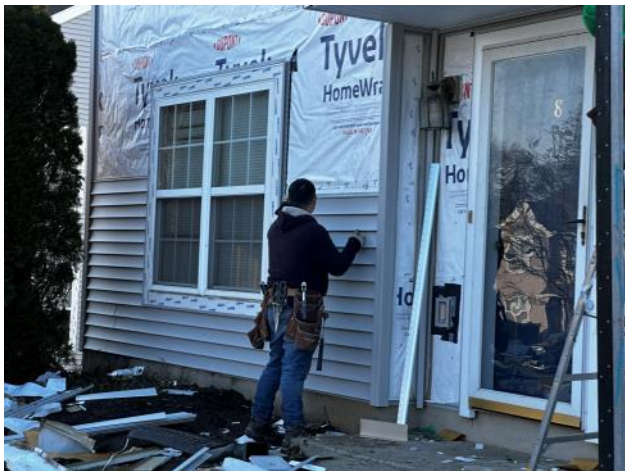
Photo #71: Overview of new vinyl flashing being installed.

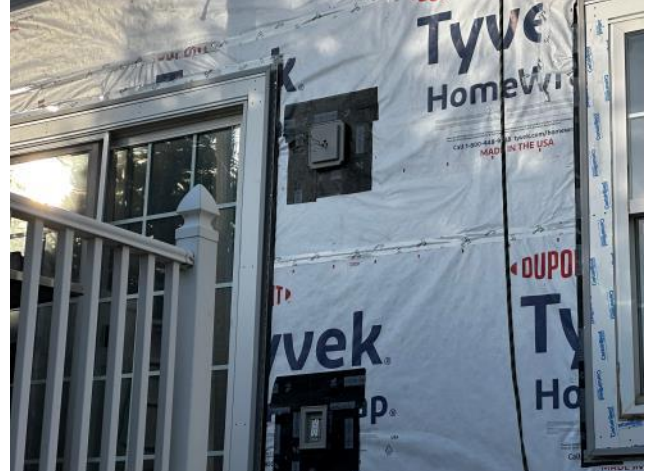
Photo #72: Overview of wall penetrations properly flashed.

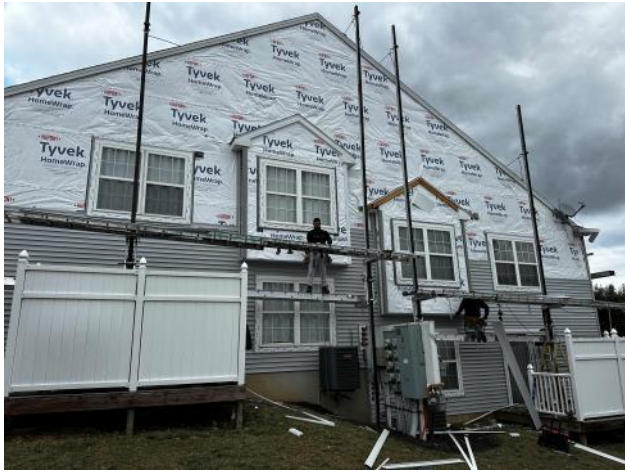
Photo #73: Overview of new vinyl siding being installed at a main side of the Building.

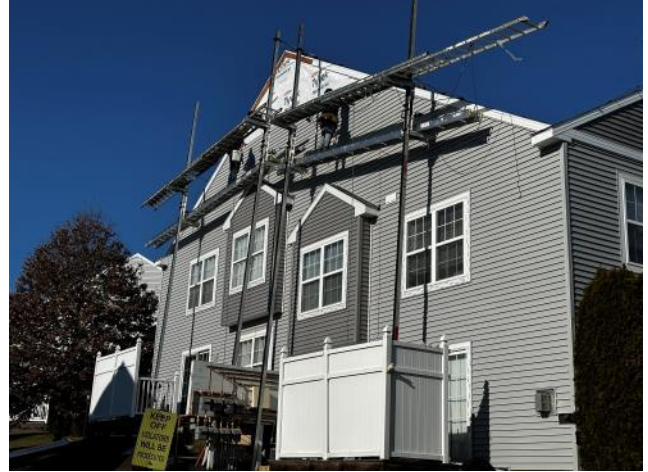
Photo #74: Overview of new vinyl siding (Granite Gray) installed at the box windows.

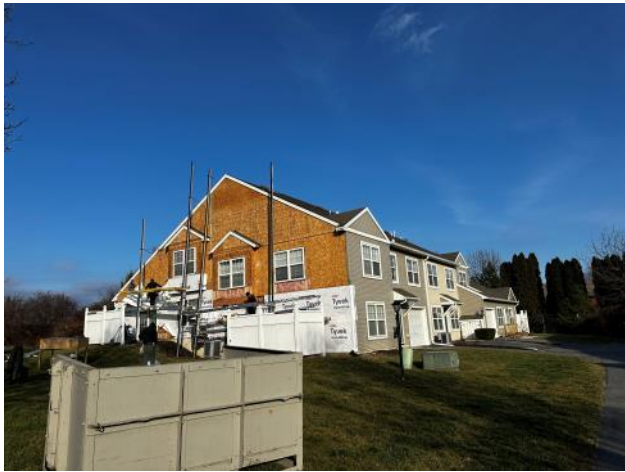
Photo #75: Overview of Lemus Siding Crew (Yellow) working at Building 19 (19-29 Courtyard Lane).

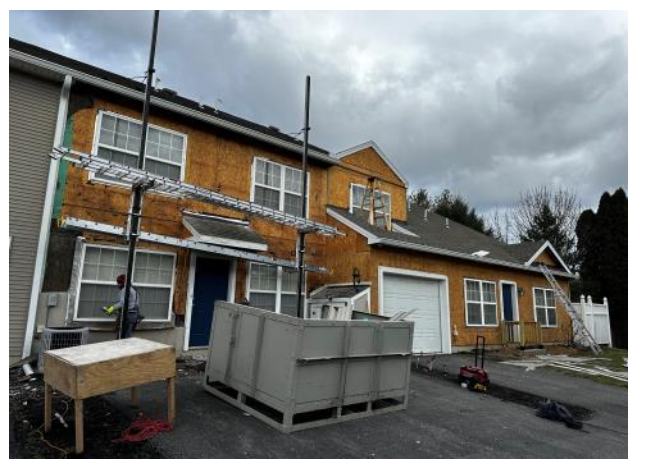
Photo #76: Overview of the existing siding/stucco being removed at the front of the Building.

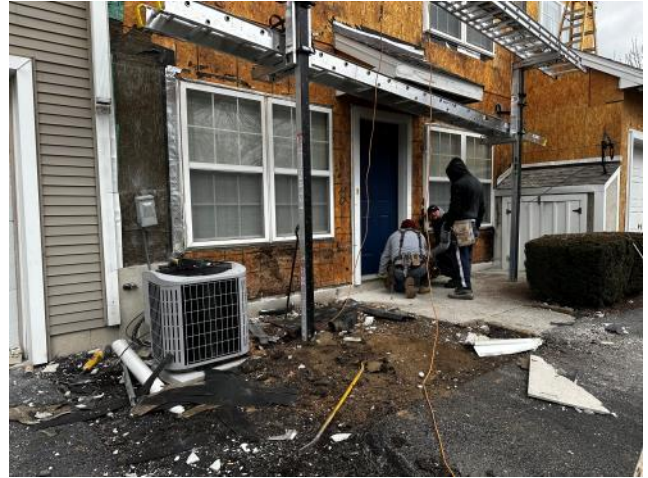
Photo #78: Overview of existing stucco being removed at a front section.

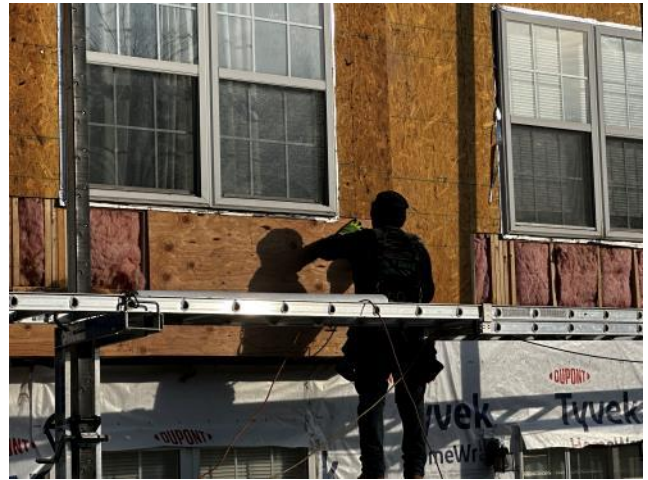
Photo #86: Overview of new sheathing being installed below a box window.

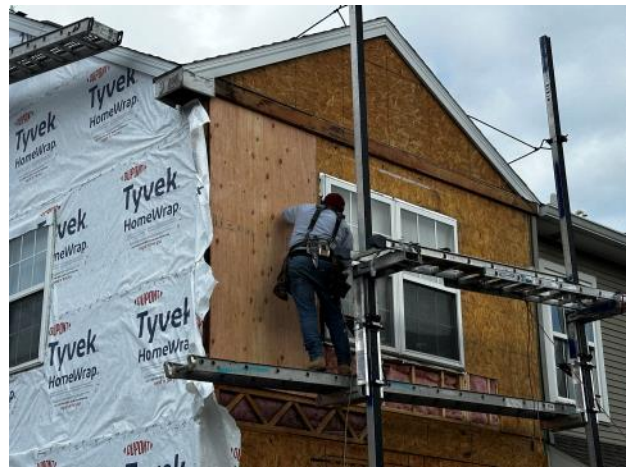
Photo #88: Overview of new sheathing being installed.

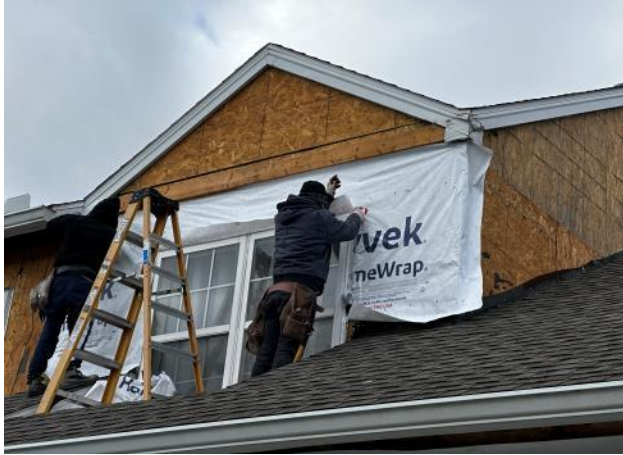
Photo #89: Overview of new Water Resistant Barrier (Tyvek) being installed.

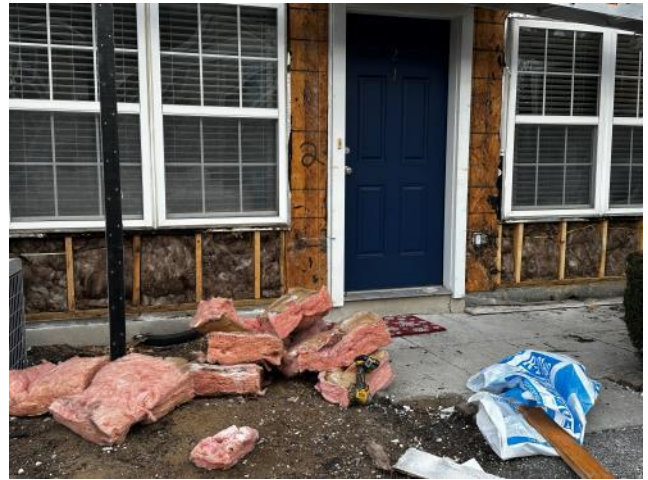
Photo #90: Overview of new insulation installed.

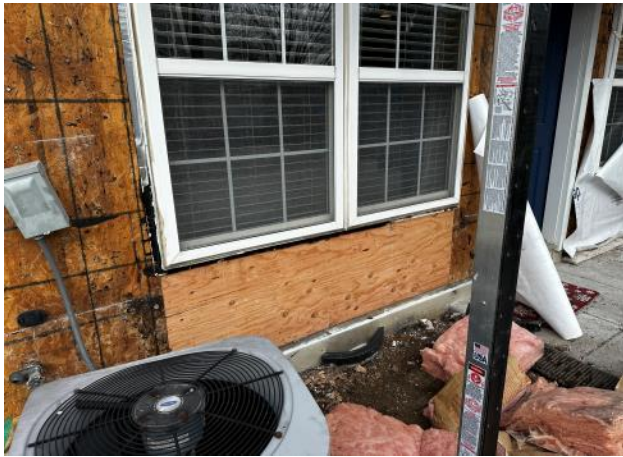
Photo #91: Overview of new sheathing installed below a lower window.

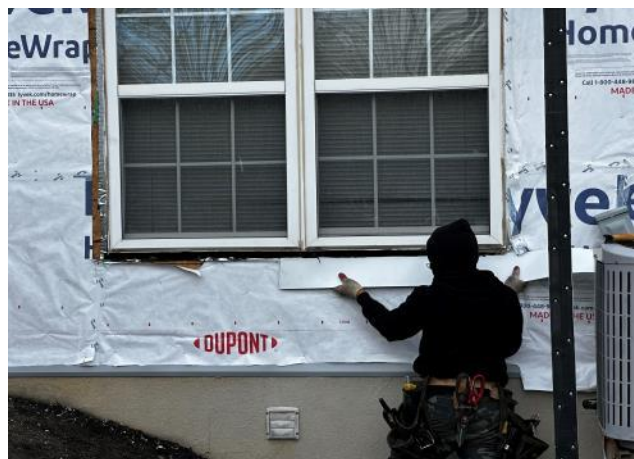
Photo #93: Overview of new metal flashing being installed at the bottom of a window.
