**Project:** Courtyards of Carlisle CA – Siding Project

**Project #:** 14372-04

**Date:** Jan 3, 4, 5, 2024

## Field Report 6

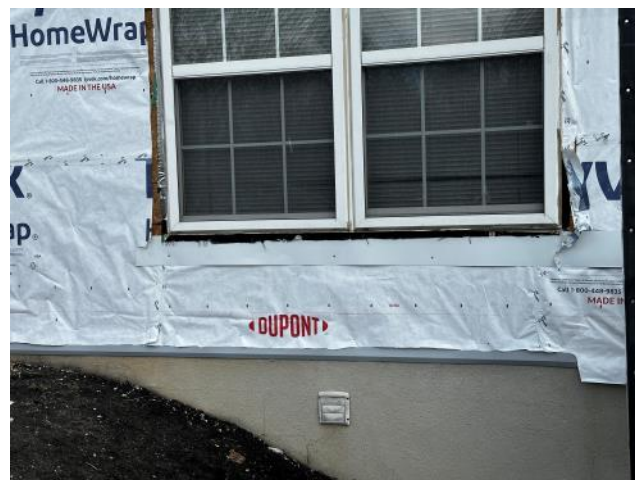
Photo #94: Overview of new metal flashing installed before installing the new starter strip.

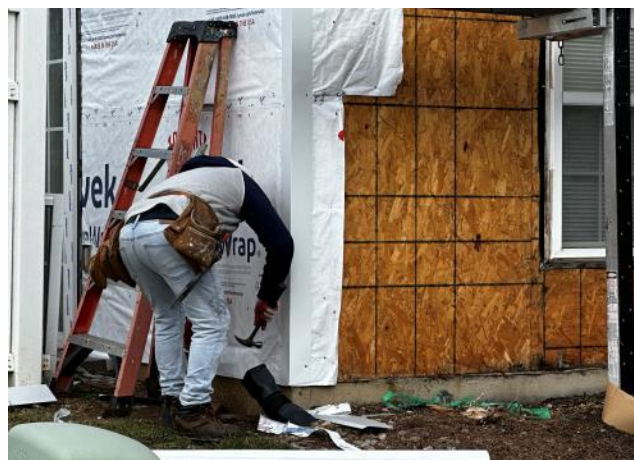
Photo #95: Overview of new metal flashing being installed at an outer corner.

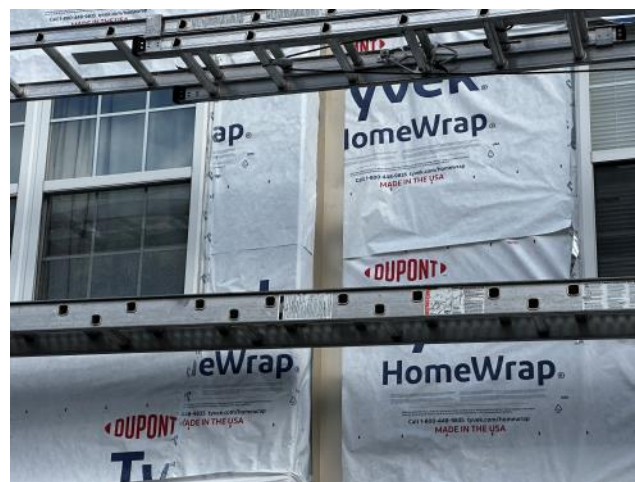
Photo #96: Overview of new metal flashing installed at an inside corner.

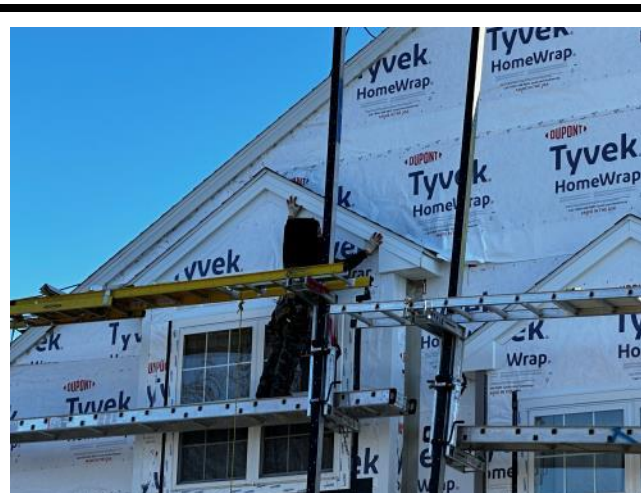
Photo #98: Overview of new metal wrap being installed at a rake board.

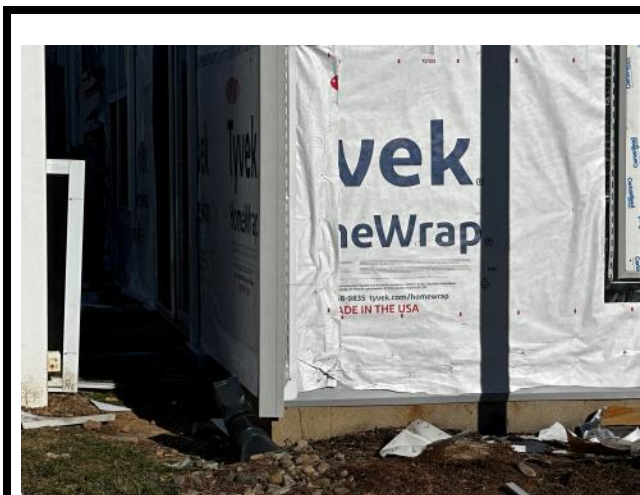
Photo #99: Overview of a new vinyl corner installed.

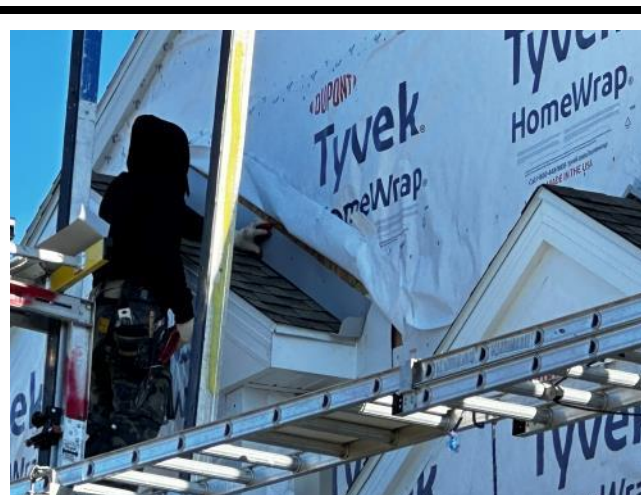
Photo #100: Overview of a new kick-out flashing installed.

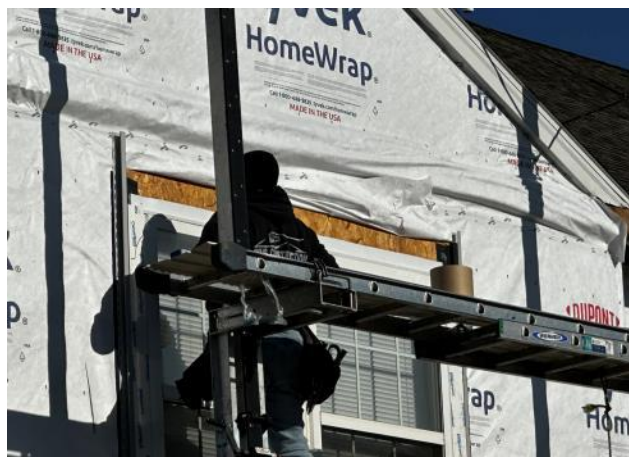
Photo #101: Overview of a new metal drip cap being installed.

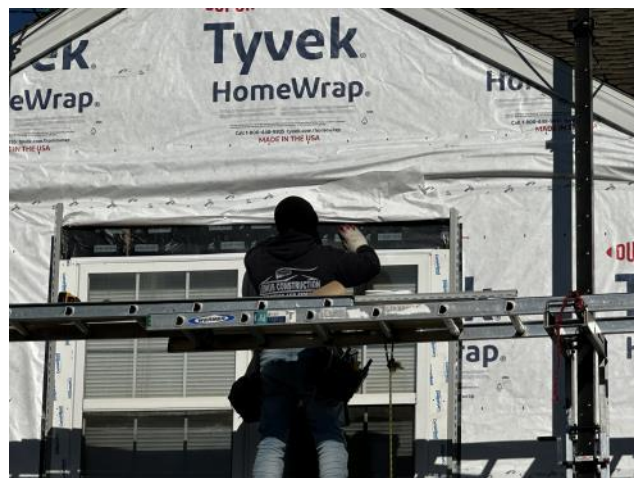
Photo #102: Overview of new flashing tape being installed at a header of another window.

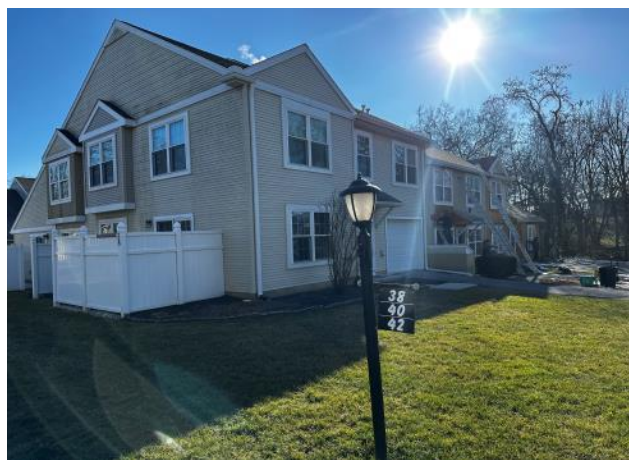
Photo #103: **Overview of Lemus Siding Crew (Blue) working at Building 4 (32-42 Courtyard Drive).**

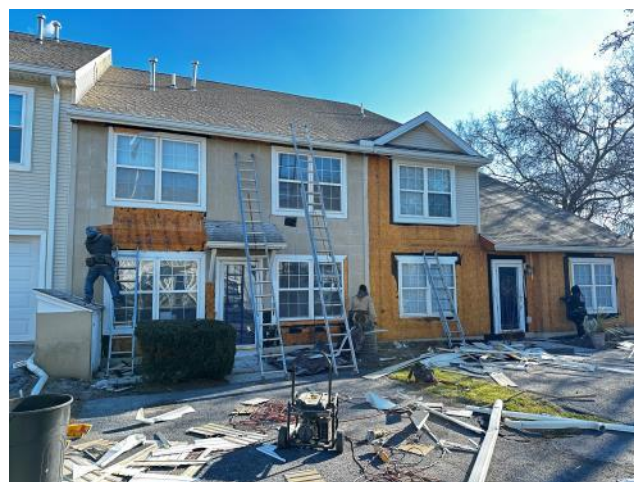
Photo #104: Overview of existing siding/stucco being removed at a front section of the Building.
